BIAS TIRE CONDITIONS ANALYSIS & REPAIR GUIDE

© Copyright 2008—Technology & Maintenance
Council of American Trucking Associations, Inc.
Printed in U.S.A.

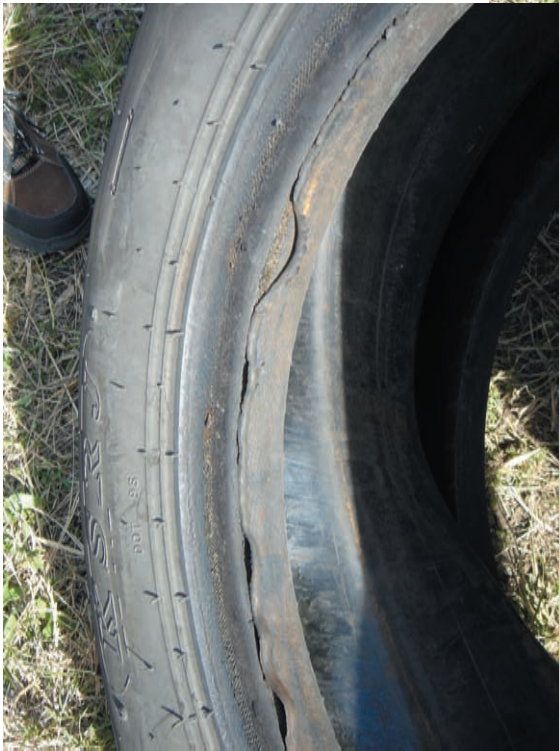
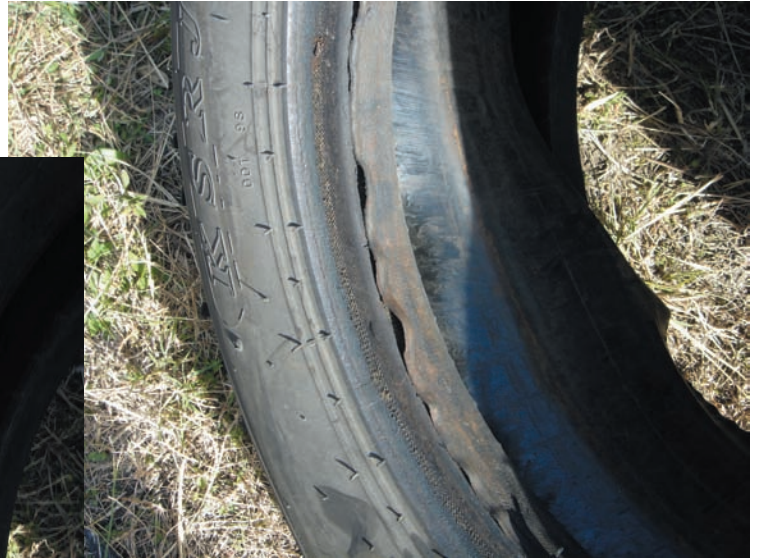
Top layer of bead rubber peeling away. Can occur on one or both beads. Found on tube-type tires.

PROBABLE CAUSE

Insufficient air pressure to carry load and/or damaged wheel components. Can be exaggerated by overload, improperly matched wheel components.

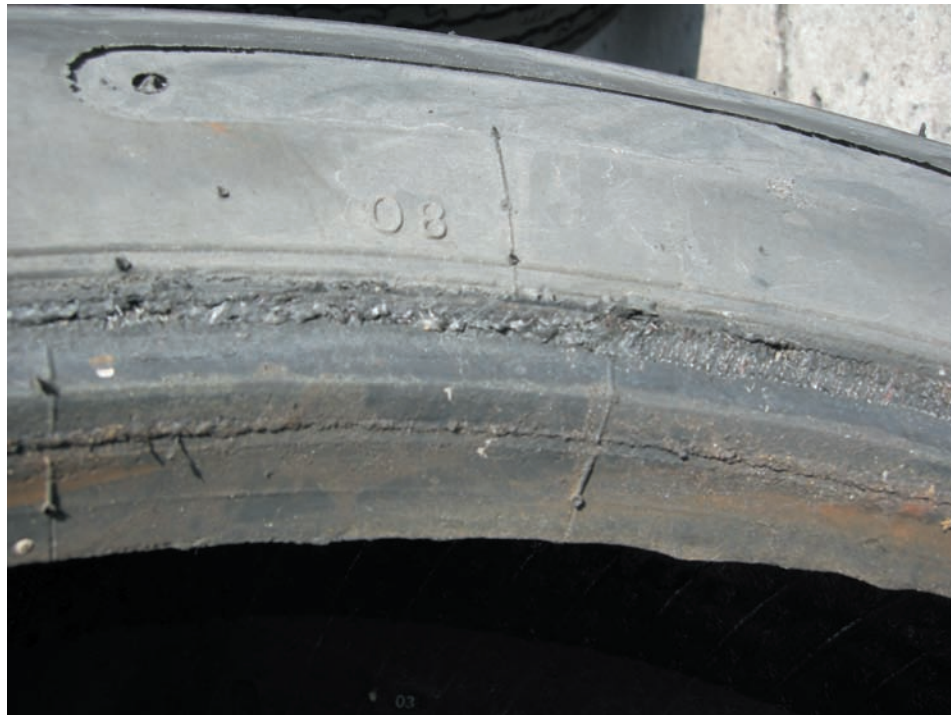
Circumferential indentation in the bead area of the tire. Found on tubeless tires.

PROBABLE CAUSE

Rusty rims, improper bead/rim lubrication, and bent or damaged rims which result in improper bead seating. Also overload or underinflation.

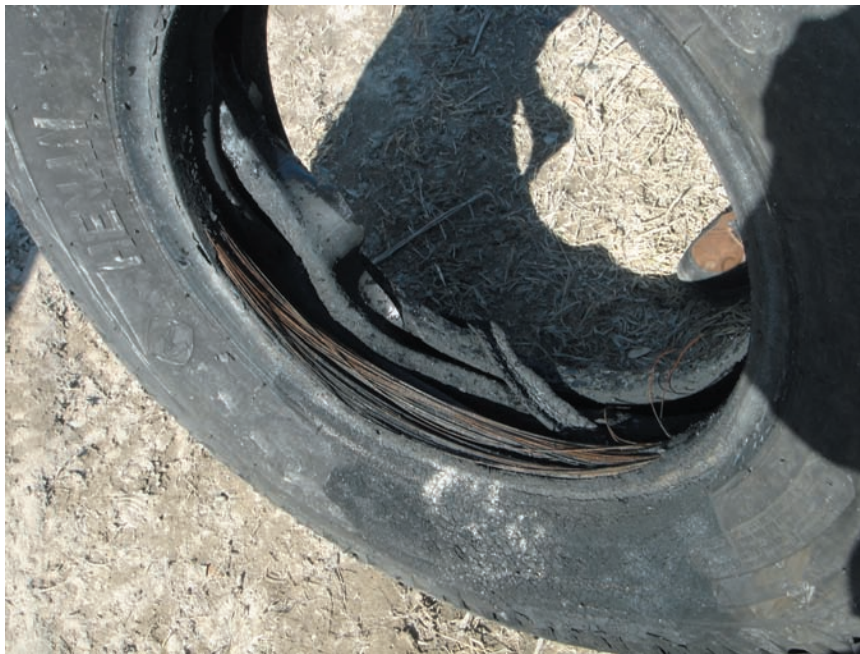
BURNED BEADS

PROBABLE CAUSE

Excessive heat exposure caused by frequent hard braking; improperly adjusted brakes; faulty braking system; insufficient air flow around brakes.

Determine the source of excessive heat and correct the condition.

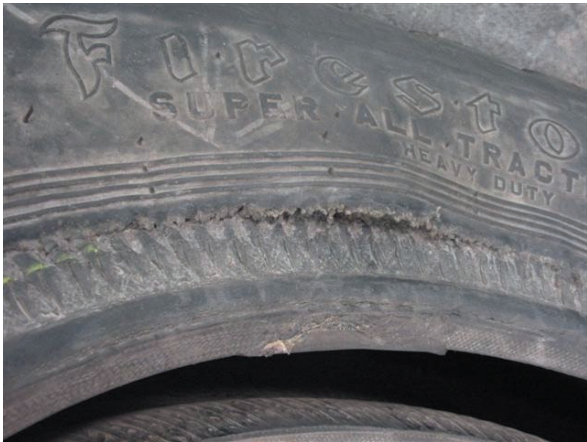
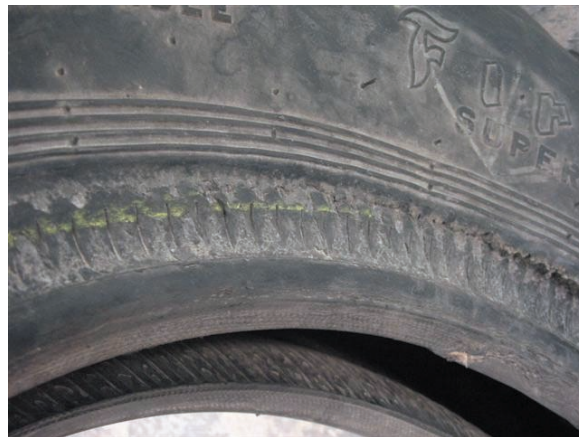
BEAD DAMAGE BY RIM/SPLIT SIDE RINGS

PROBABLE CAUSE

Improper mounting; friction between bead area and rim/side ring.

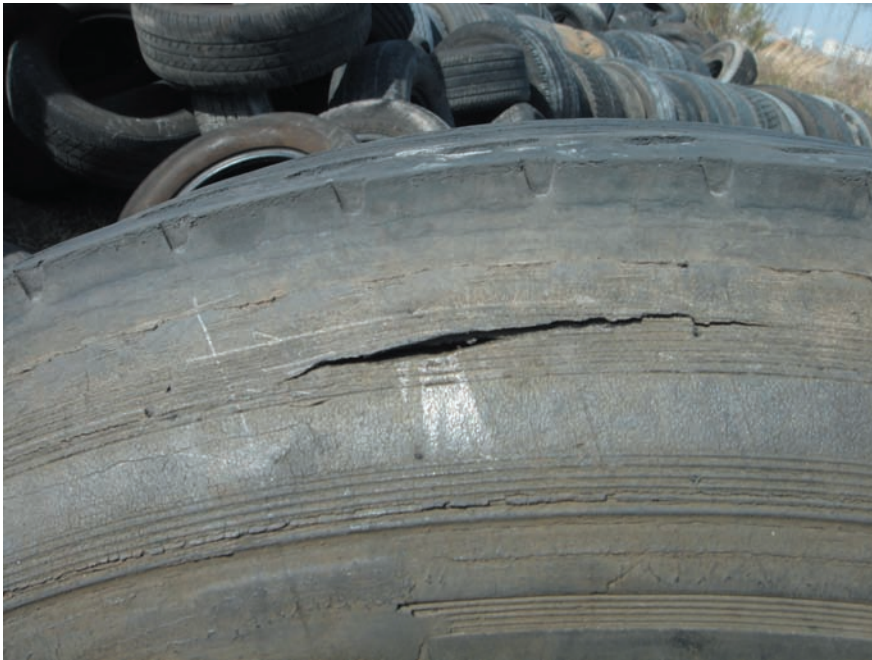
PROBABLE CAUSE

Weathering/ozone cracking.

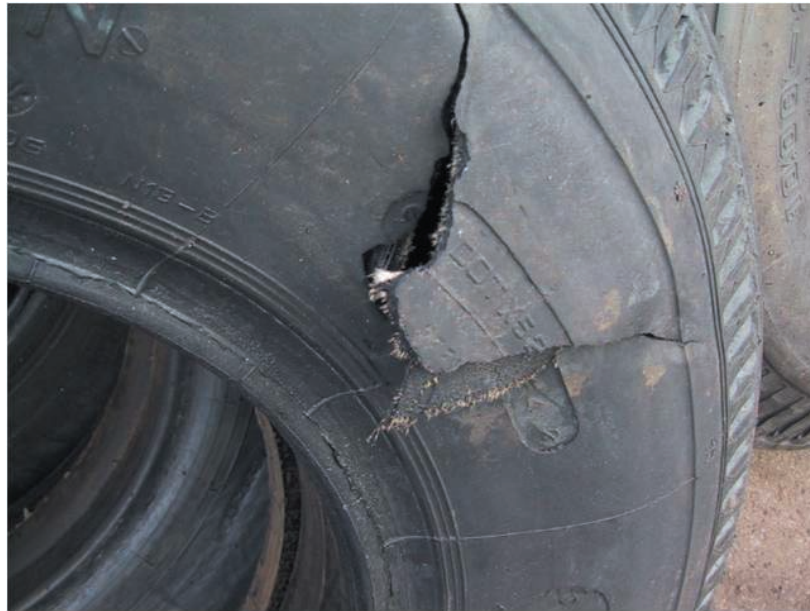
PROBABLE CAUSE

Caused by a sudden impact with a road hazard or pot hole. Aggravated by overinflation.

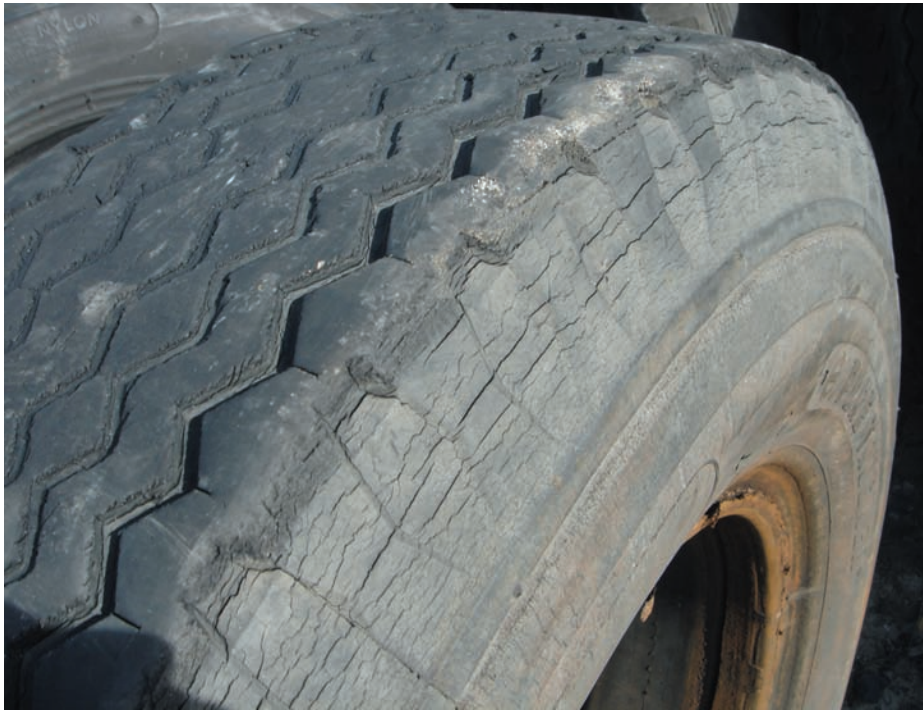
WEATHERING/CRACKING/DRY ROT

Numerous tiny cracks in the rubber surface, usually 360° around the tire.

PROBABLE CAUSE

Normal aging condition but can be aggravated by extended periods of parking and exposure to high concentrations of ozone. Ozone can be generated from many sources, such as engine exhaust, mercury vapor lamps, welding, electric generators, etc.

All tires may eventually exhibit this condition in late service-life stage. Tires with ozone cracks deeper than 2/32" should be removed from service.

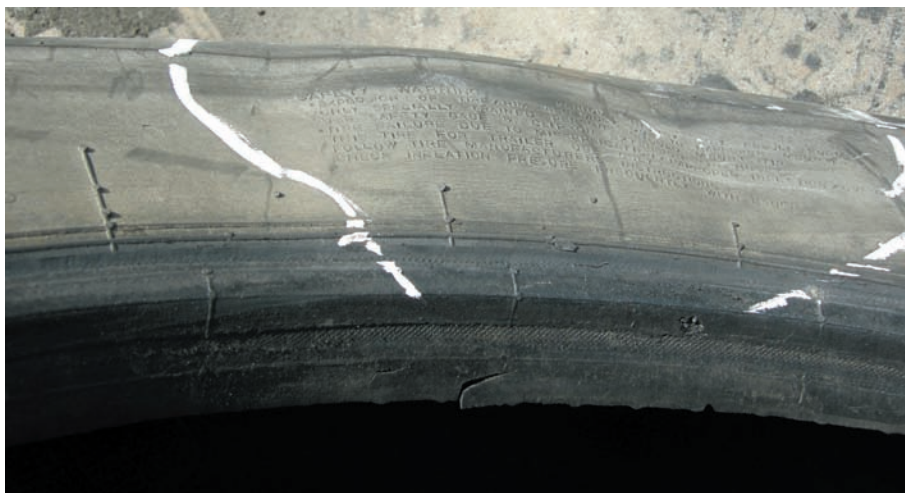
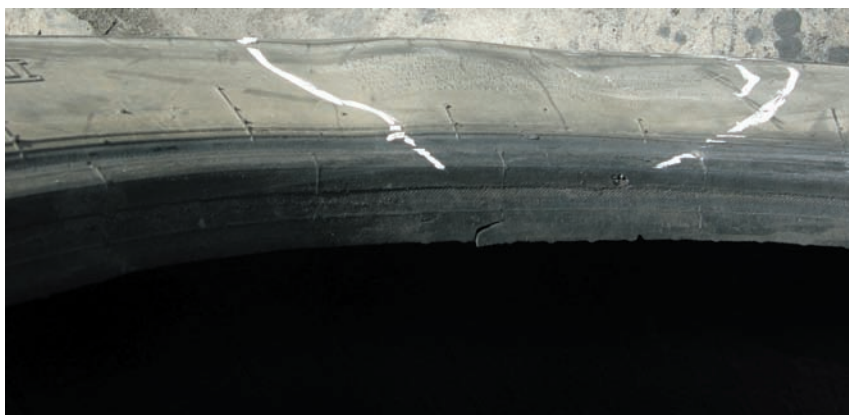
SIDEWALL SEPARATION DUE TO BEAD DAMAGE

PROBABLE CAUSE

Air migration through the casing resulting from bead damage.

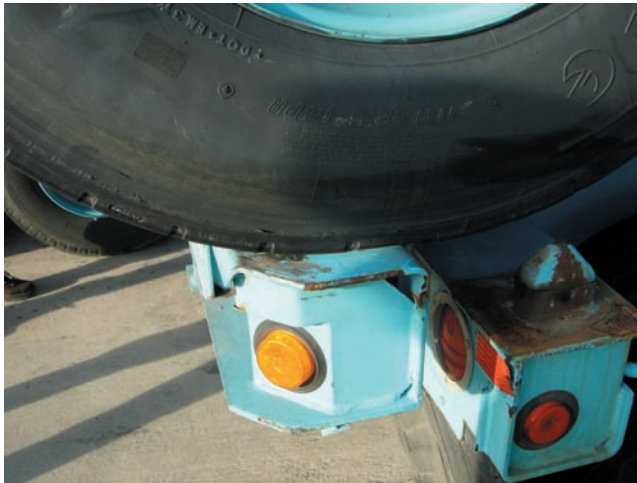
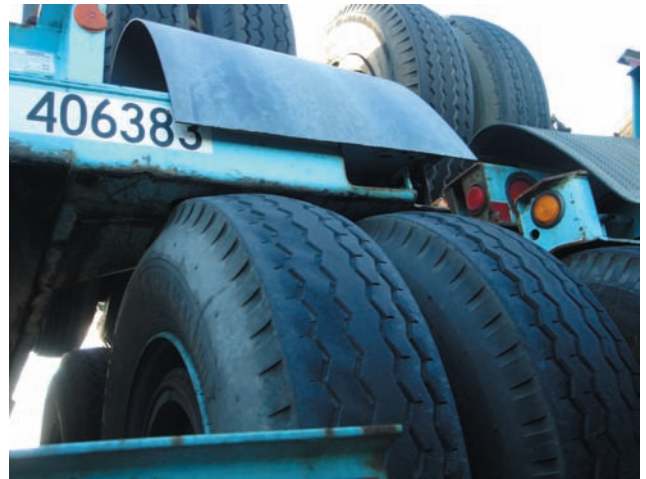
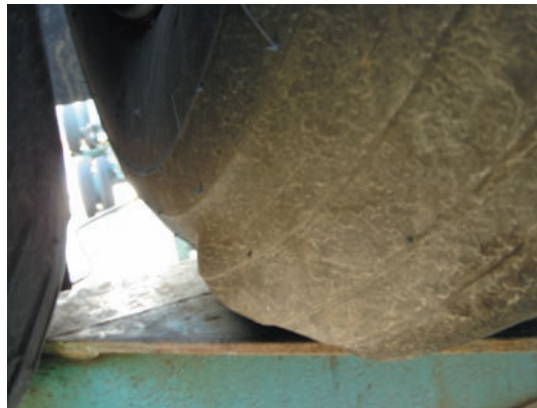
STACKING DAMAGE—SIDEWALL/SHOULDER

PROBABLE CAUSE

Contact with vehicle components, such as loose u-bolts, slipped spring clips, restraining bolts, loose fenders, flap hangers, and trailer wheel house molding, etc.

Return the tire to service on a dual position unless abrasion extends to the ply cords. If the cords are exposed, consult your tire repair facility for the possibility of repair.

Analyze cause of the condition and correct. Ensure the tire does not come in contact with vehicle components.

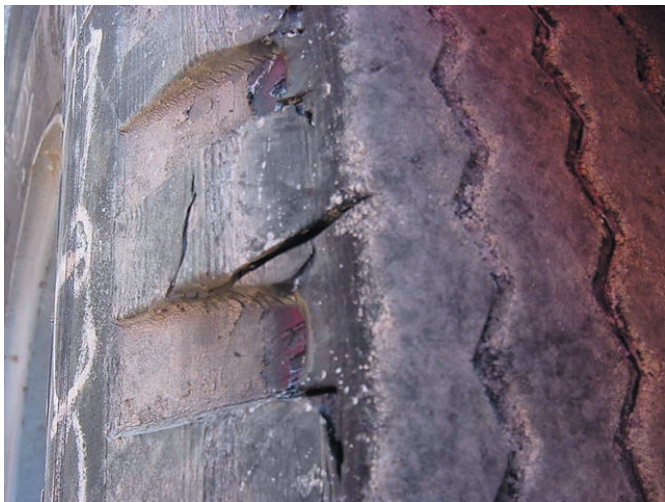
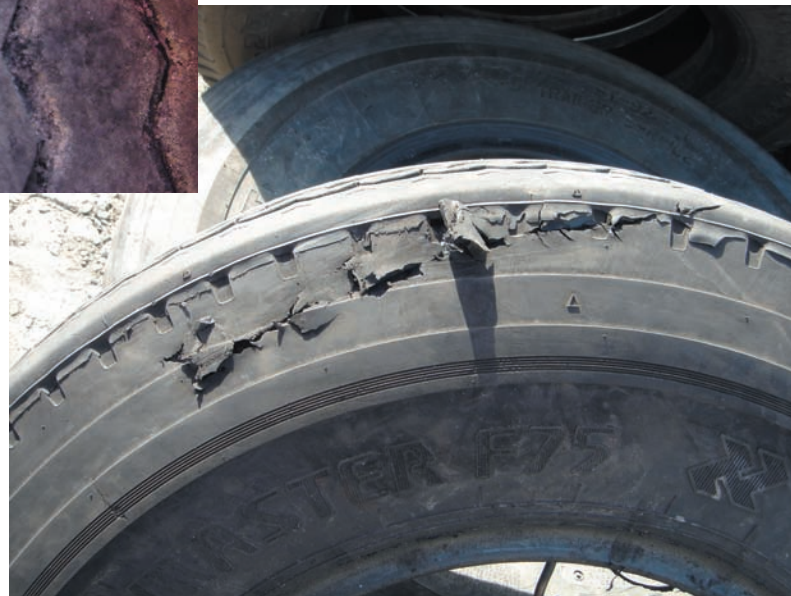
SURFACE CUT FROM STACKING DAMAGE

PROBABLE CAUSE

Road hazard, rails, rebar, etc. May occur during chassis stacking.

Remove tire from service. Send to repair/retread supplier for possible repair or scrap.

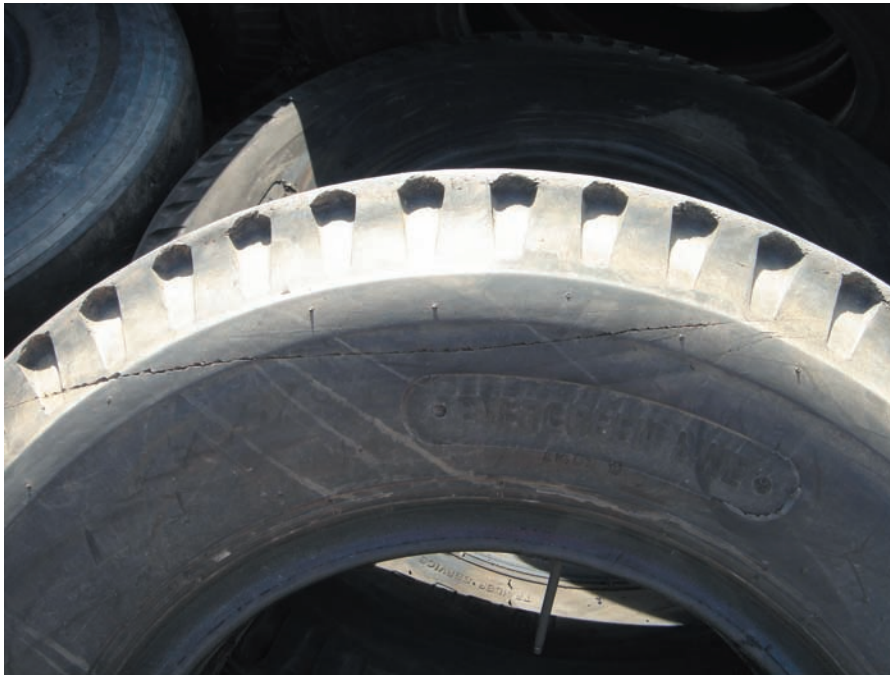
PROBABLE CAUSE

Road hazard, curbing, rails, vandalism, etc.

If cords are visible, repair the tire if damage to cords is within repair limits and return to service; otherwise scrap tire. If cords are not visible, have a spot repair made to prevent damage growth.

If similar damage occurs on several tires, investigate vehicle operations to determine the cause of the damage.

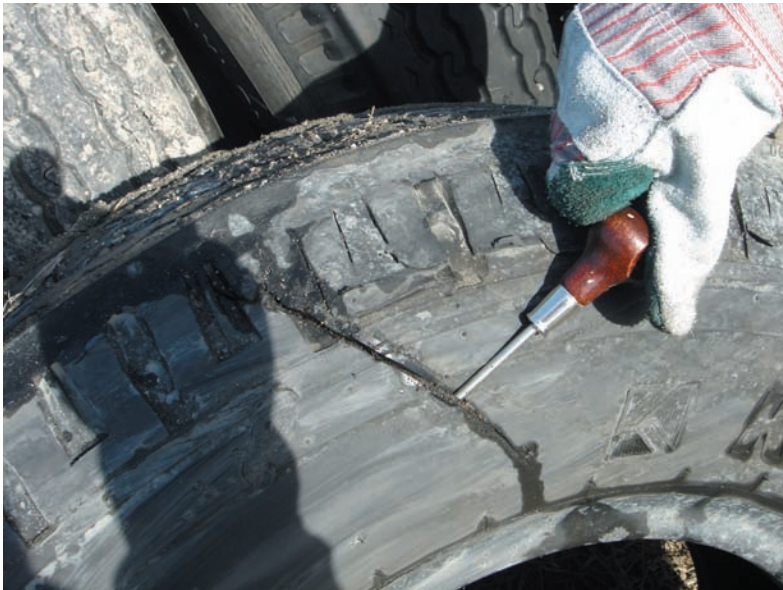
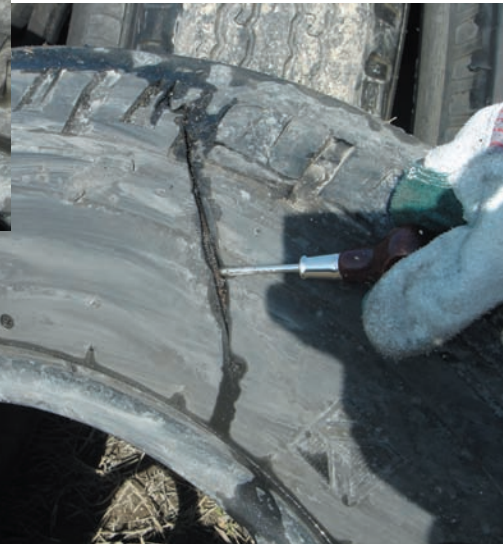
PROBABLE CAUSE

Contact with road debris/hazard.

If cords are visible, repair the tire if damage to cords is within repair limits and return to service; otherwise scrap tire. If cords are not visible, have a spot repair made to prevent damage growth.

If similar damage occurs on several tires, investigate vehicle operations to determine the cause of the damage.

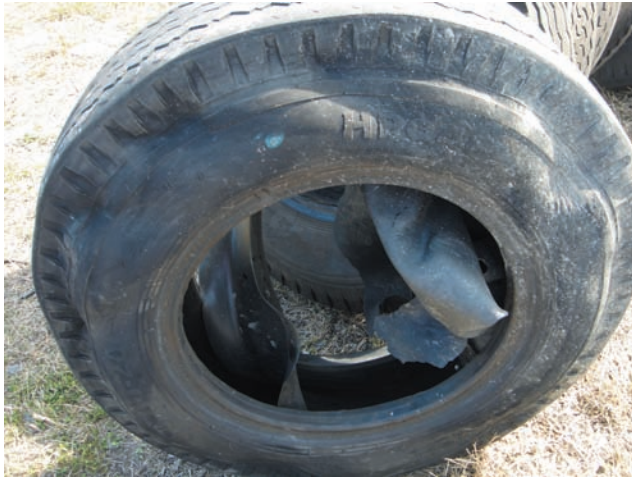
PROBABLE CAUSE

Continued operation while underinflated and/or overloaded.

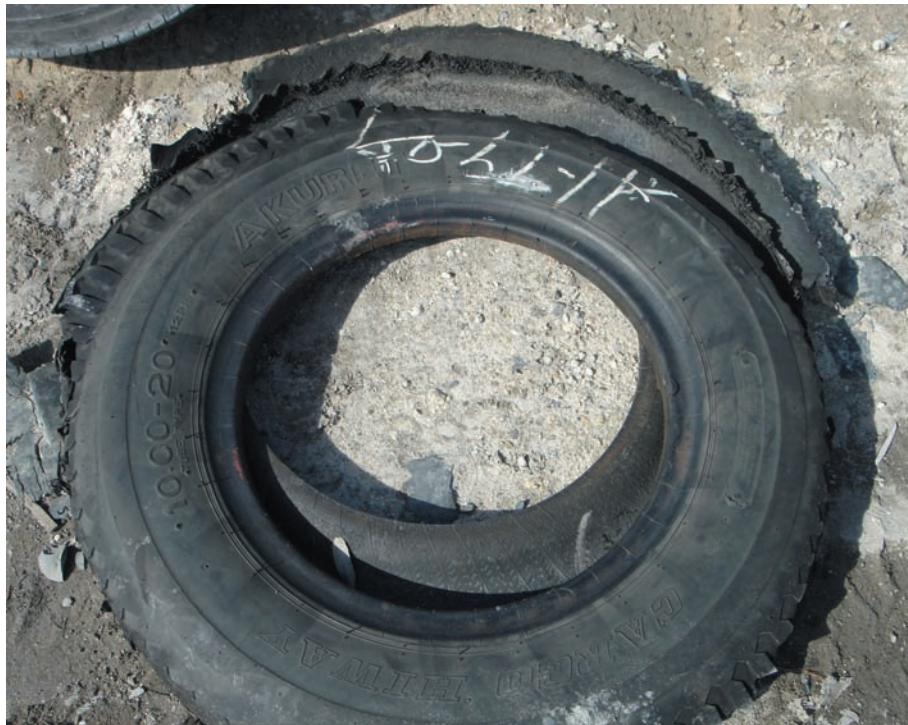
PROBABLE CAUSE

Continued operation while underinflated and/or overloaded.

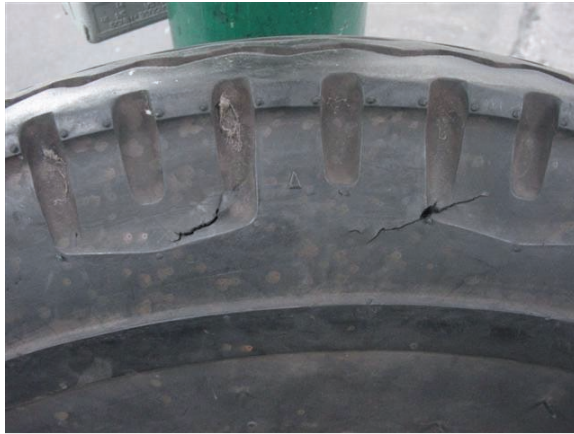
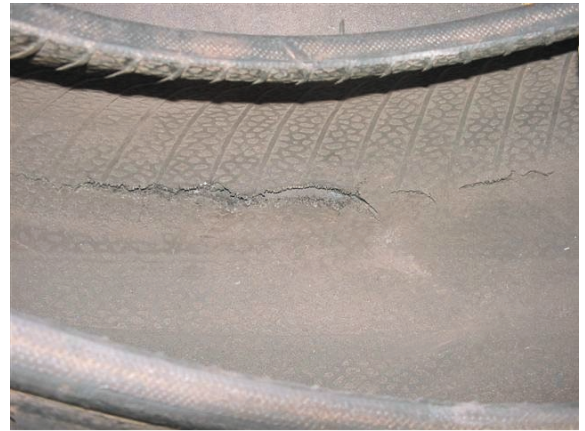
SIDEWALL INNERLINER CRACKS

PROBABLE CAUSE

Continued operation while overloaded and underinflated

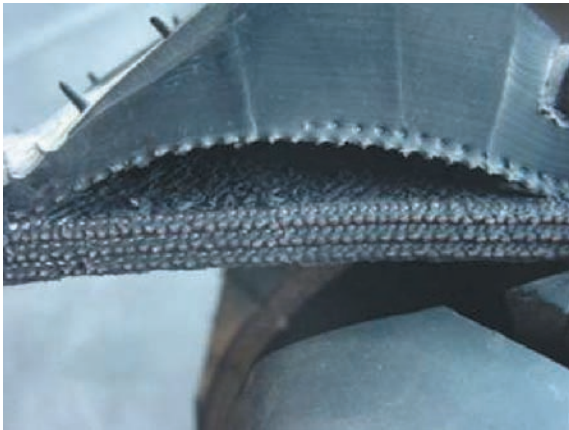
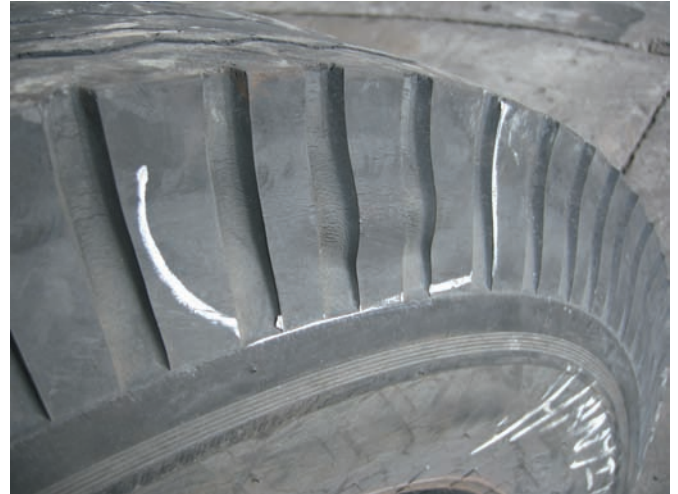
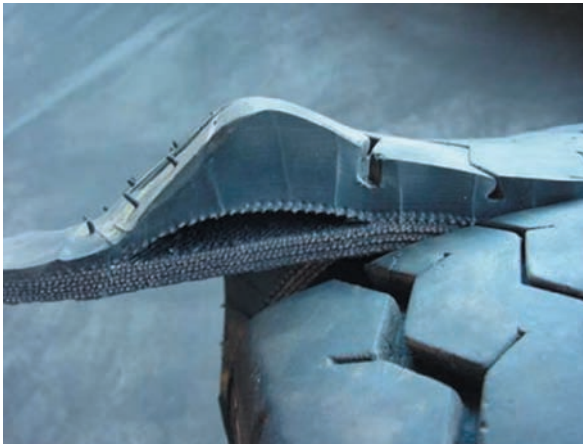
PROBABLE CAUSE

Contamination, foreign material, overload, improper pressure. Check for punctures, repairs, contamination, breaks or underinflation.

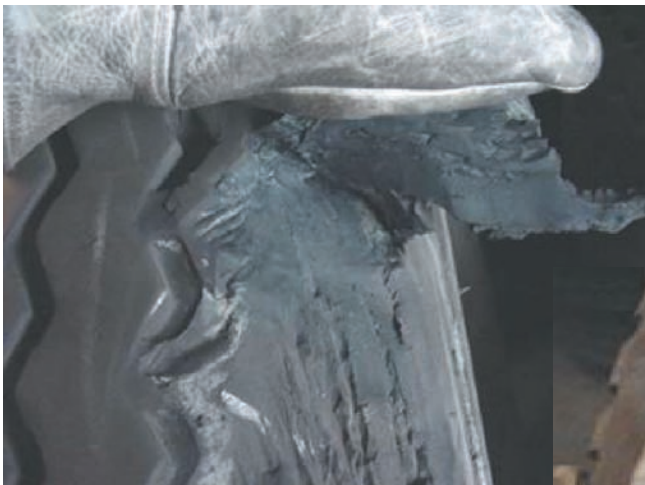
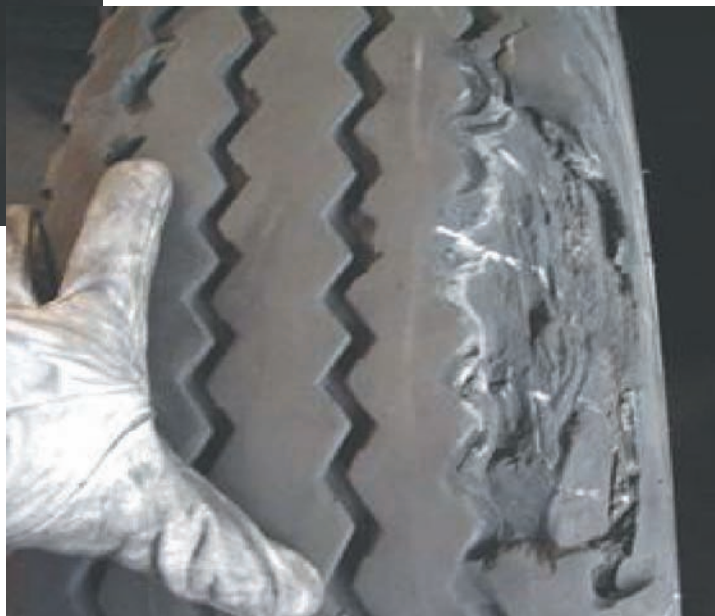
Caused by running over curbs, rails, sidewalks, severe localized impacts and aggravated by underinflated and overloaded tires.

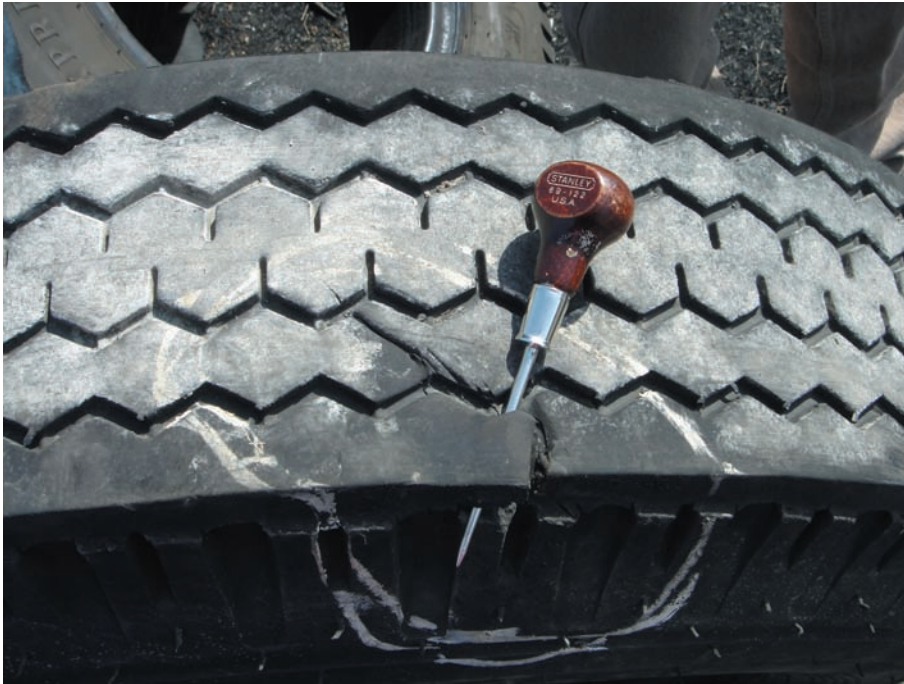
PROBABLE CAUSE

Road hazard, curbing, rails, vandalism, etc.

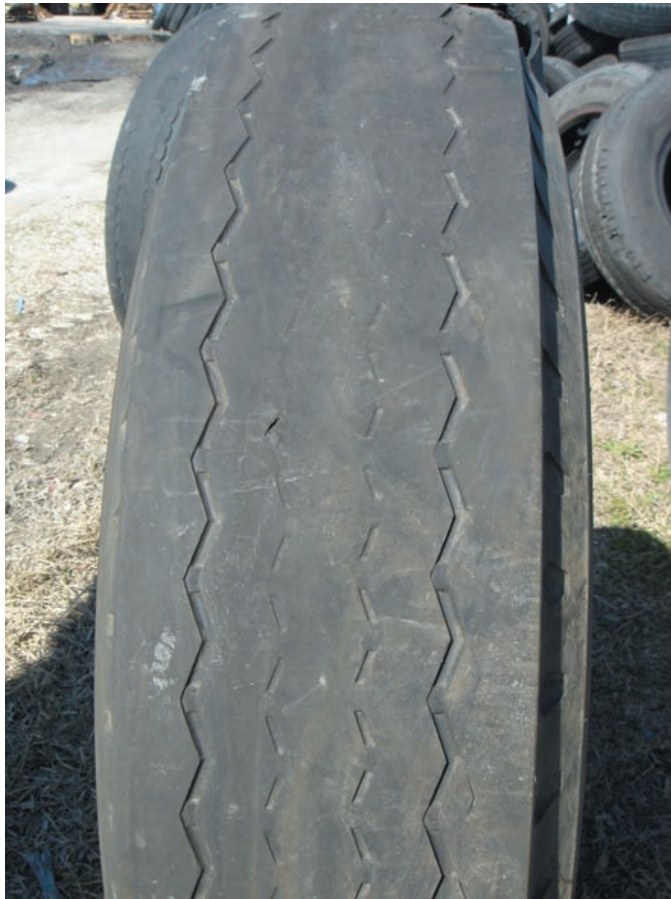
PROBABLE CAUSE

Tire run too long in service or worn brake skid left in service.

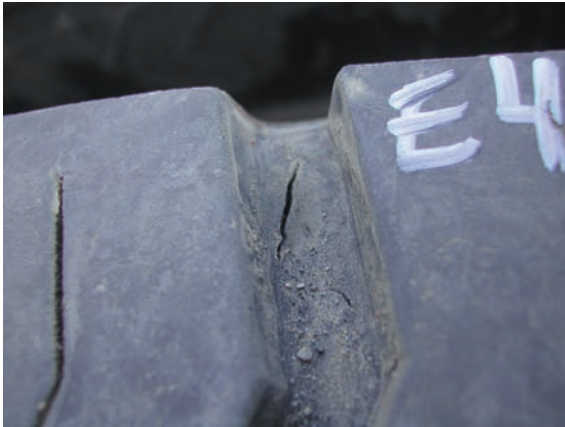
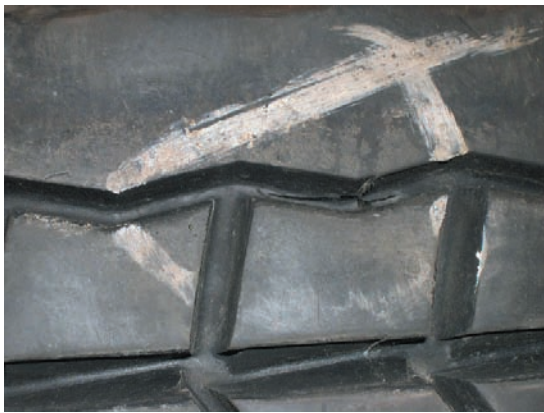
PROBABLE CAUSE

Caused by casing growth, prolonged underinflation, weathering or insufficient undertread in new tire. Can be aggravated by excessive speed and rock cuts.

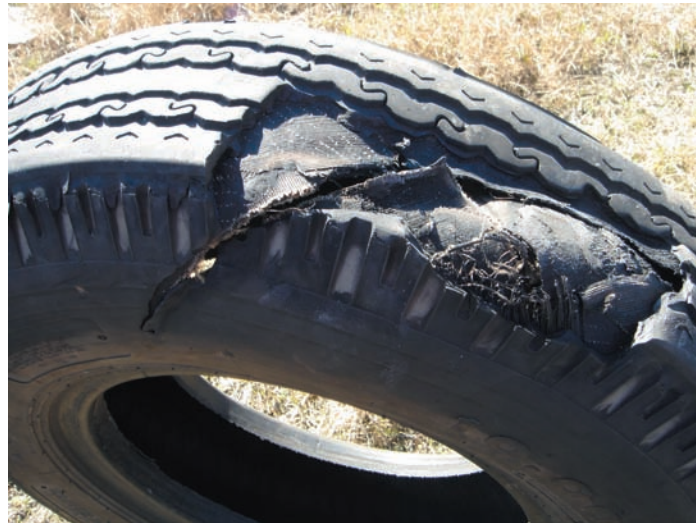
Severe, concentrated impact with a foreign object or a pothole. Aggravated by overinflation and high speed.

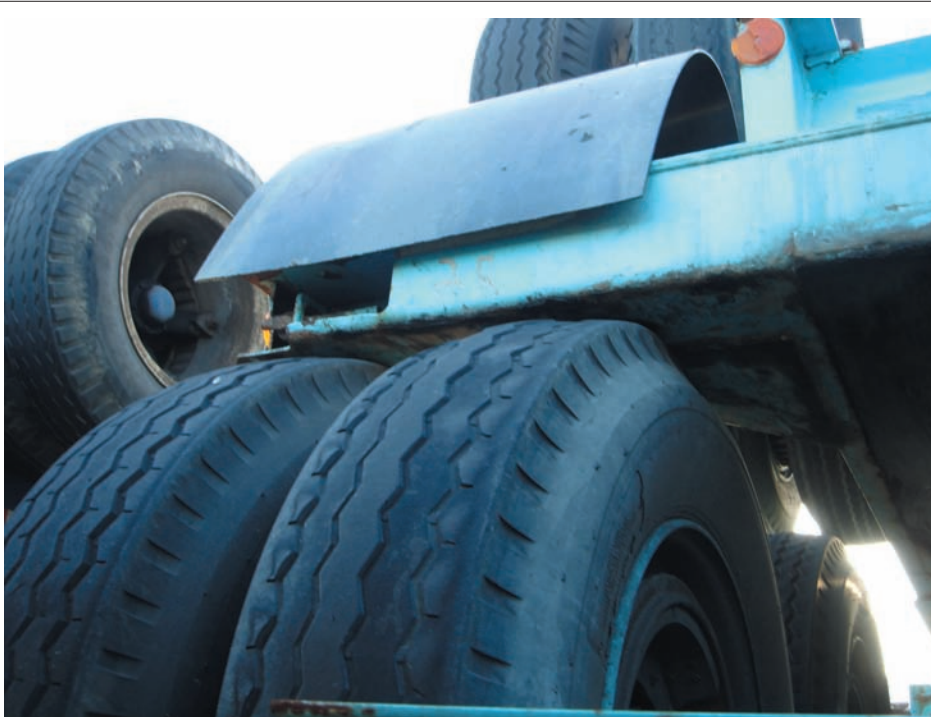
PROBABLE CAUSE

Excessive camber, misaligned or bent axle, or improper bearing adjustment.

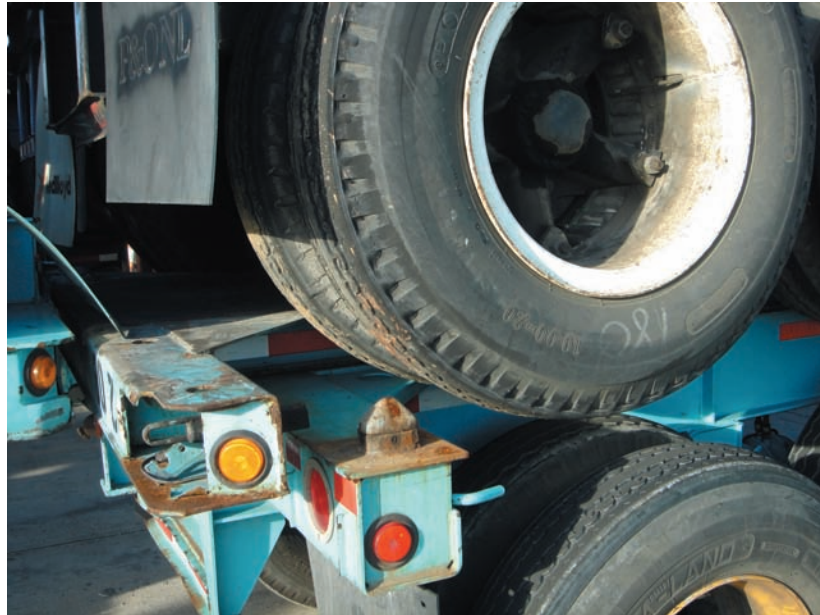
Caused by tire contact with stacked chassis component.

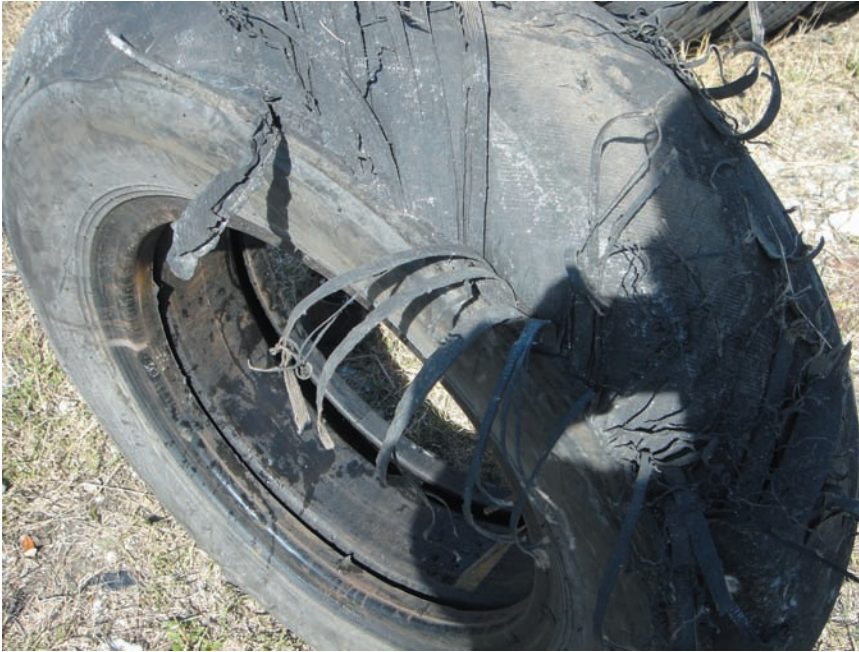
PROBABLE CAUSE

Operation after tread separation or body cord exposure.

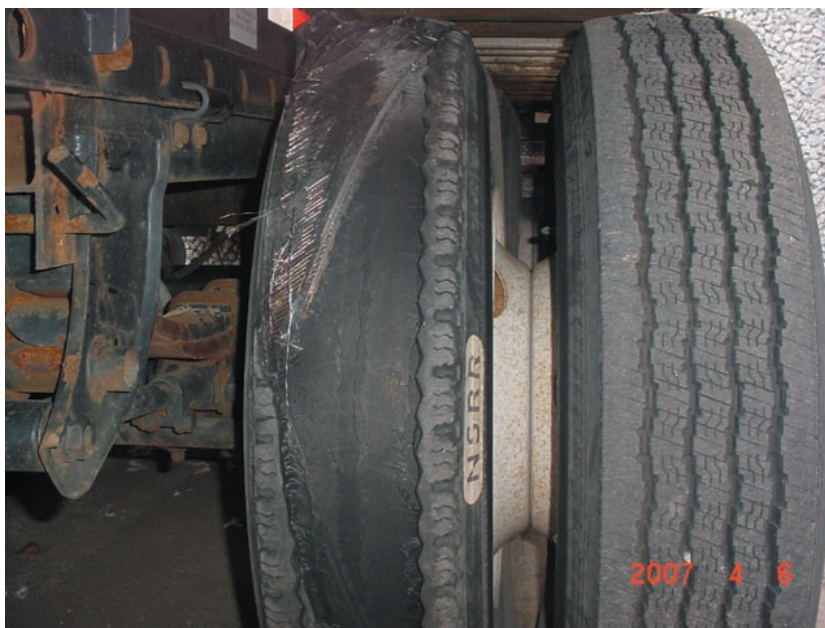
Faulty retread and/or repair workmanship and/or material.

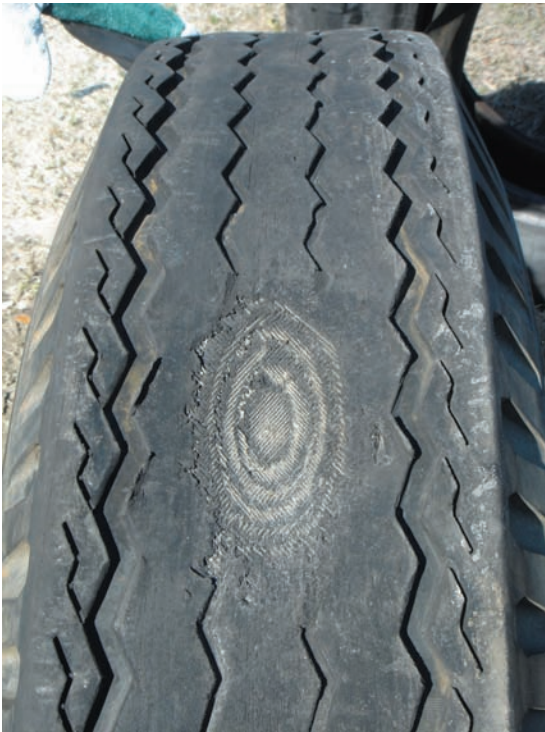
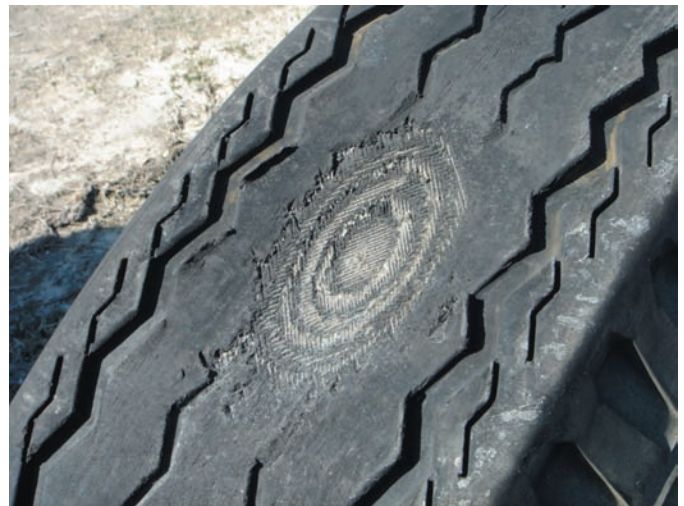
PROBABLE CAUSE

Brake skid usually occurs on trailer and drive tires. Aggravated by new brakes (high friction, not worn in), unbalanced brake system, aggressive use of brakes, driver abuse and unloaded vehicles. Frequently associated with gravel surfaces

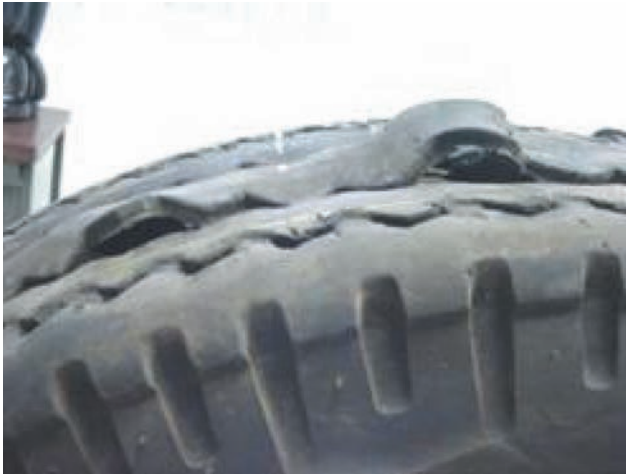
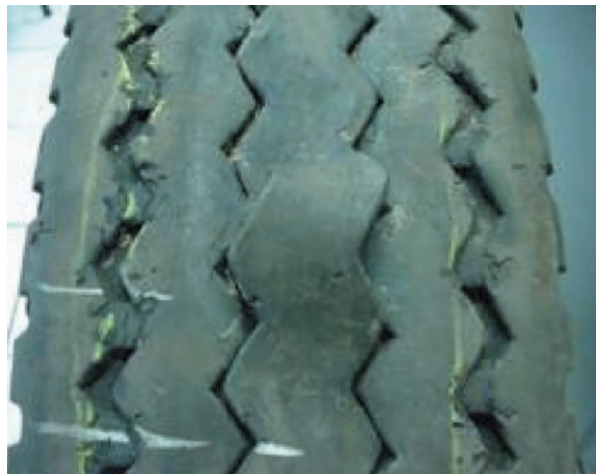
Caused by tire running over curbs or rails or by severe localized impacts.

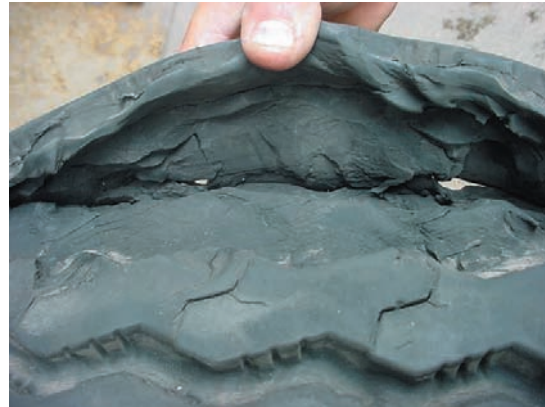
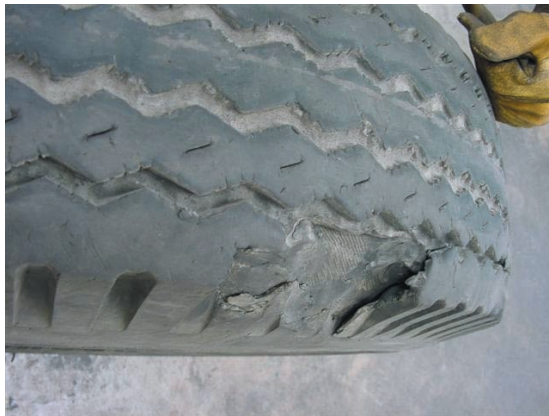
PROBABLE CAUSE

Caused by running over curbs, rails, sidewalks or sharp turning. Sometimes could be caused by a tread leaving casing.

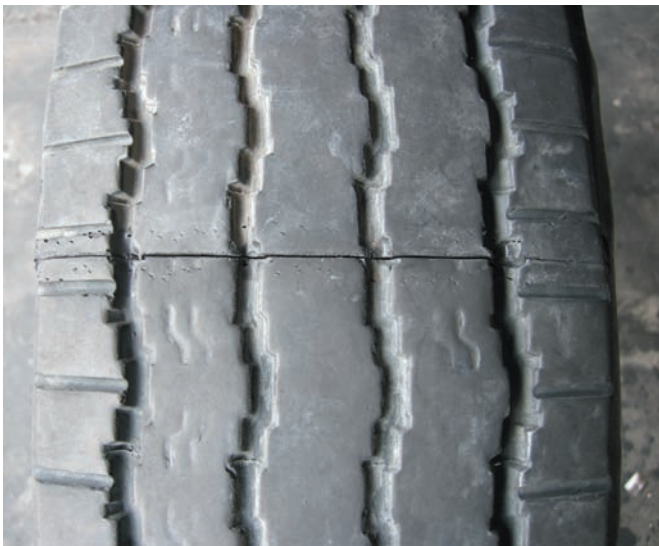
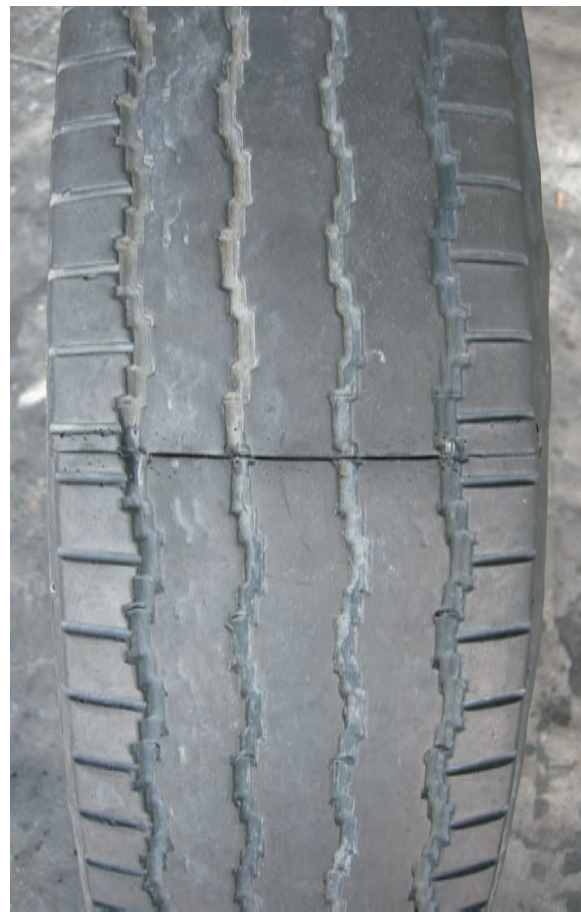
PROBABLE CAUSE

Poor workmanship, poor tread end adhesion or the tread was cut too short.

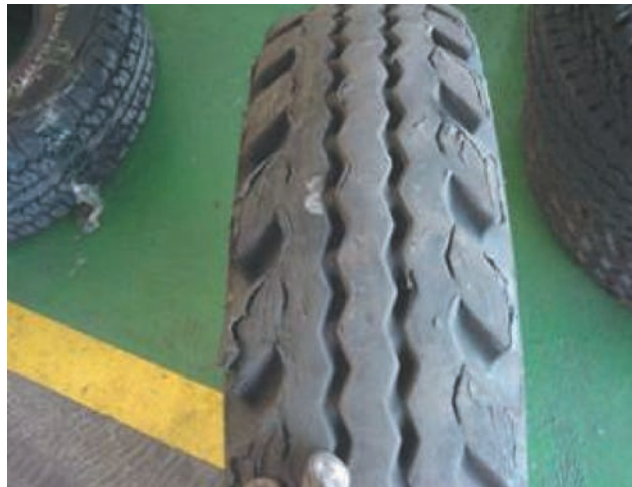
PROBABLE CAUSE

Rubber compounding condition, contamination of tread rubber.

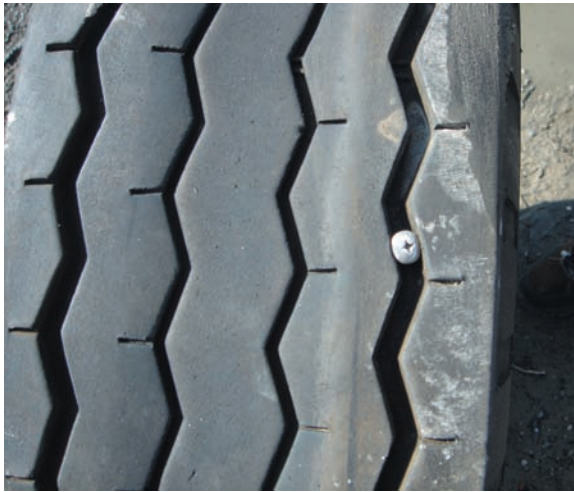
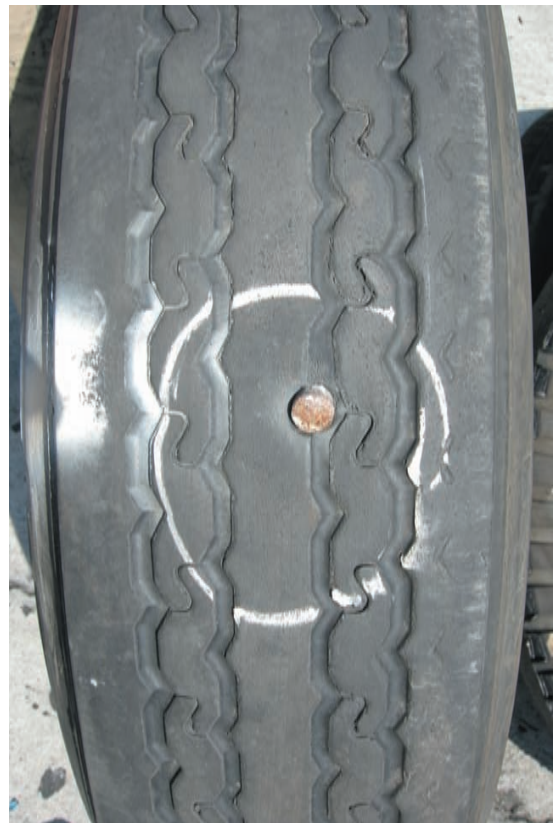
PROBABLE CAUSE

Road hazard or foreign object.

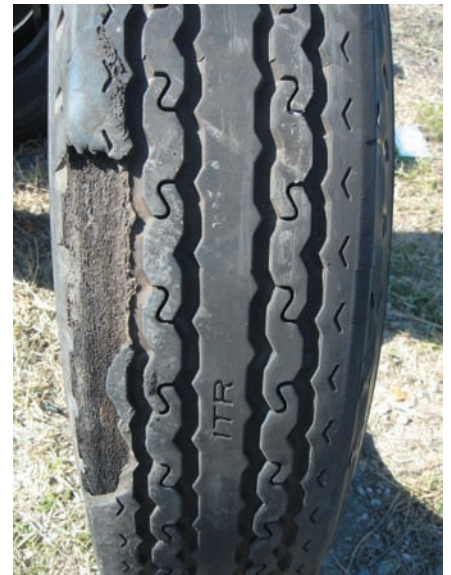
PROBABLE CAUSE

Cure pressure. Faulty retread workmanship and/or material such as a scorched or contaminated buffed surface, old cushion gum, wet cement, or tread rubber, improper cure conditions, missed nail hole, or a faulty repair.

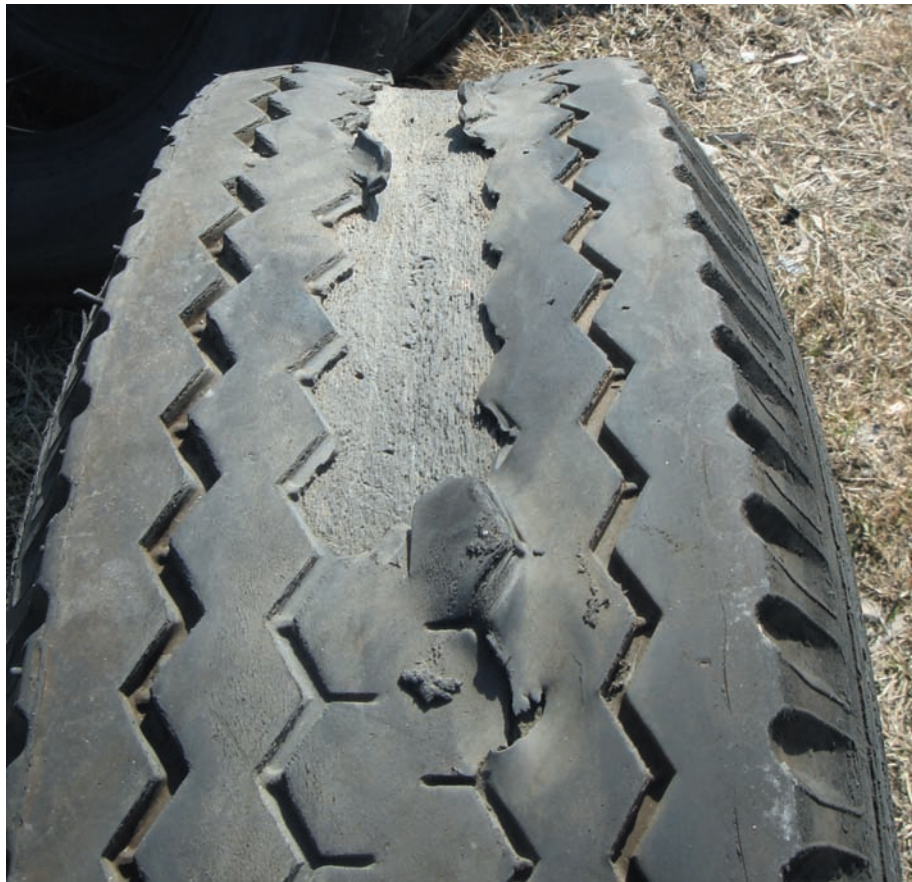
PROBABLE CAUSE

Mold cure retread with insufficient rubber in center of tread.

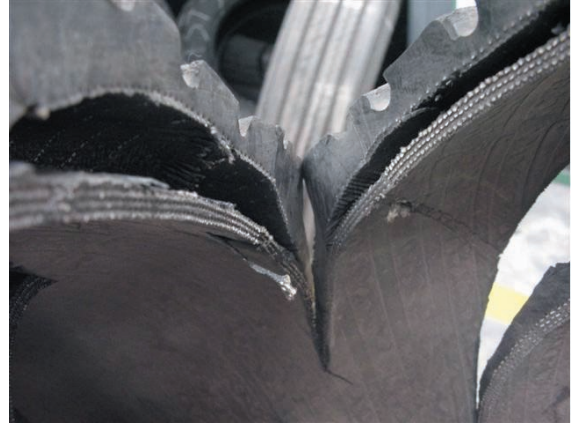
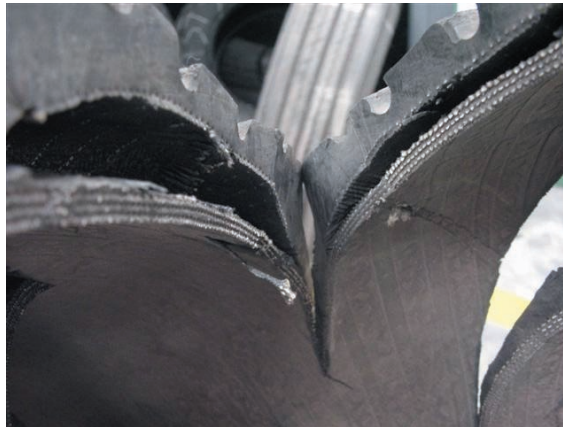
PROBABLE CAUSE

Faulty repair. Air seeped through or was trapped in the injury and under the tread which eventually reduced adhesion between the tread and the tire and resulted in a separation.

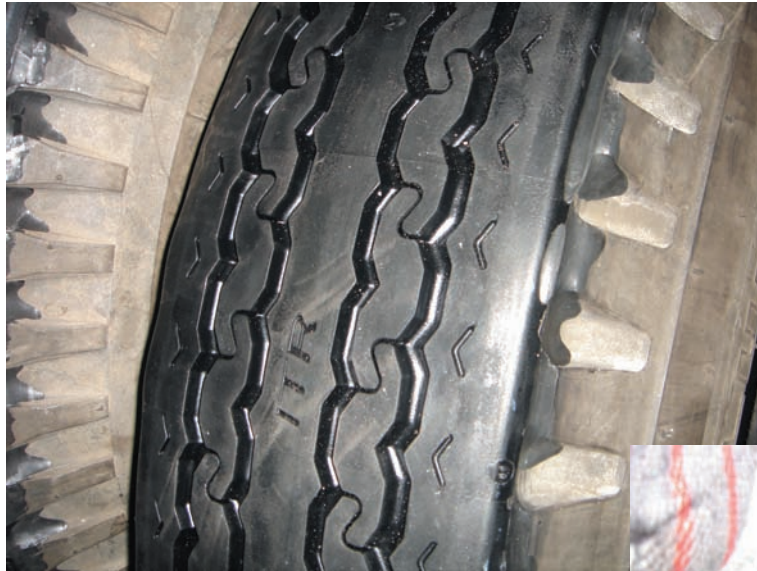
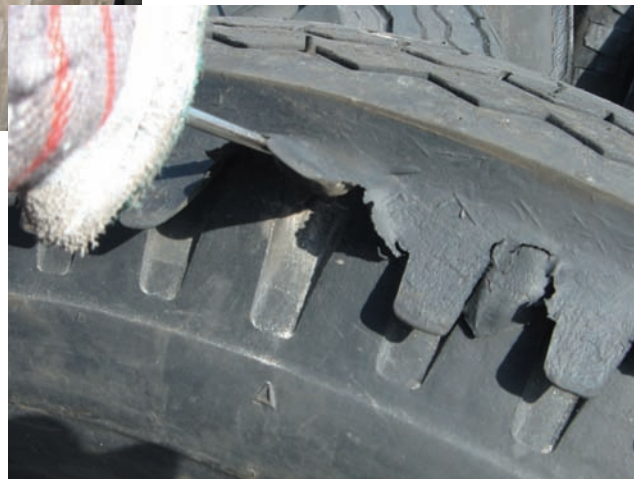
PROBABLE CAUSE

Untrimmed rubber after curing.
