BIAS TIRE CONDITIONS ANALYSIS & REPAIR GUIDE

© Copyright 2008—Technology & Maintenance
Council of American Trucking Associations, Inc.
Printed in U.S.A.

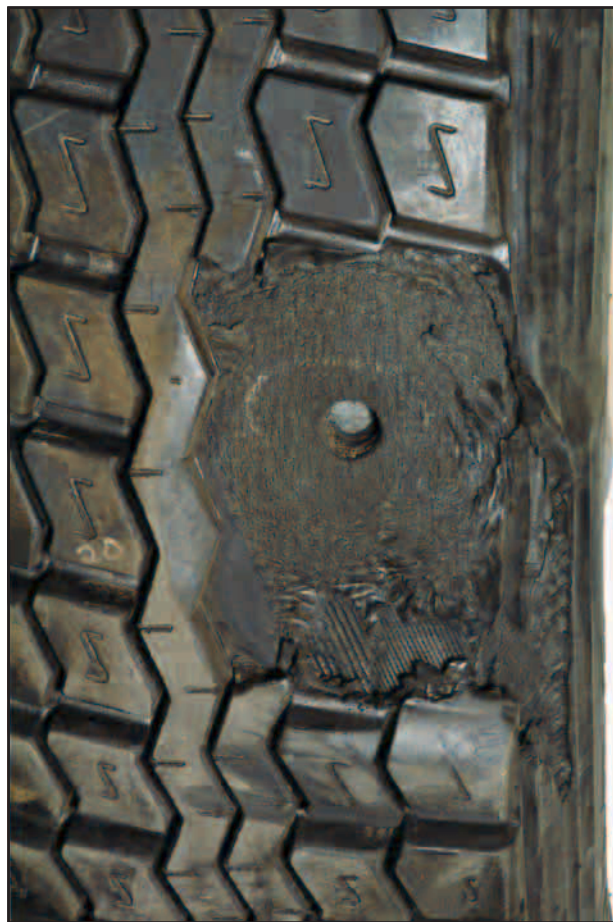
PROBABLE CAUSE

Faulty repair. Air seeped through or was trapped in the injury and under the tread which eventually reduced adhesion between the tread and the tire and resulted in a separation.

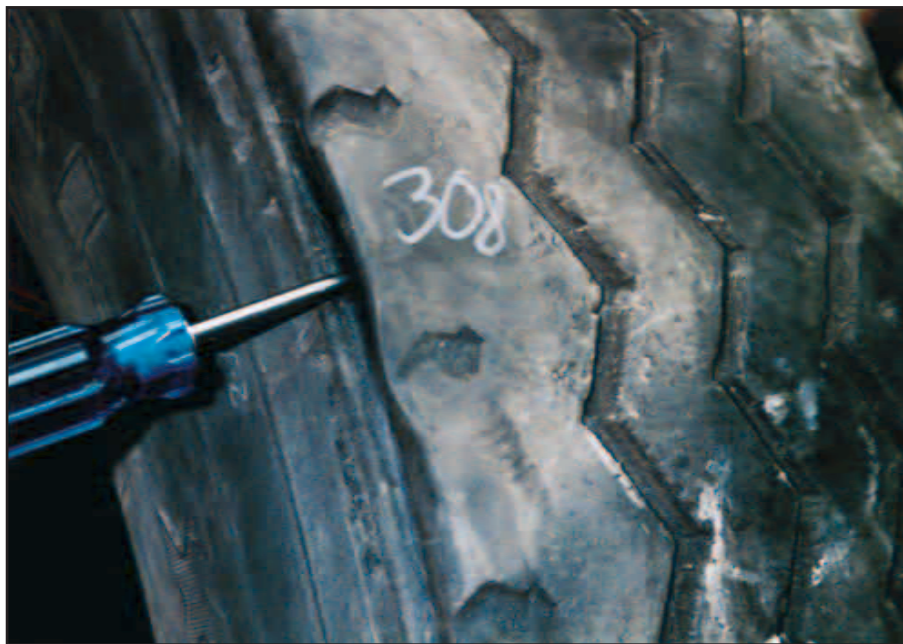
Caused by: cure related problems, retread processing problems, improper shoulder buff, insufficient bonding gum, or improper tread selection for application.

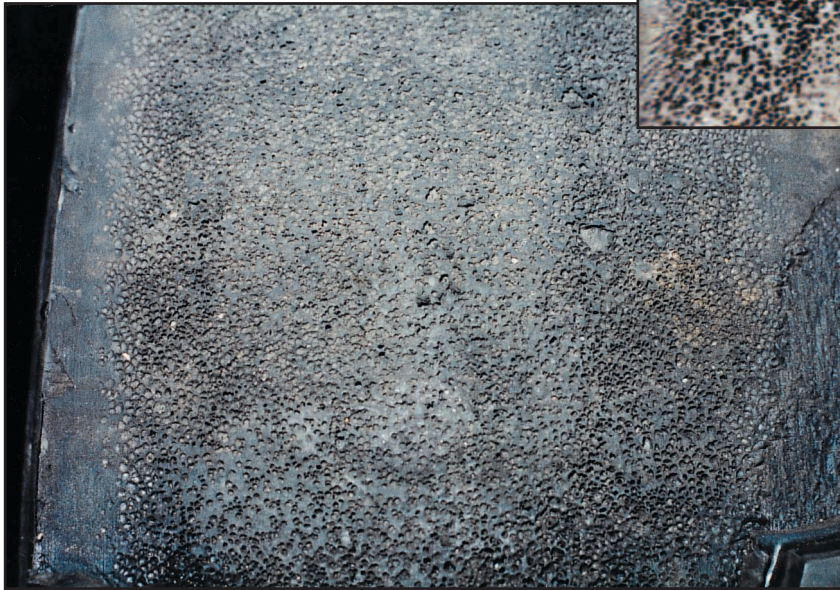
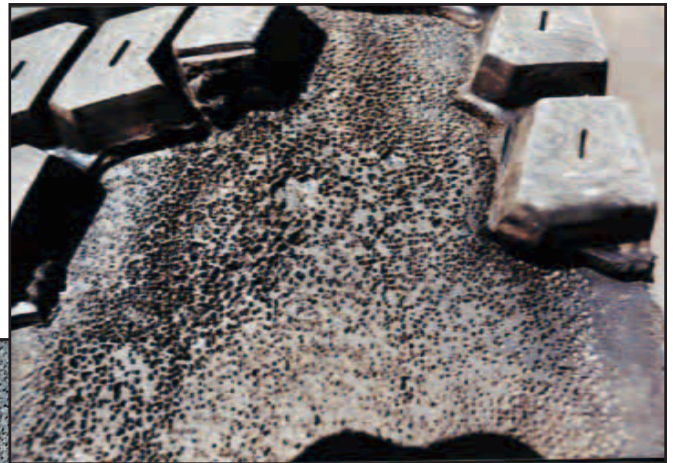
PROBABLE CAUSE

Lack of proper cure conditions, i.e., time, temperature and pressure.

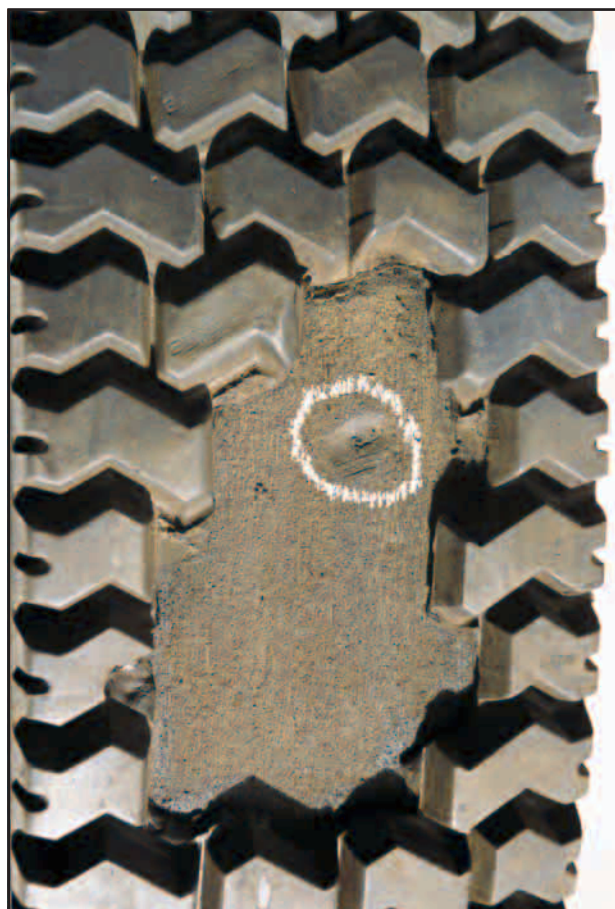
PROBABLE CAUSE

An undetected and/or unrepaired penetration.

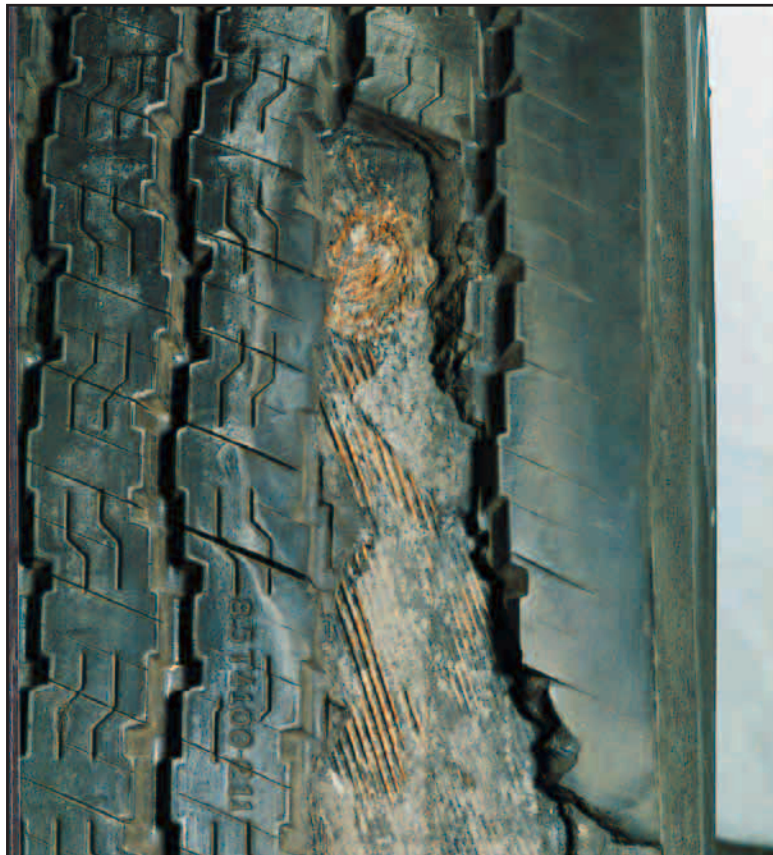
SKIVE FAILURE

PROBABLE CAUSE

Improper skive workmanship which causes poor adhesion resulting from scorching, loose cable ends, wet cement, and/or incorrect skive fill that traps air.

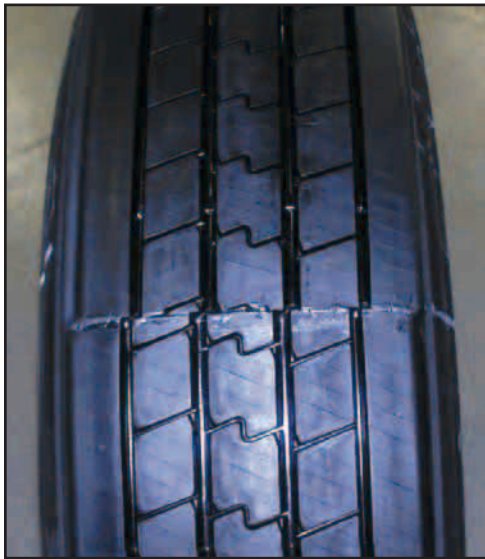
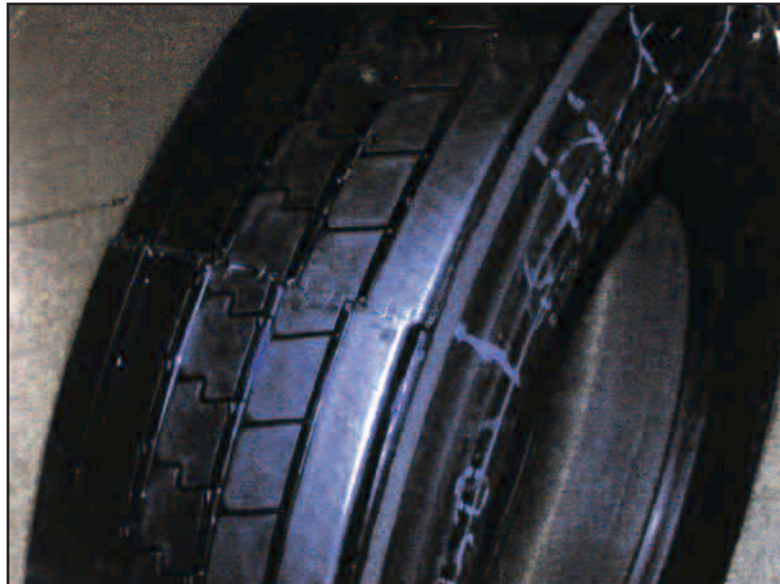
PROBABLE CAUSE

Poor/improper tread application.
