## INTERMODAL INSPECTION PROGRAM

Properly Identifying the  
Components of Intermodal  
Equipment

## Section F Damage

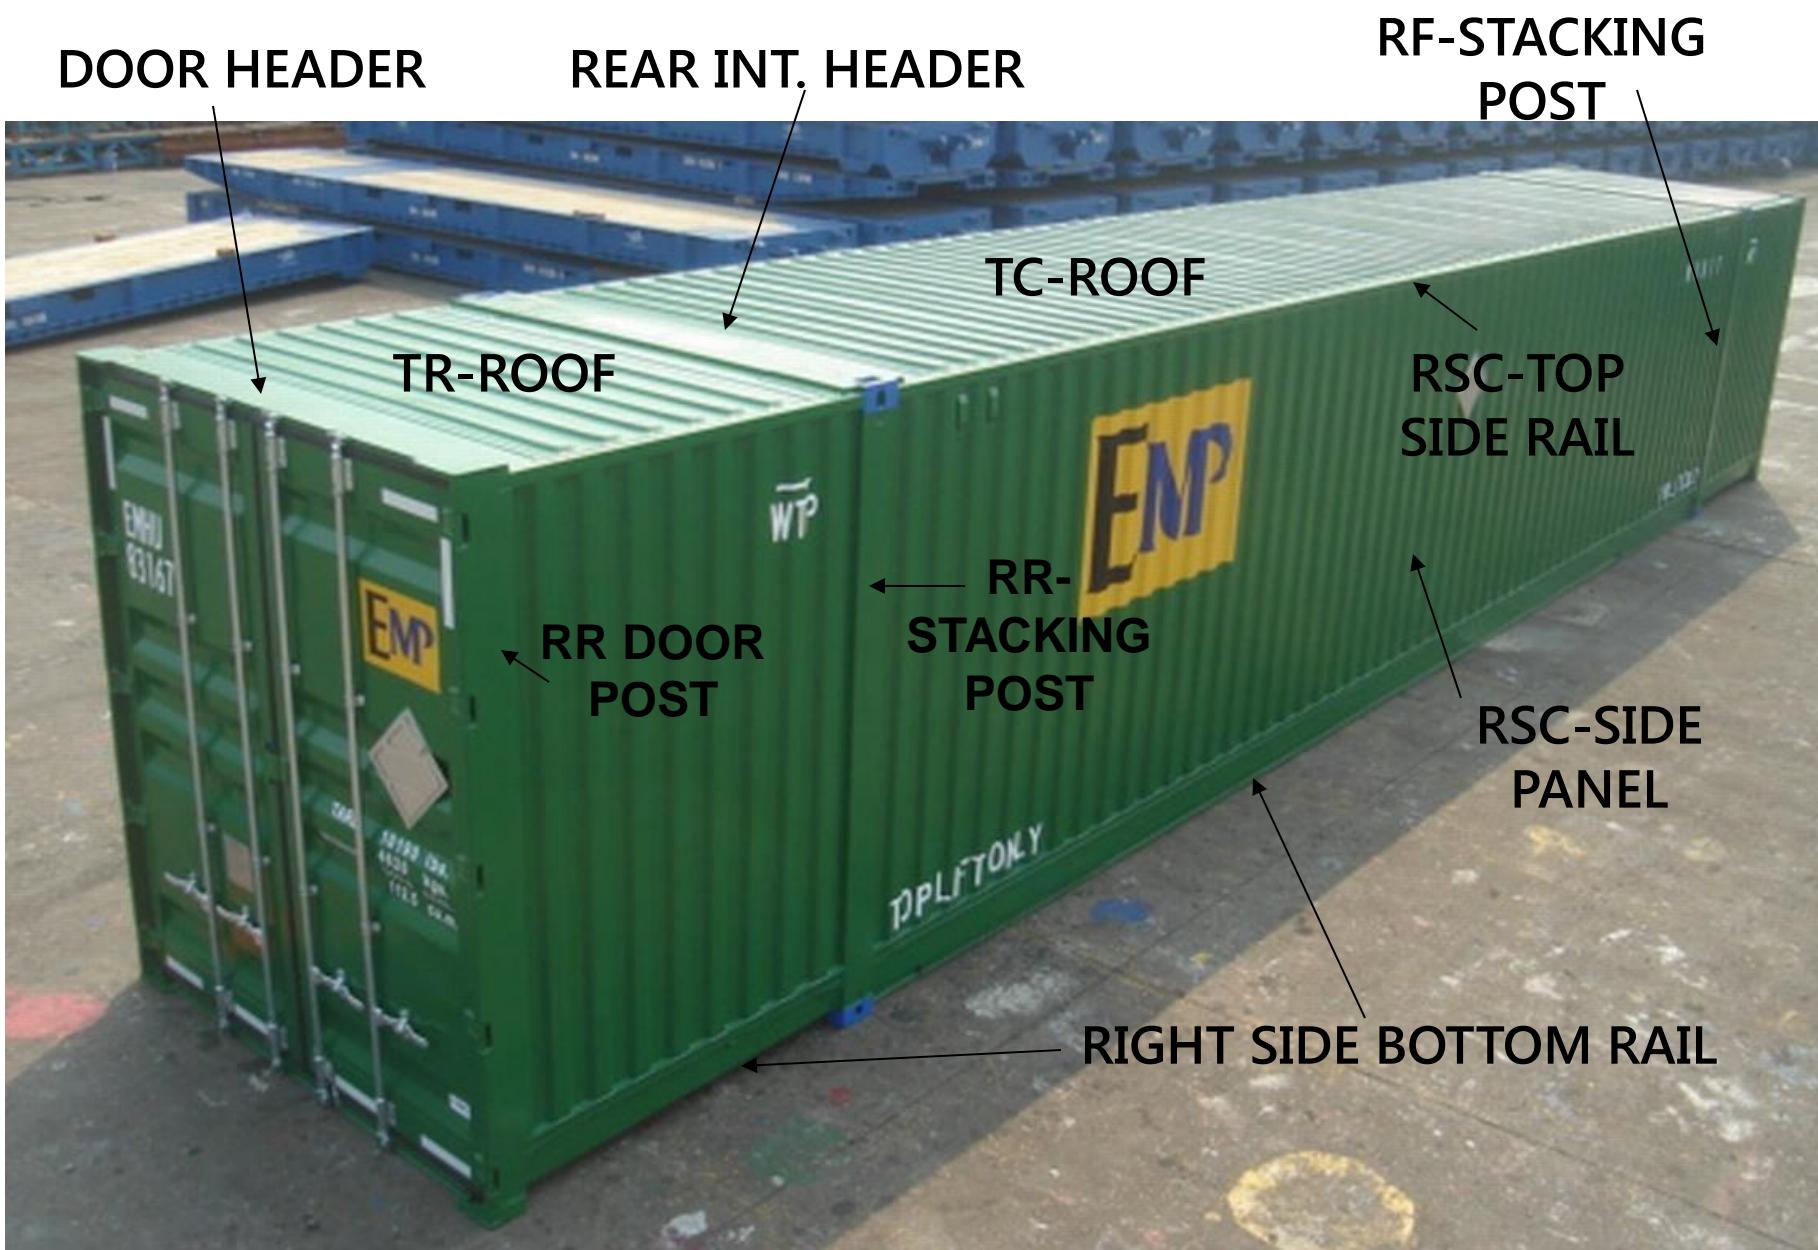
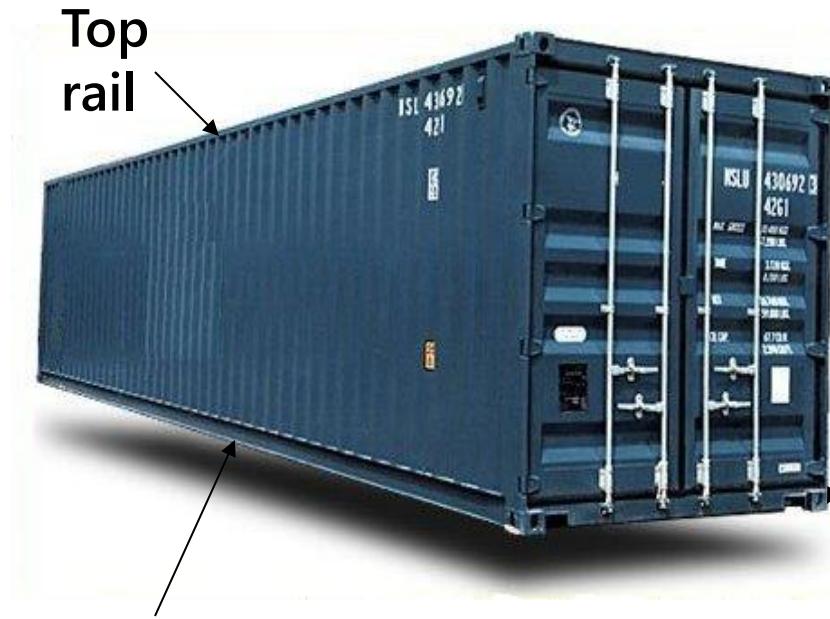
# Steel Container

Top rail

Bottom rail

Corrugated panels

Steel boxes 40ft. and under have corner castings

Steel boxes 45ft. and over have stacking posts

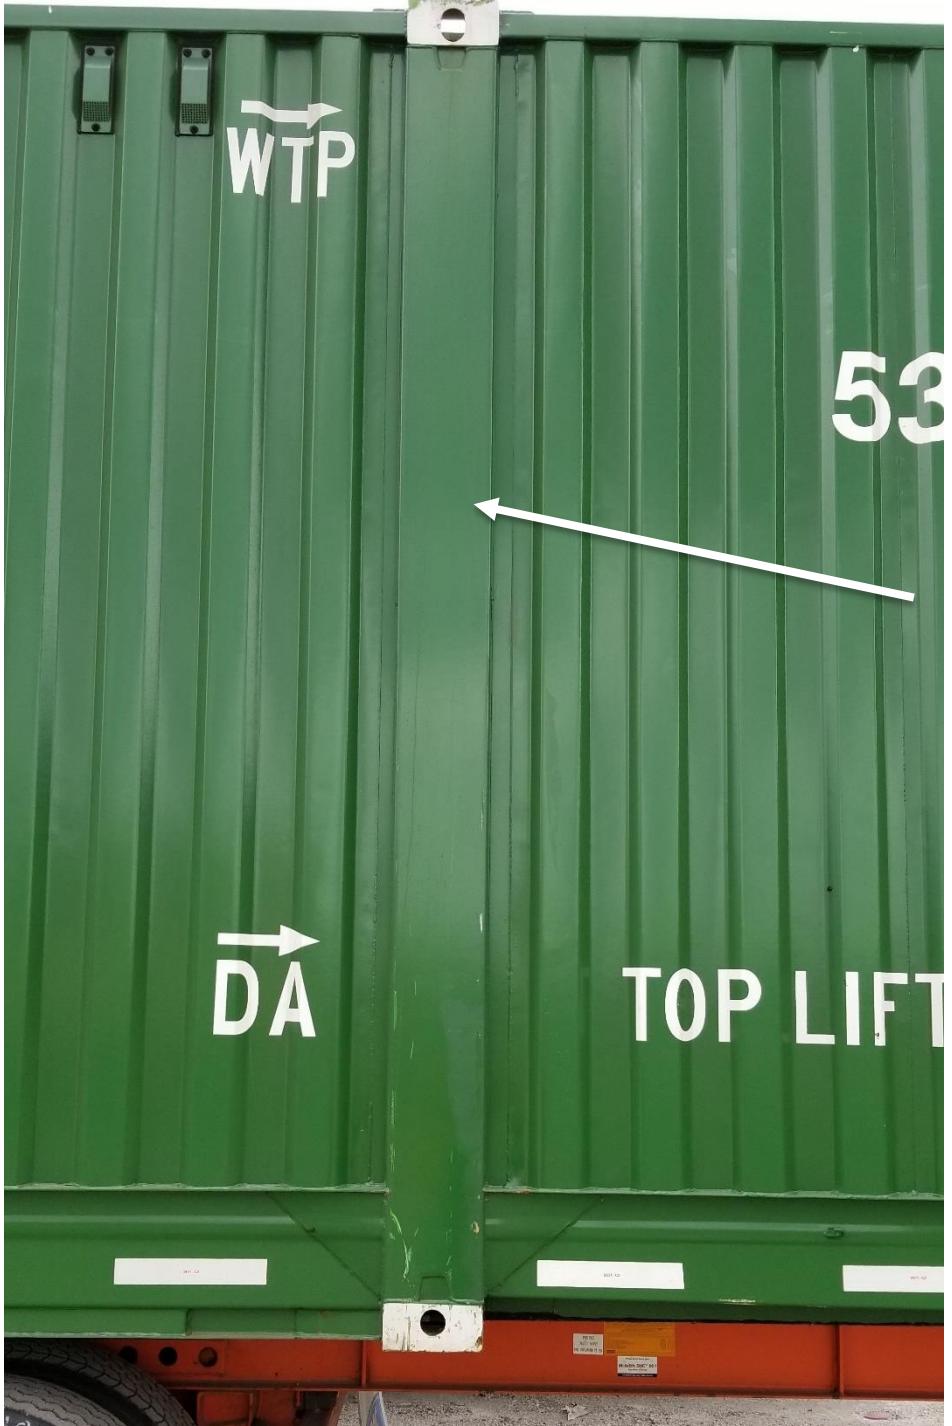
Stacking Post

Steel Cont.

Aluminum Cont.

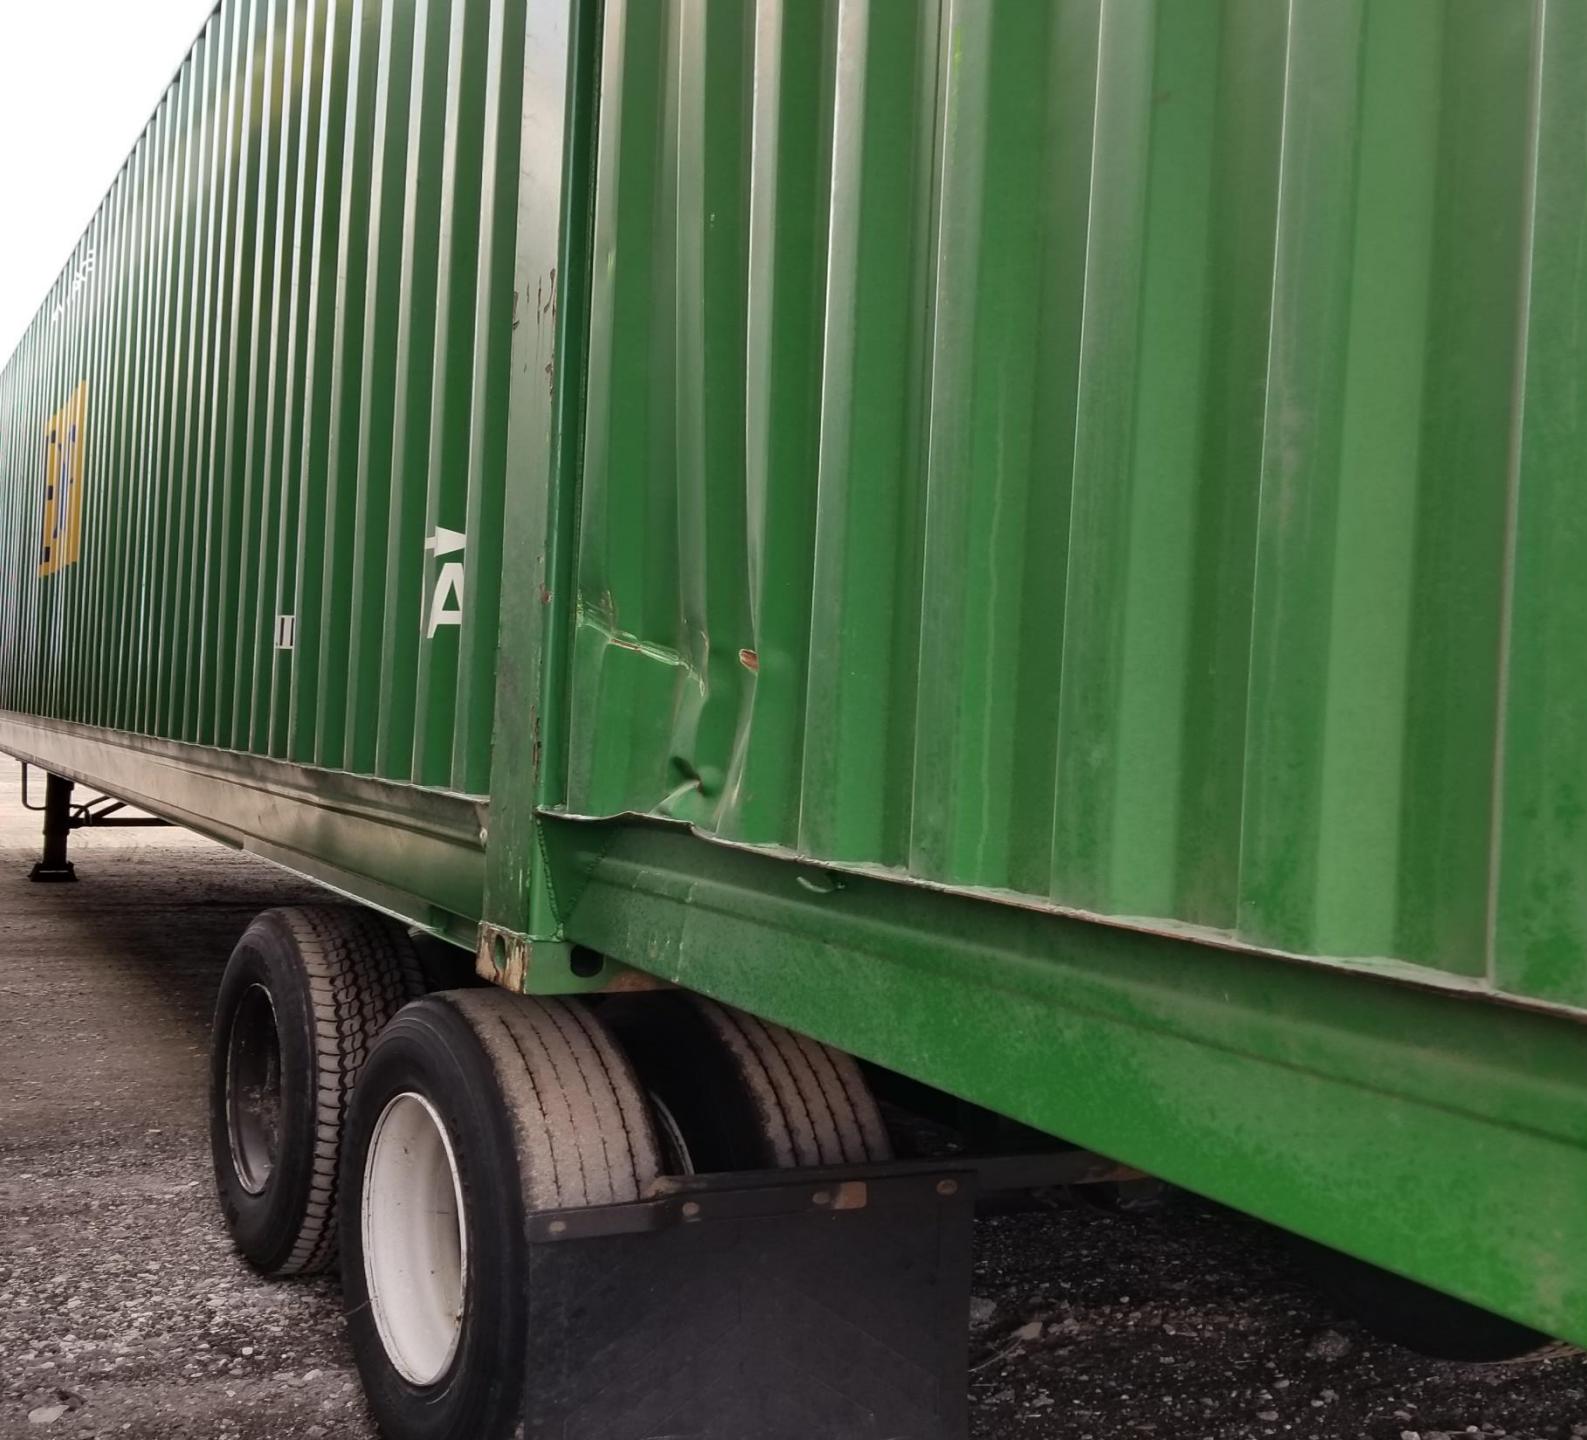
**Location: Left Side Rear (LSR)**  
**Item: Steel Side Panel**  
**Defect: Bent**  
**Dimension: 36"**

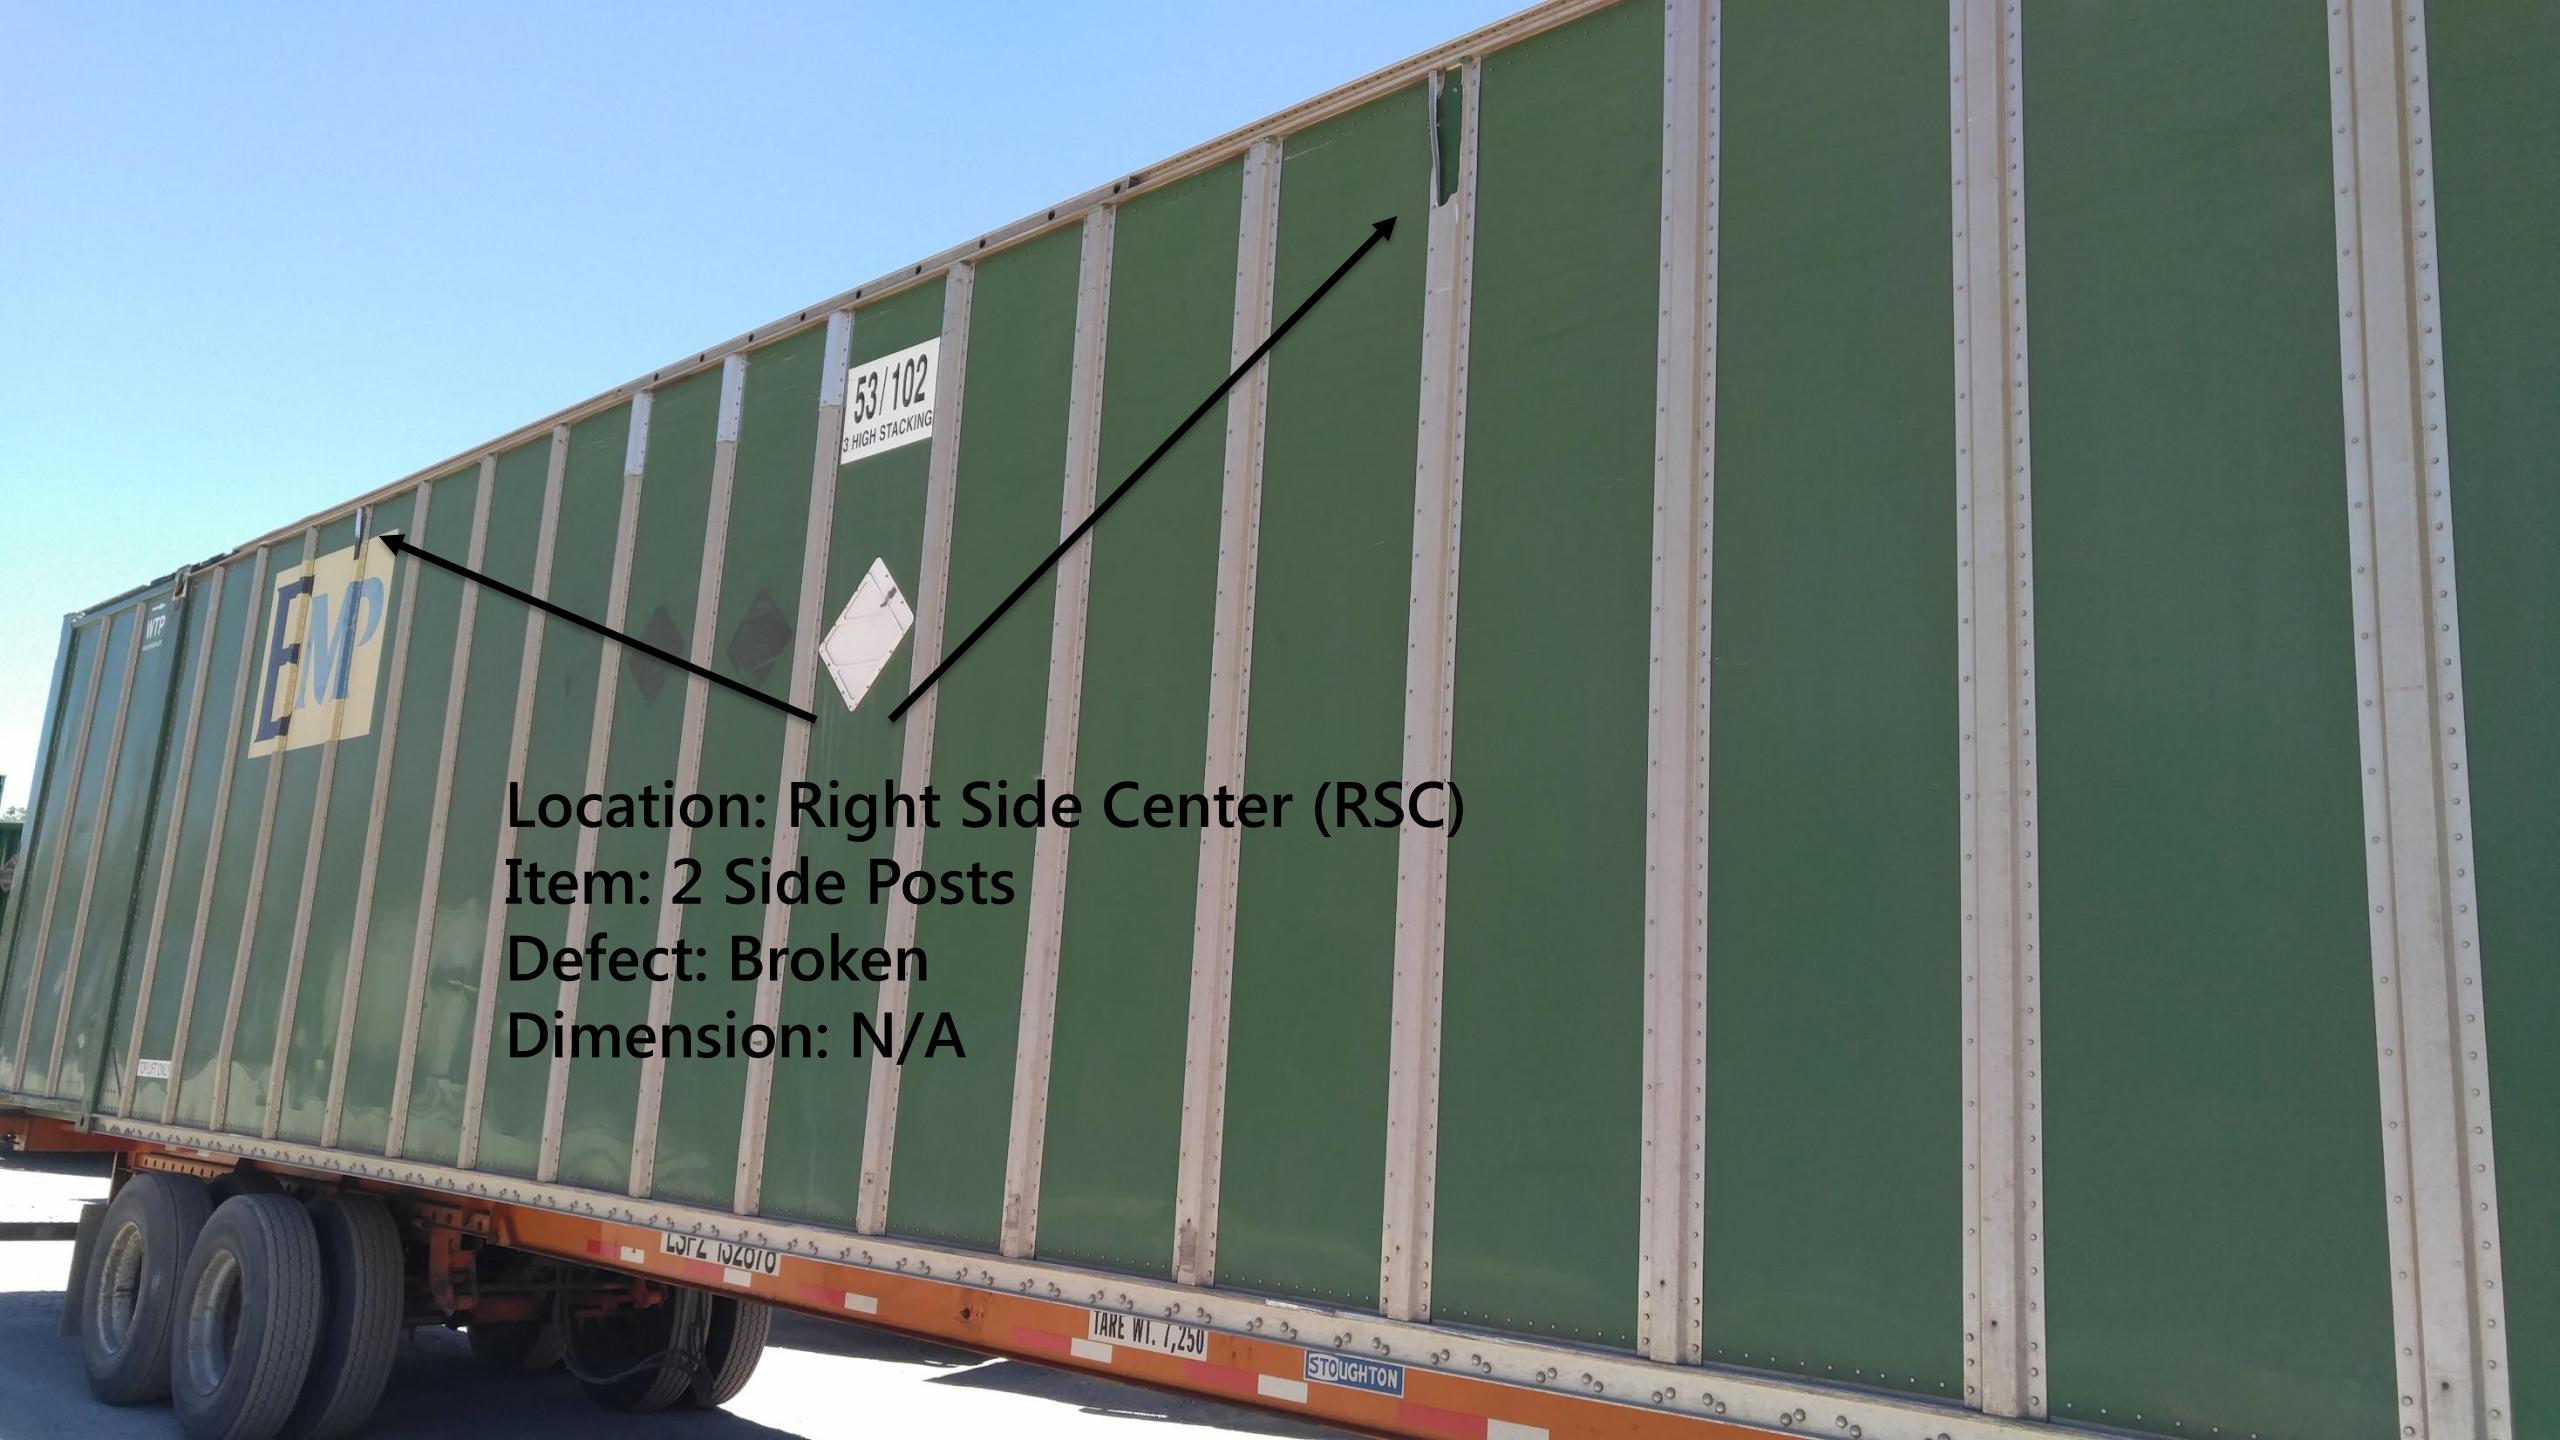
Location: Right Side Center (RSC)

Item: 2 Side Posts

Defect: Broken

Dimension: N/A

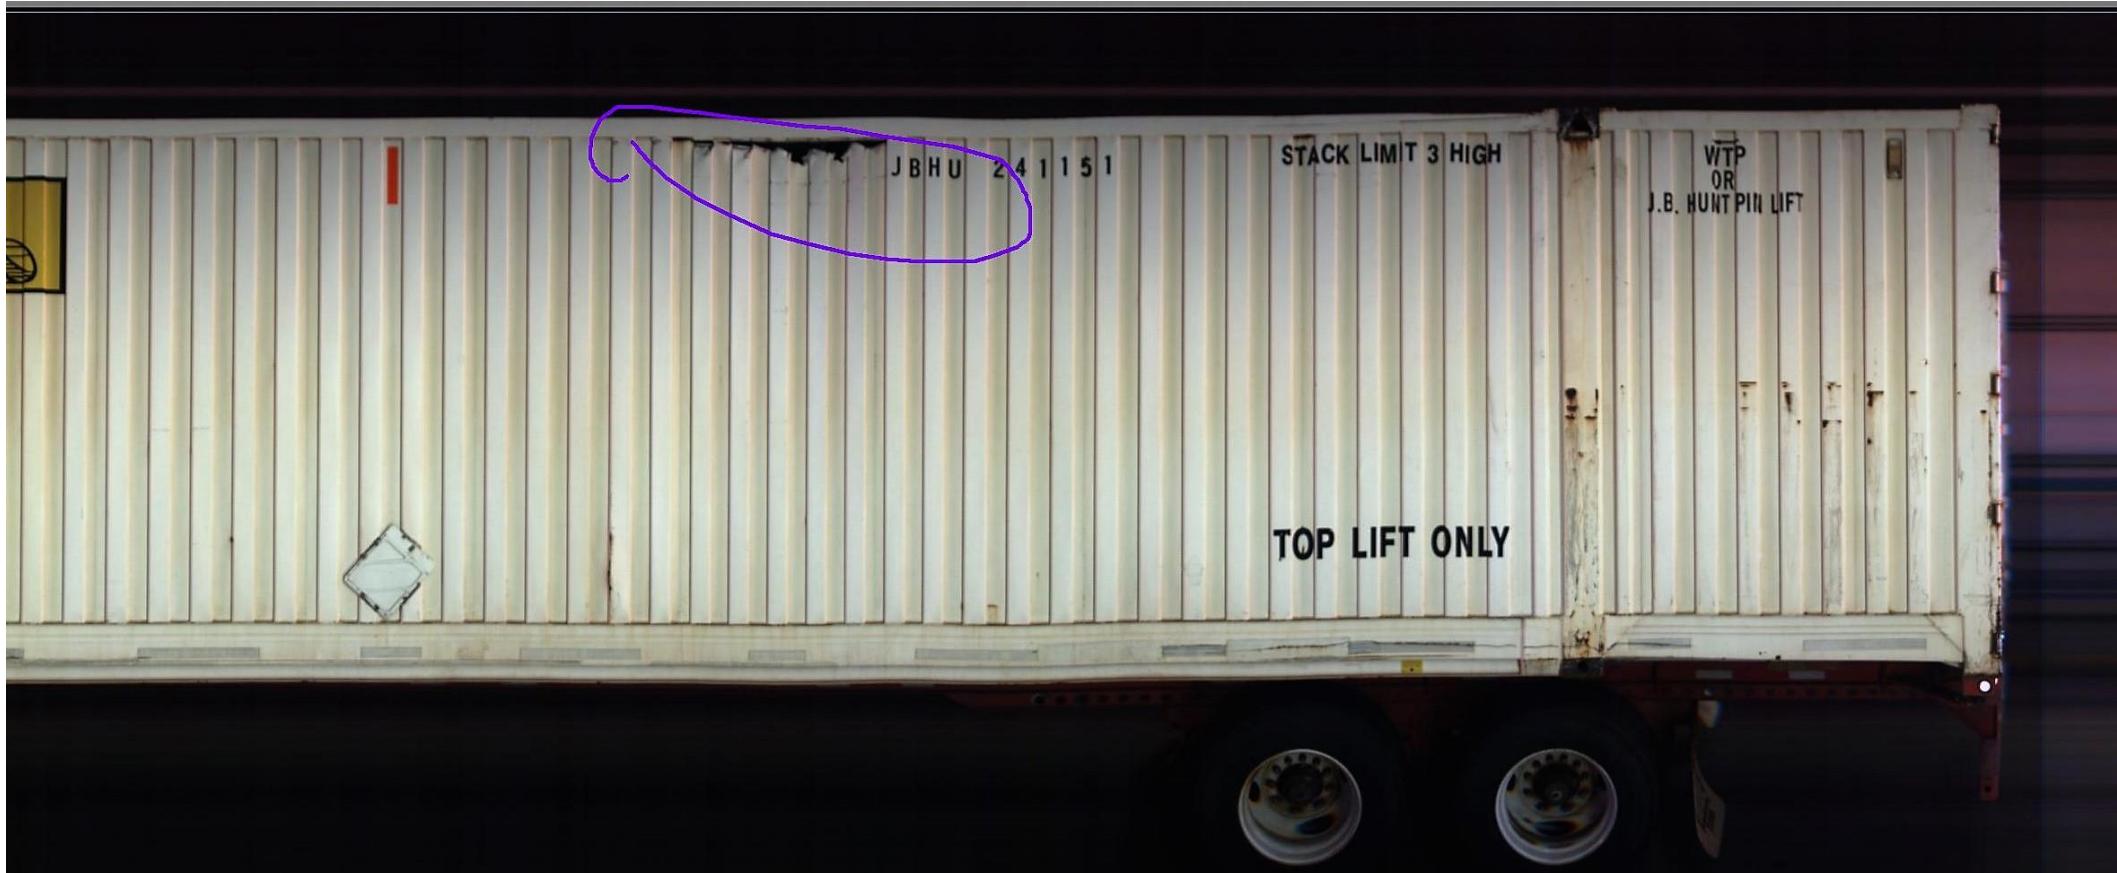
# AGS View

Location: Left Side Center (LSC)

Item: Steel Side Panel

Defect: Cut

Dimension: 36"

Assume a cut if equipment is taped or caulked

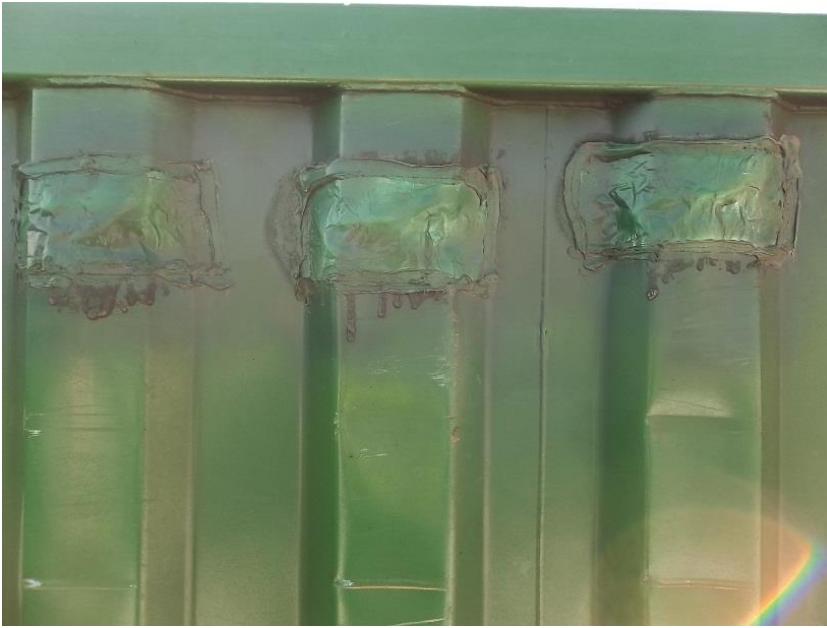
Cut shown from inside

Tape painted to cover a cut - Damage

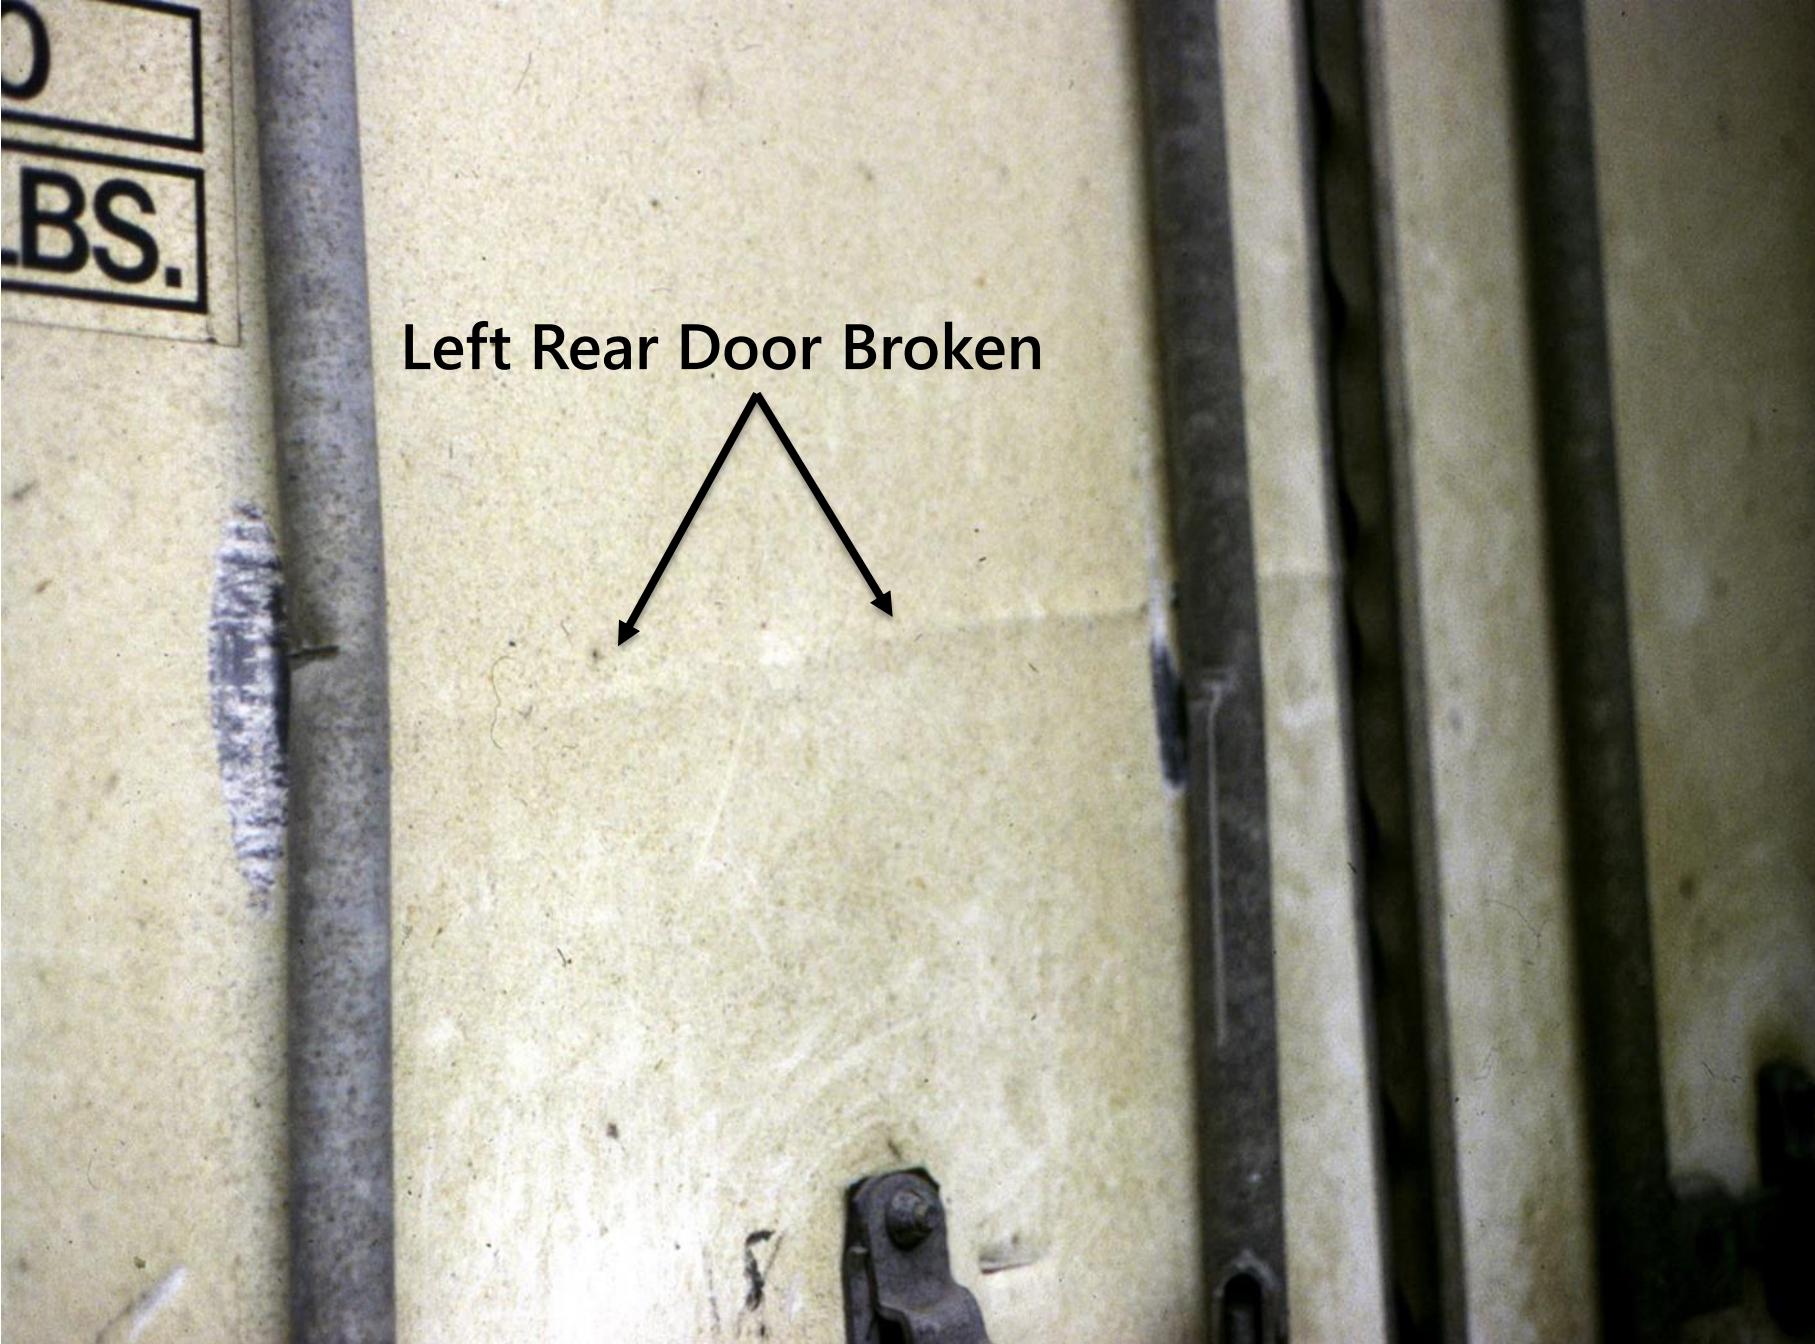
**Left Rear Door Broken**

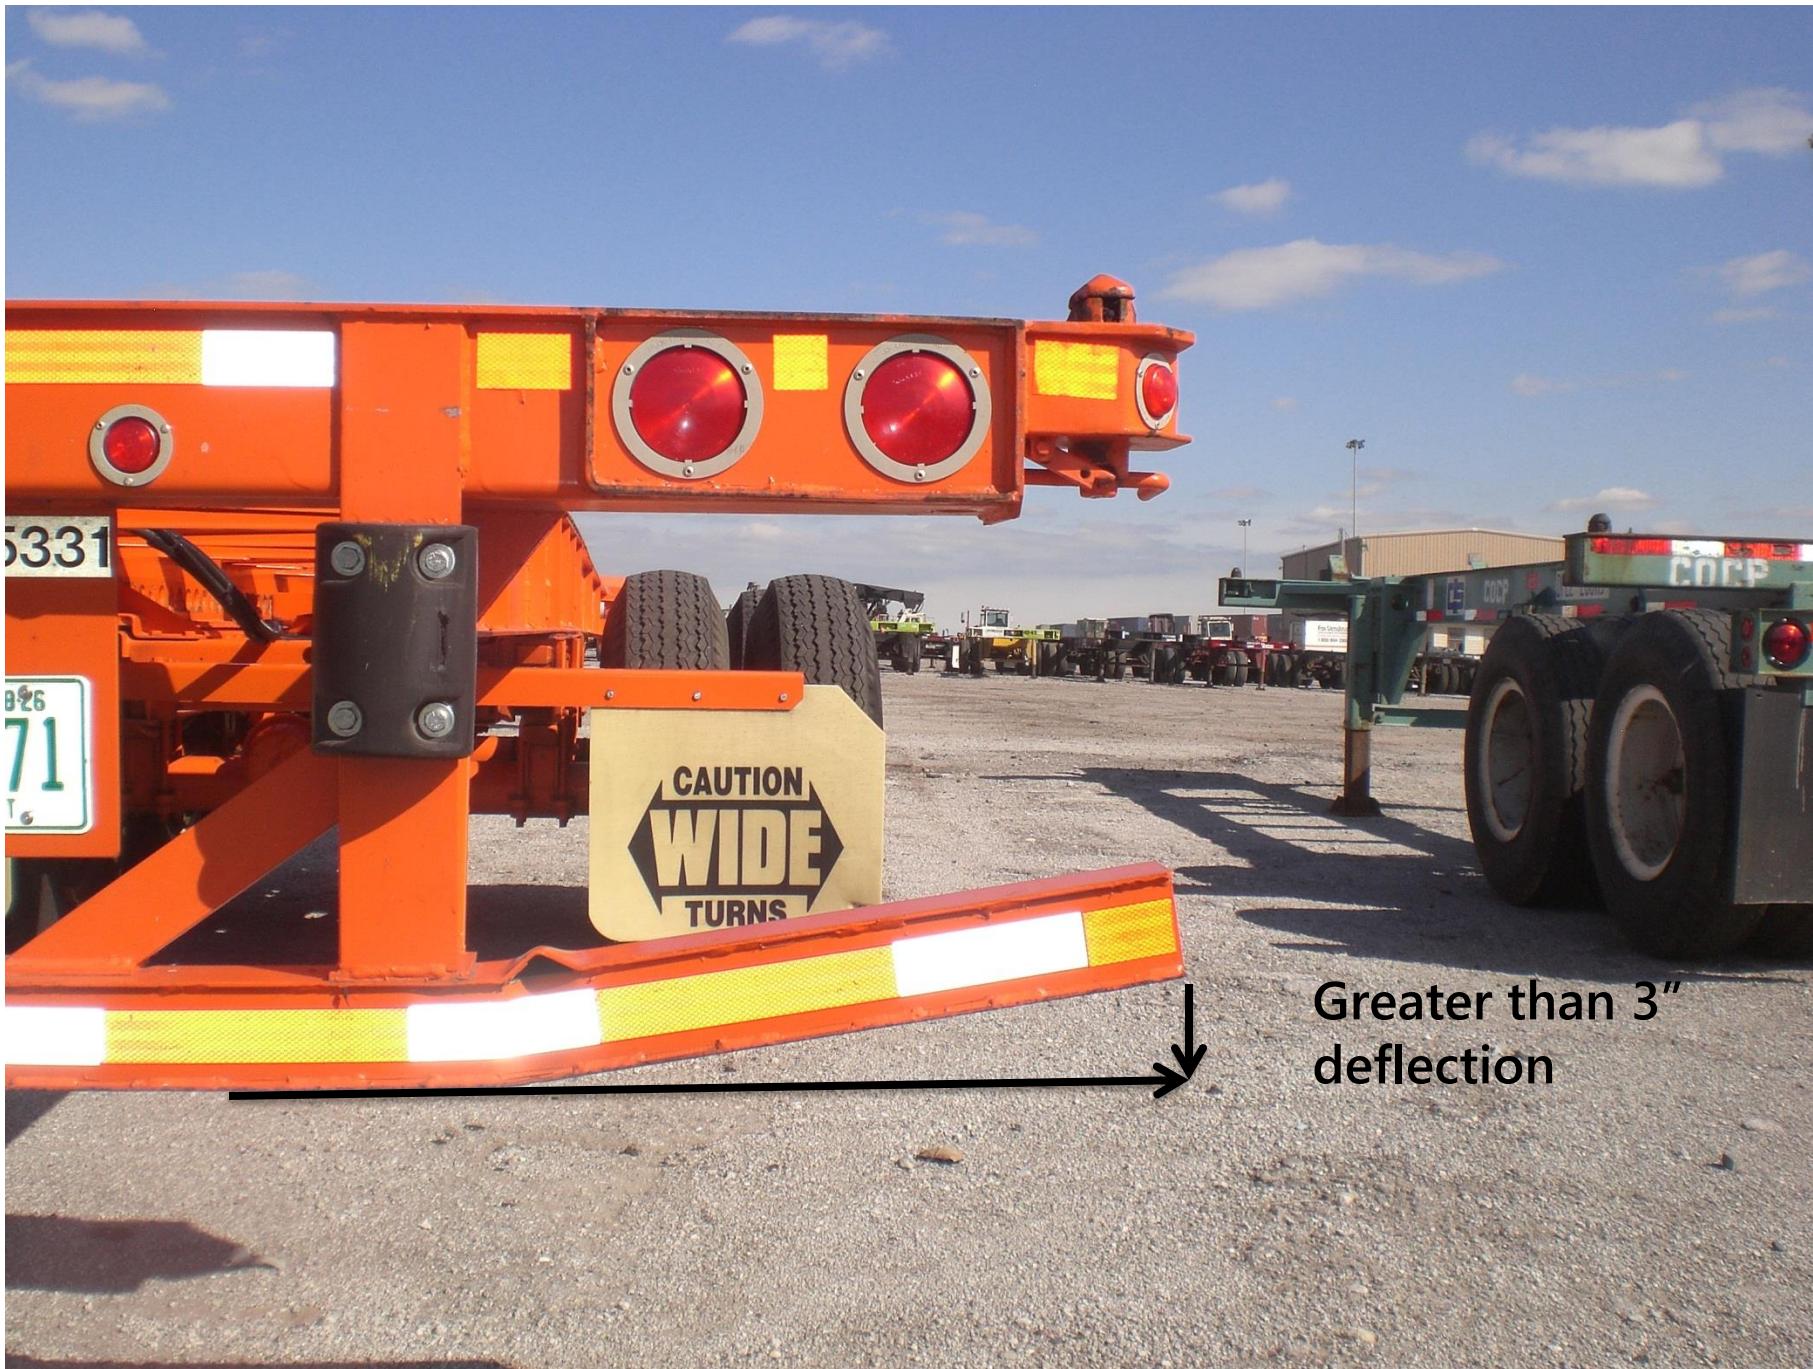
## DOT UNDER-RIDE GUARD

Greater than 3"  
deflection

- a. Metal door, gate, sheet, post, crossmember, brace, or support cut or torn through thickness of metal, including such cuts or tears covered by tape, caulk, and/or tar
- b. Metal door, gate, sheet, post, crossmember, brace, or support bent, where proper operation or function of unit is impaired, except when caused by deterioration due to corrosion or Decay
- c. Clean Interior
- d. DOT Under Ride Guard missing or damaged per Appendix B15

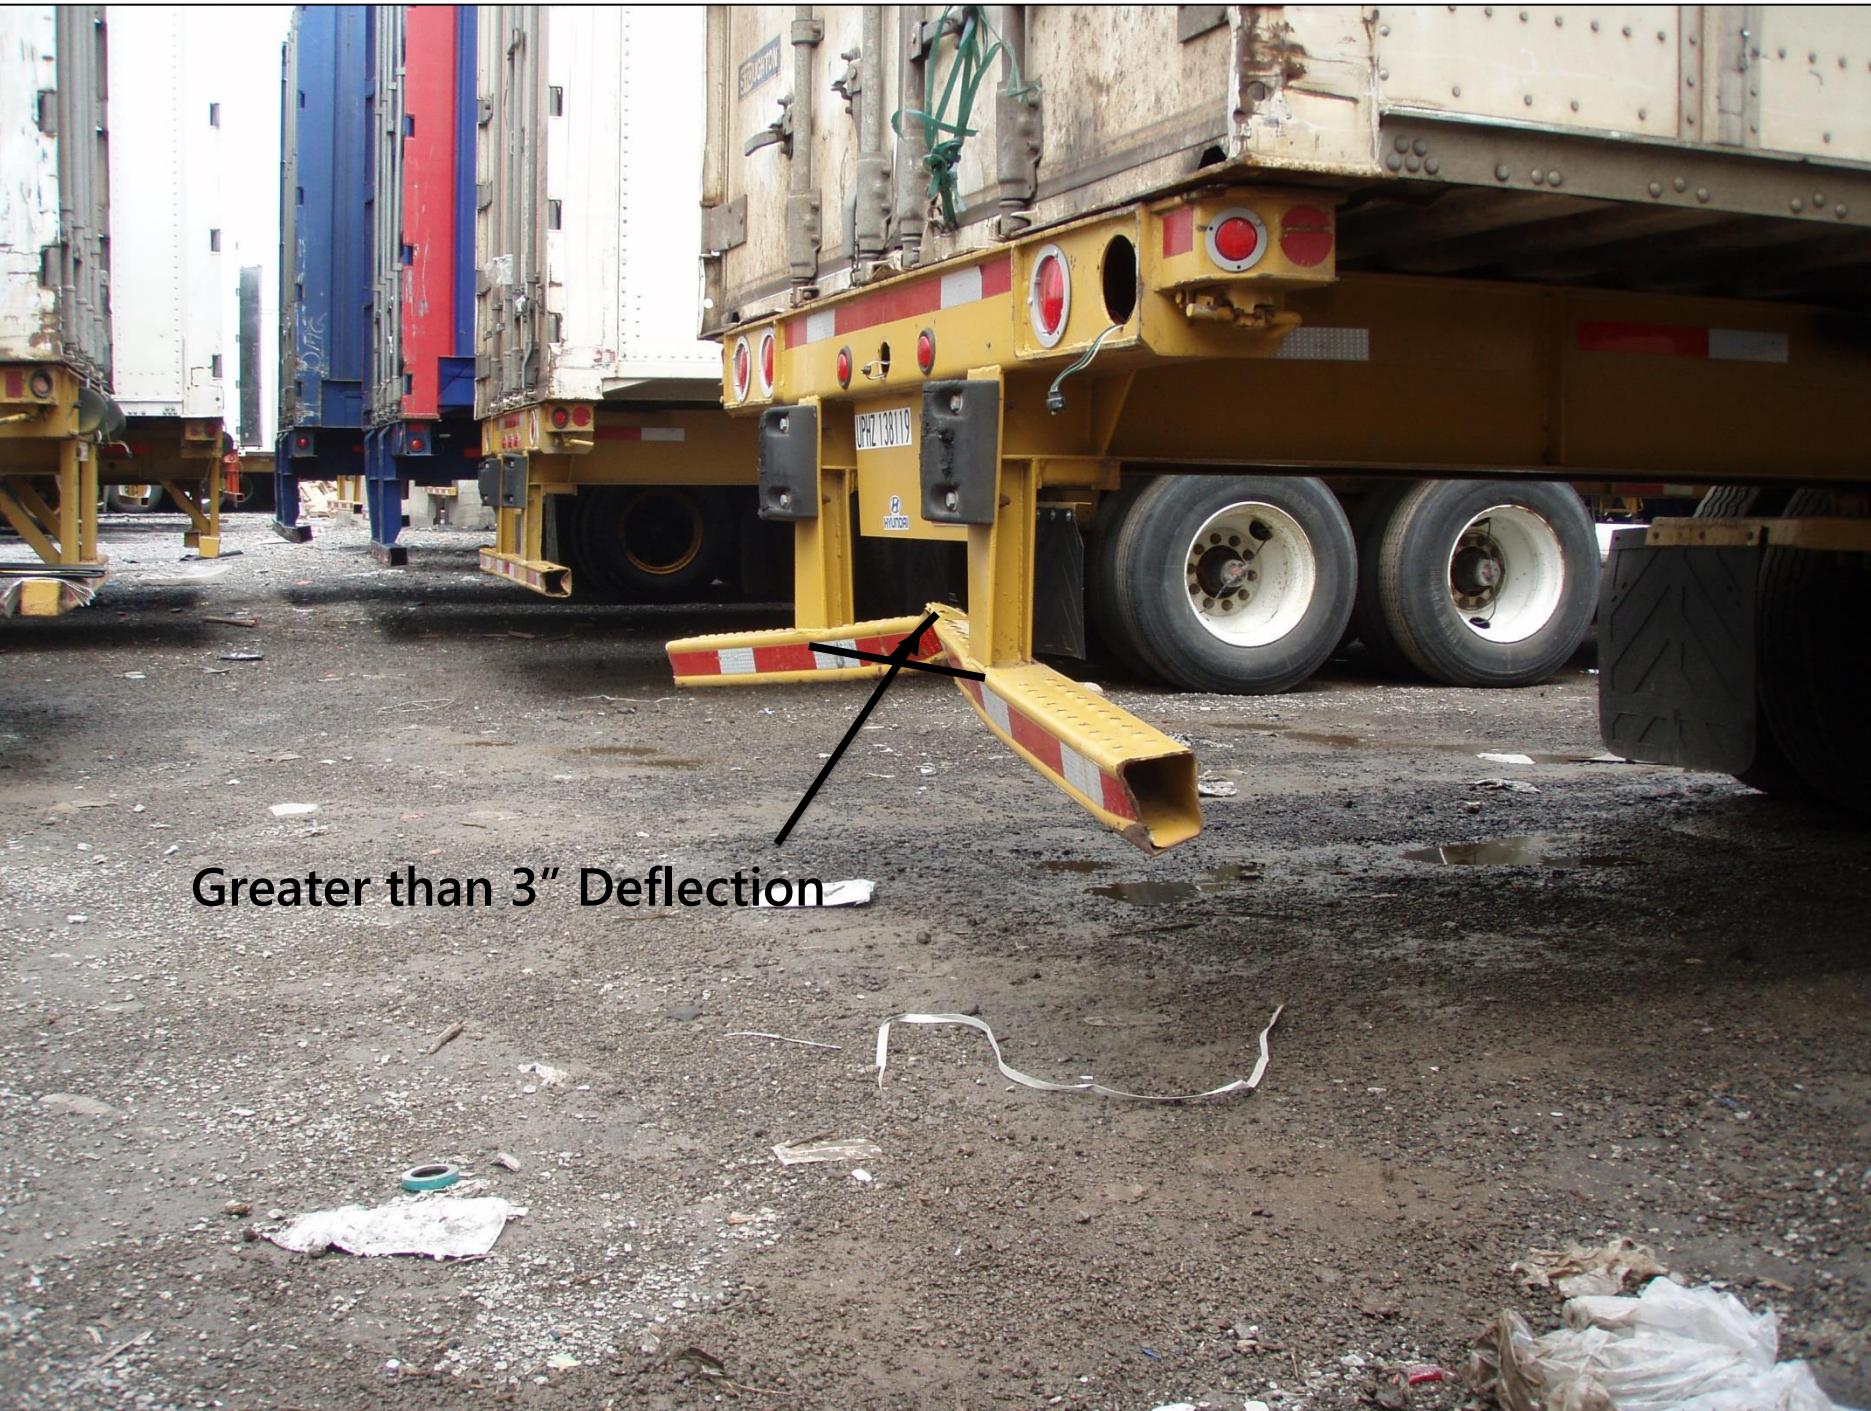
Greater than 3" Deflection

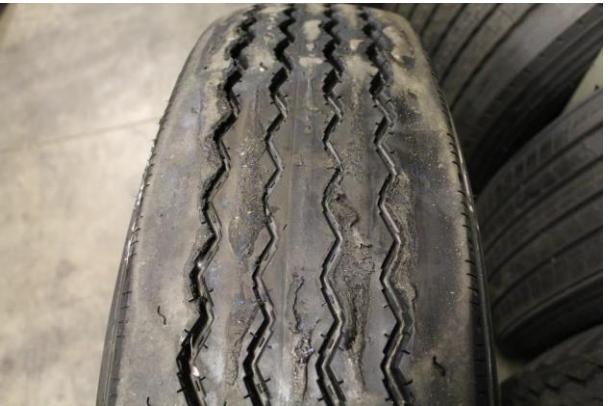
**Below - Good tire**

Above is an example of a tire with a flat spot at 4/32 and the remaining tread in all other areas at 12/32. This is now a good tire under the new rules. If a tire with the same flat spot is on the same wheel set, the outer tire should be rotated 90 to 180 degrees to purposely misalign the flat spots.

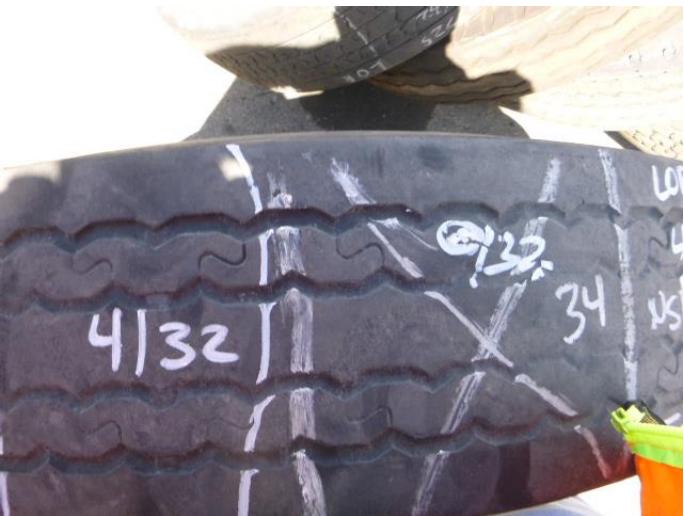
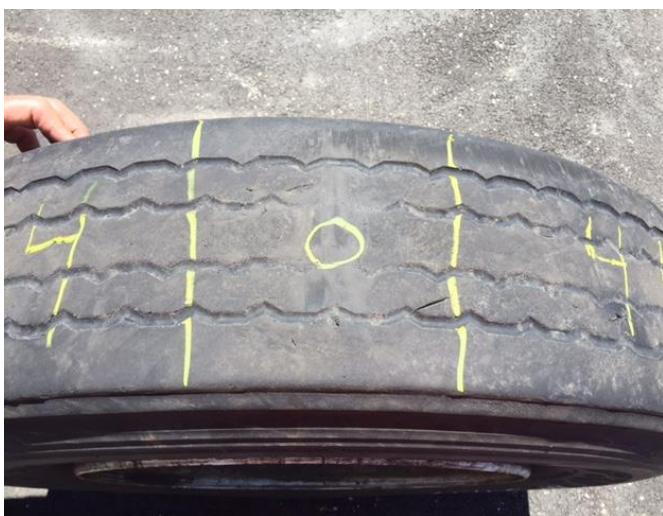
**Below - Bad tire - Worn**

Above are examples of flat spots that are at 0/32 with the remaining tread at 4/32. Under previous AAR rules this would have been considered handling line/damage responsibility. Under the new rule, a tire with a flat spot to 0/32 or through the cords with the remaining unaffected areas at **4/32 or less** is considered a worn tire.

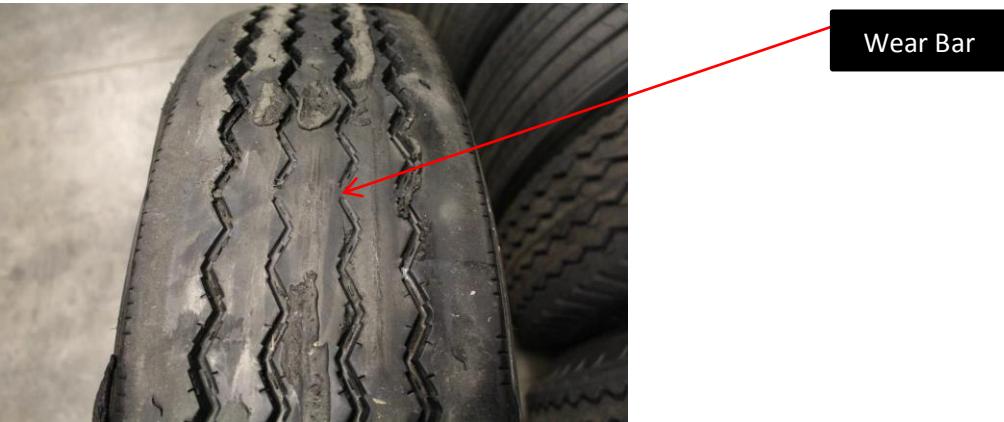
**Below - Bad tire - Damage**

Above is an example of a new tire with a flat spot at 2/32 while the remaining tread is at 12/32. You can see the wear bars (red arrow) have been penetrated. Wear bars are at 2/32 on all DOT tires. This is a slid flat tire and must be replaced.

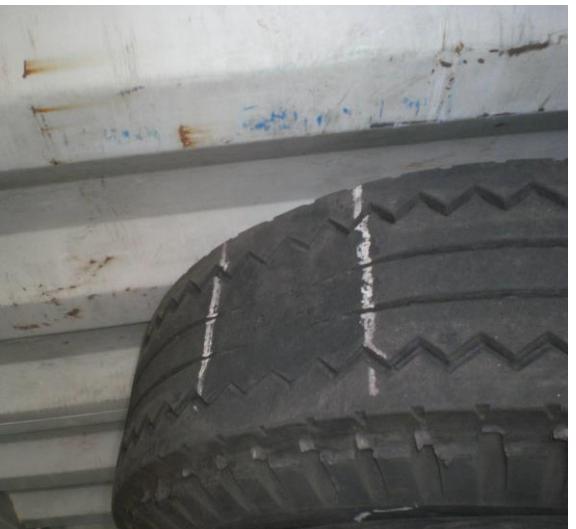
**Below - Bad tire - Damage**

Above is an example of a flat spot below 2/32 (completely through the wear bars) with remaining area tread at 6/32. This is a slid flat damaged tire and must be replaced.

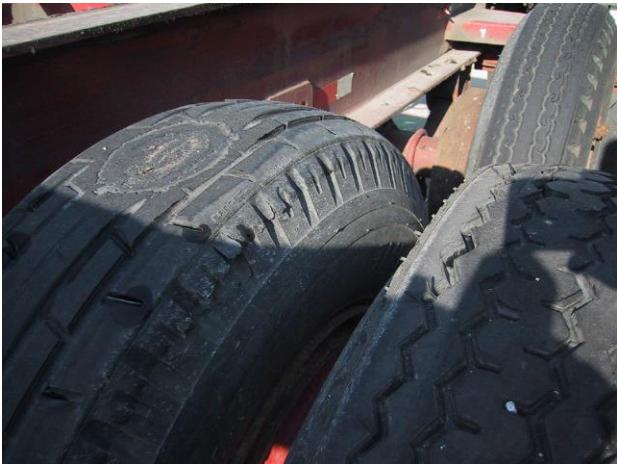
**Below - Bad tire - Damage**

Obviously a bad tire due to slid flat damage to the casing. Remaining area tread is at 8/32.

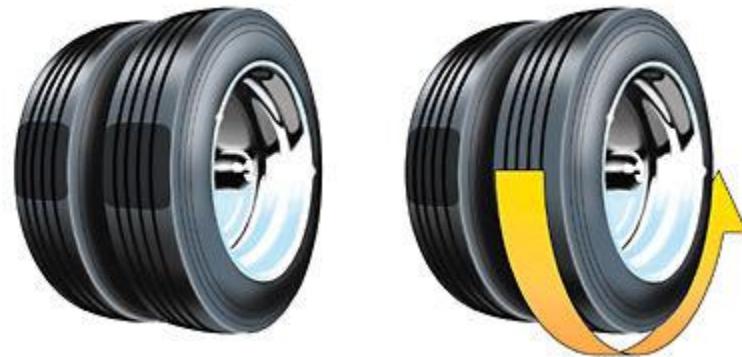
Tires with matching flat spots on the same wheel set that are above 2/32 with a 6/32 or greater difference between the flat spot and rest of the tire may be rotated 90 to 180 degrees from each other to separate the flat spots. This will provide a better ride and reduce the bouncing effect.
