## INTERMODAL INSPECTION PROGRAM

Properly Identifying the  
Components of Intermodal  
Equipment

## Section F Damage

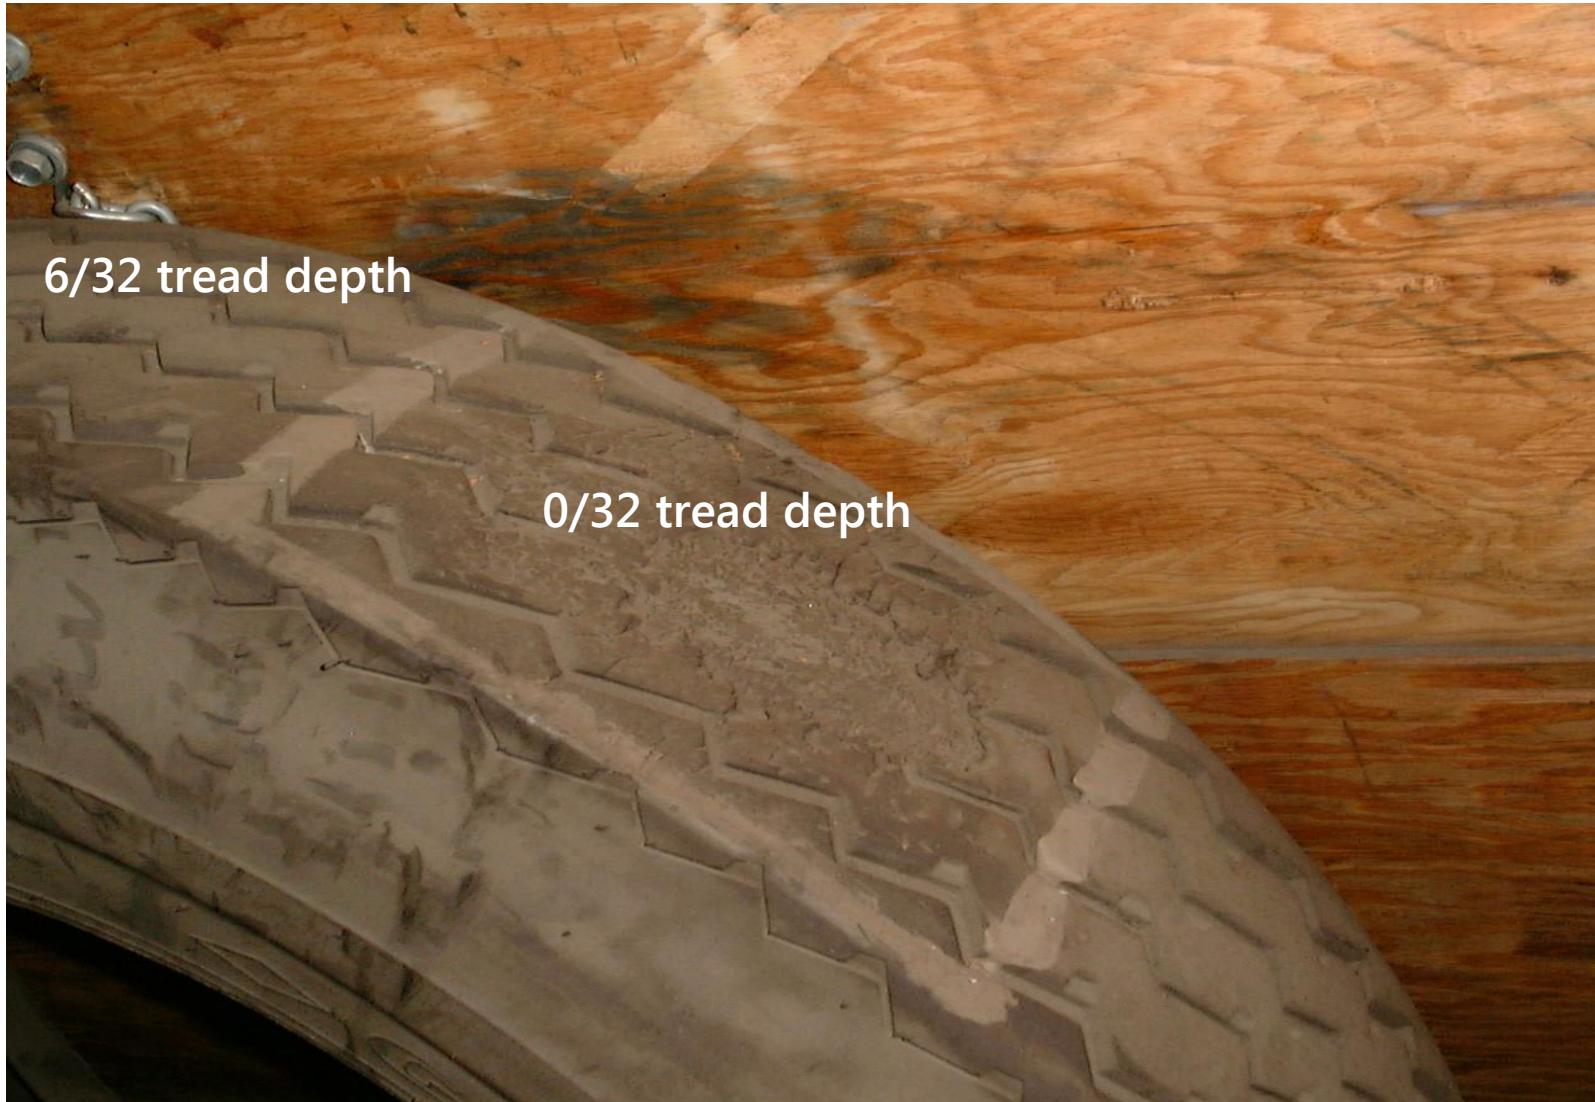
Slid Flat Tire – J2 Condition

Damage to tires and tubes as a result of being slid flat. Any tire is considered to be "slid flat" if a flat spot occurs and removes tread or rubber to 2/32 in. of remaining tread or less in the affected area (flat spot) while the remaining unaffected tread is more than 4/32 in. It is not necessary for the tire to have a loss of air. Any tire with more than 2/32 in. of tread remaining at all locations does not require replacement.
  - (2) Repair

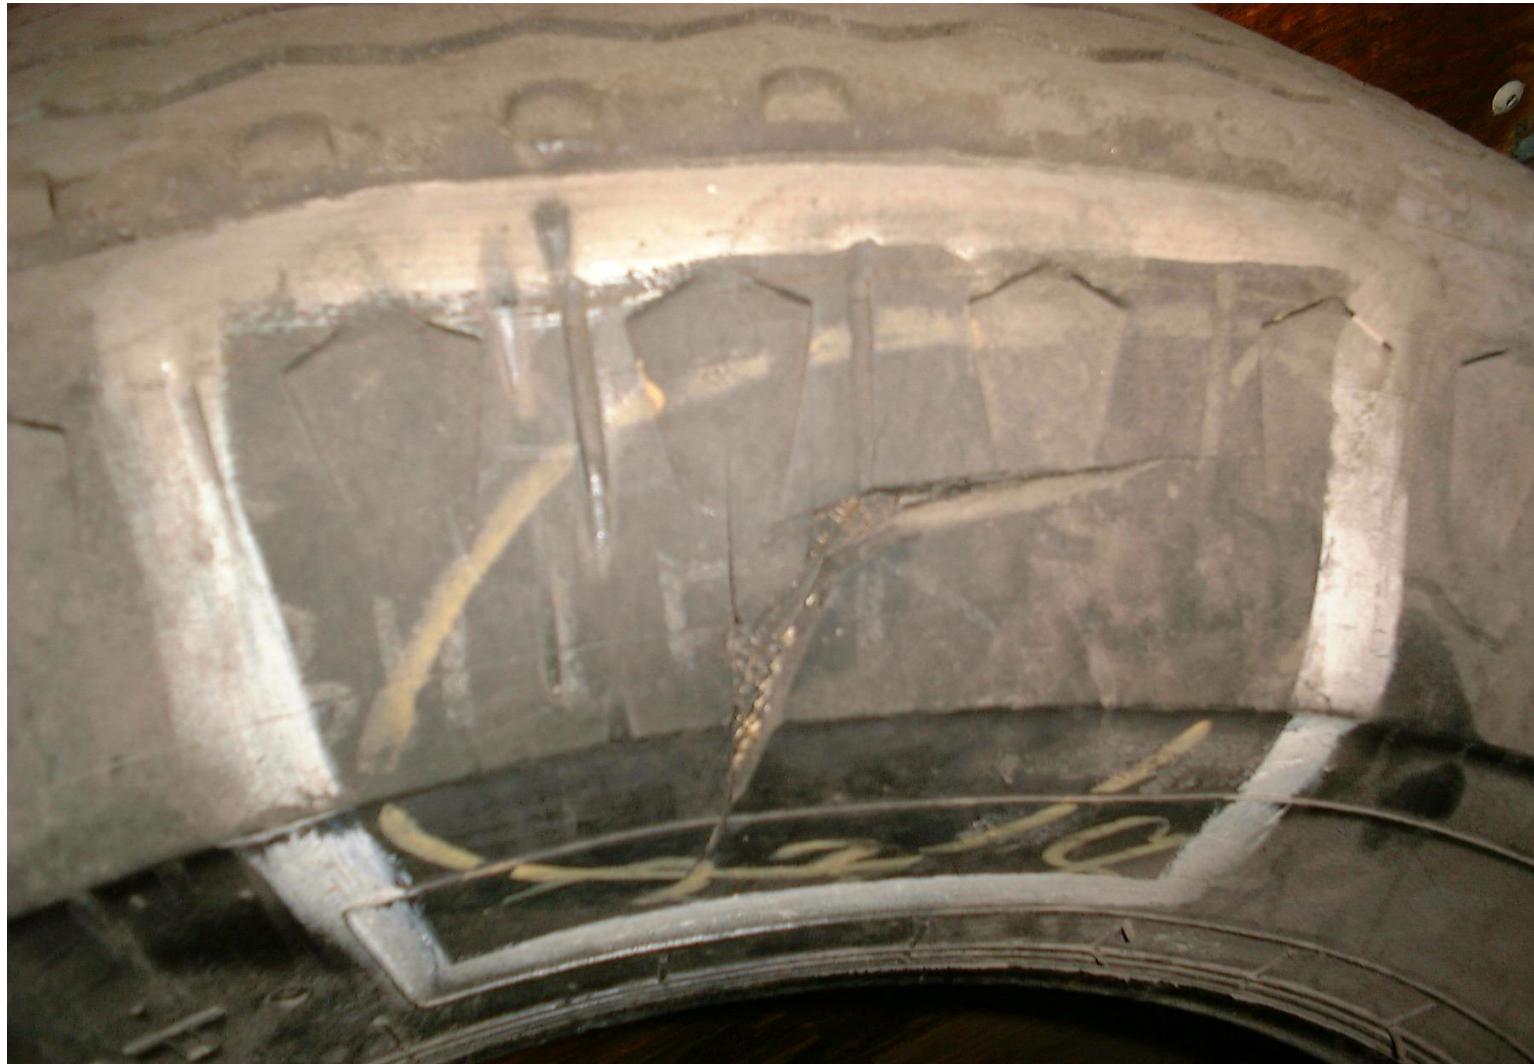
Tire sidewall cut/punctured, exposing belt material – J2 Condition

- e. Tire sidewall cut/punctured, exposing belt material
- f. Tire shoulder and/or tread cut/punctured, exposing belt material, when such injury is larger than 1/4 in. When the tire shoulder and/or tread is punctured through the tire, causing a hole 1/4 in. in diameter or less, the injury must be patched prior to reuse.
- g. Tires Slid Flat
  - (1) Replacement

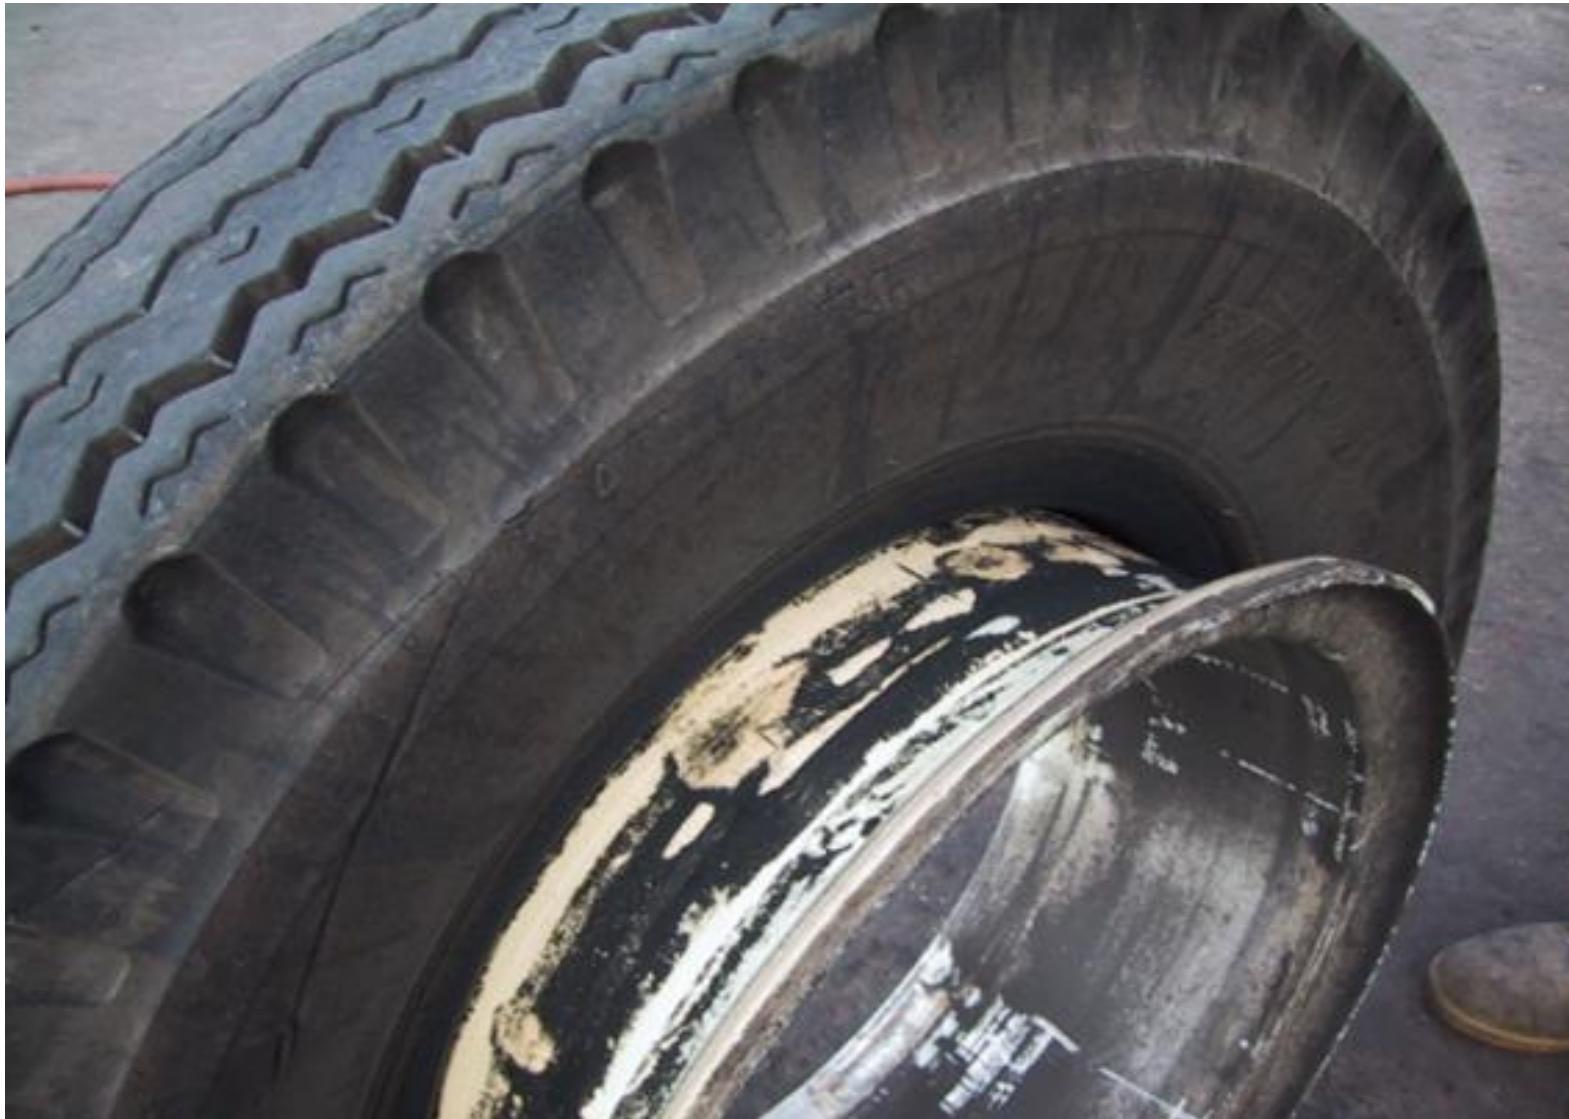
#### Run Flat Tire – J2 Condition

Damage to tires and tubes as a result of being run flat, resulting in discoloration, blistering, wrinkling, and/or casing damage being evident

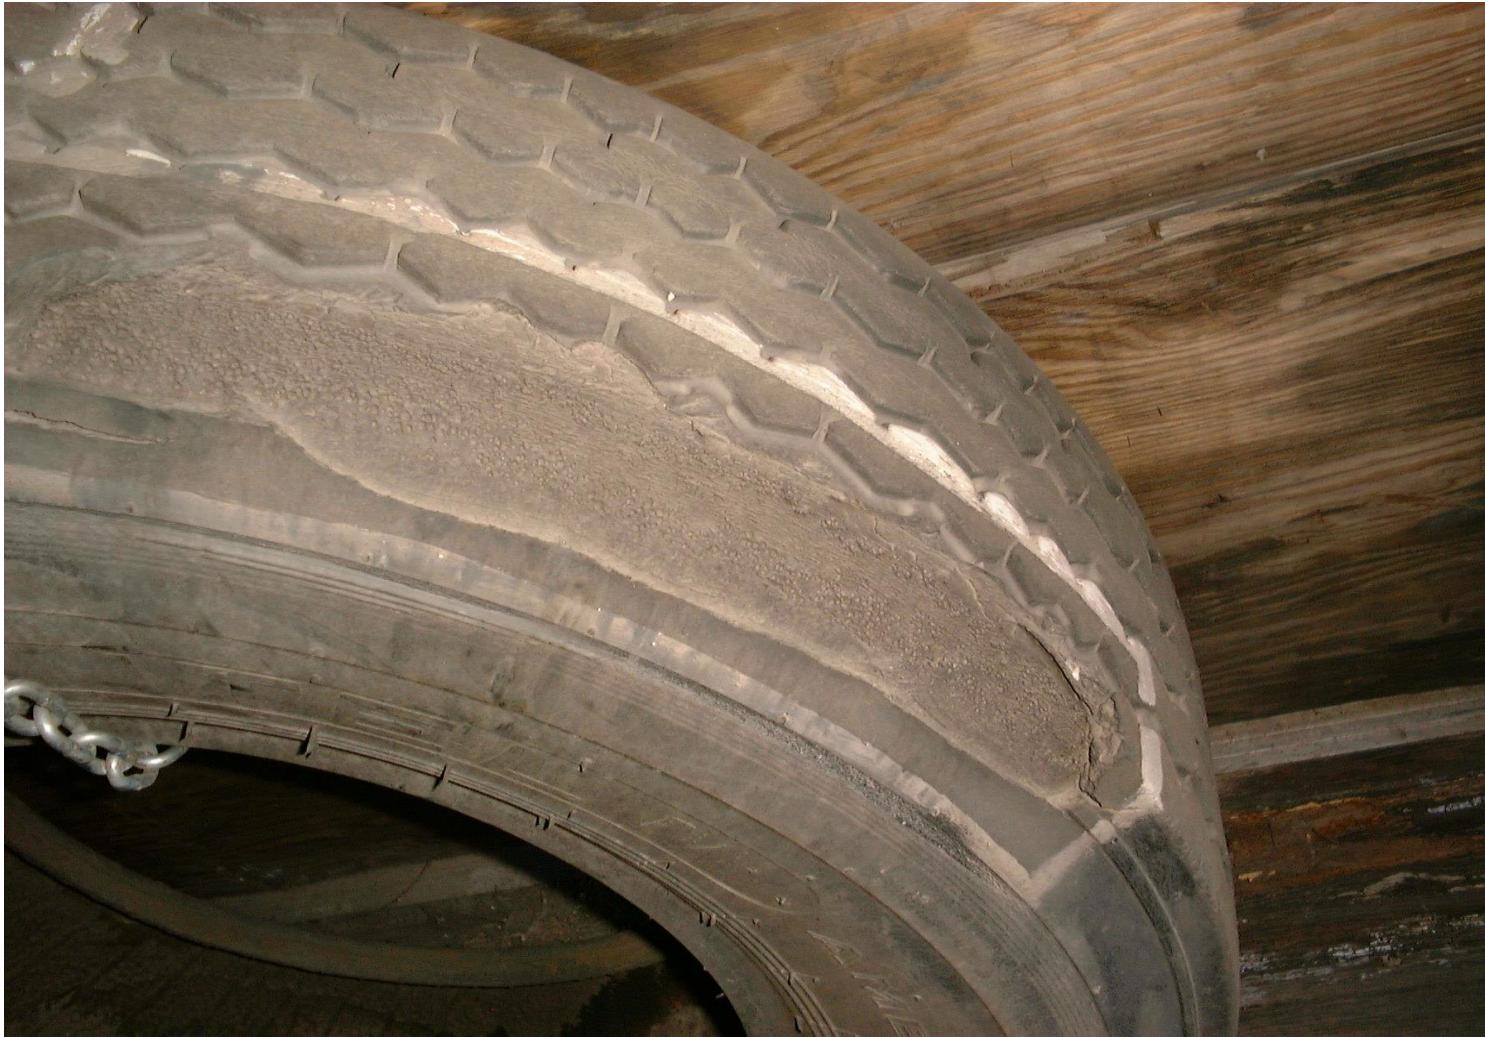
**Separated Cap – Owner's Responsibility**

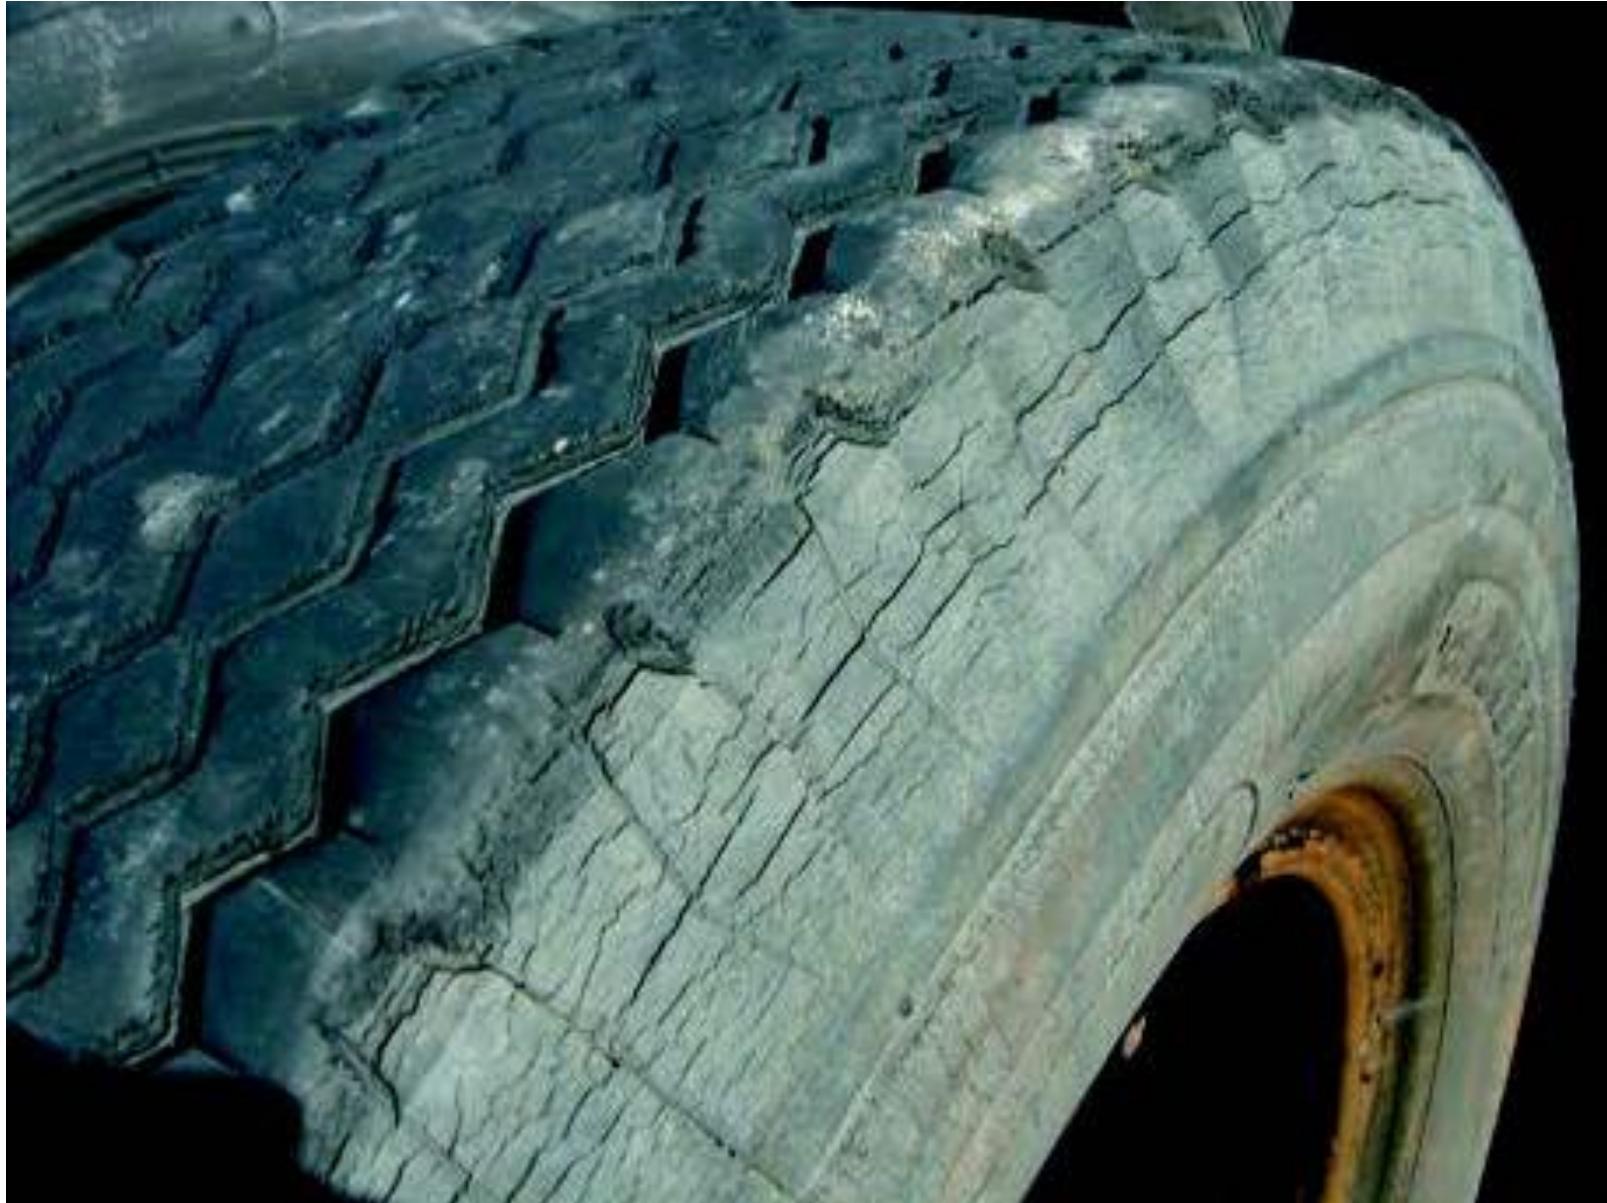
Weather Checking – Owner's Responsibility

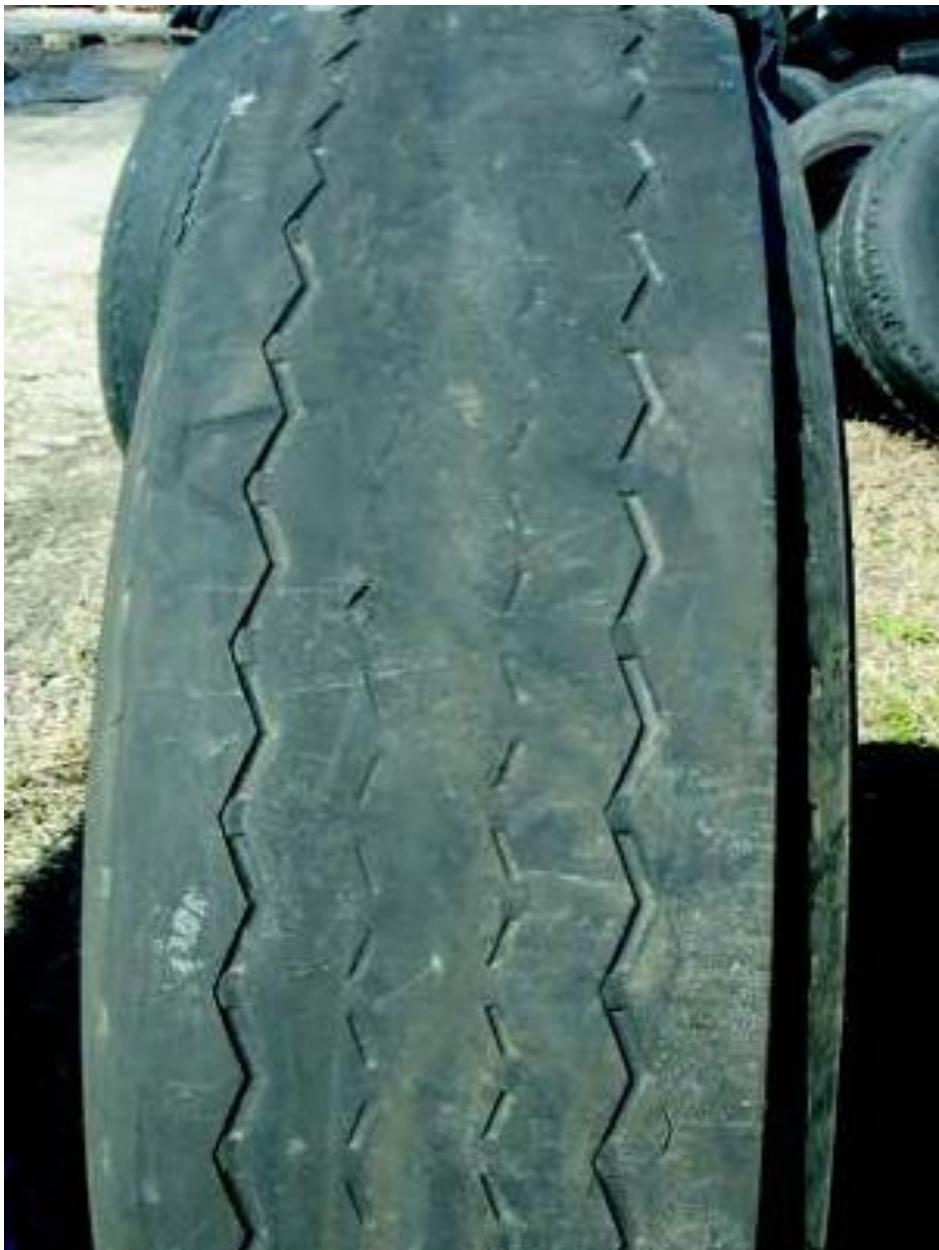
**Worn Out Tire – Owner's Responsibility**

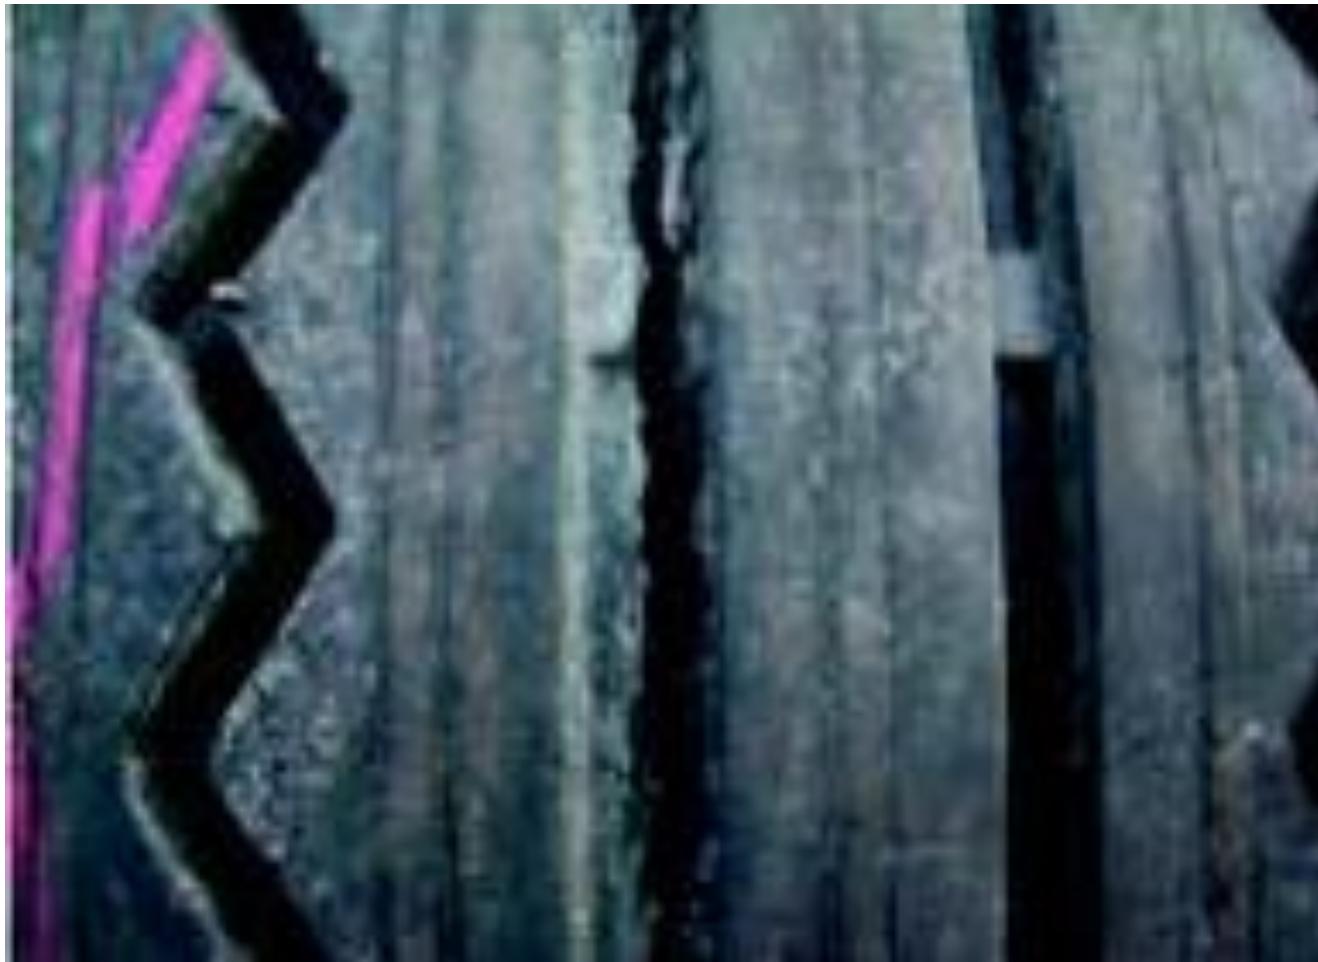
Channel Cracking – Owner's Responsibility

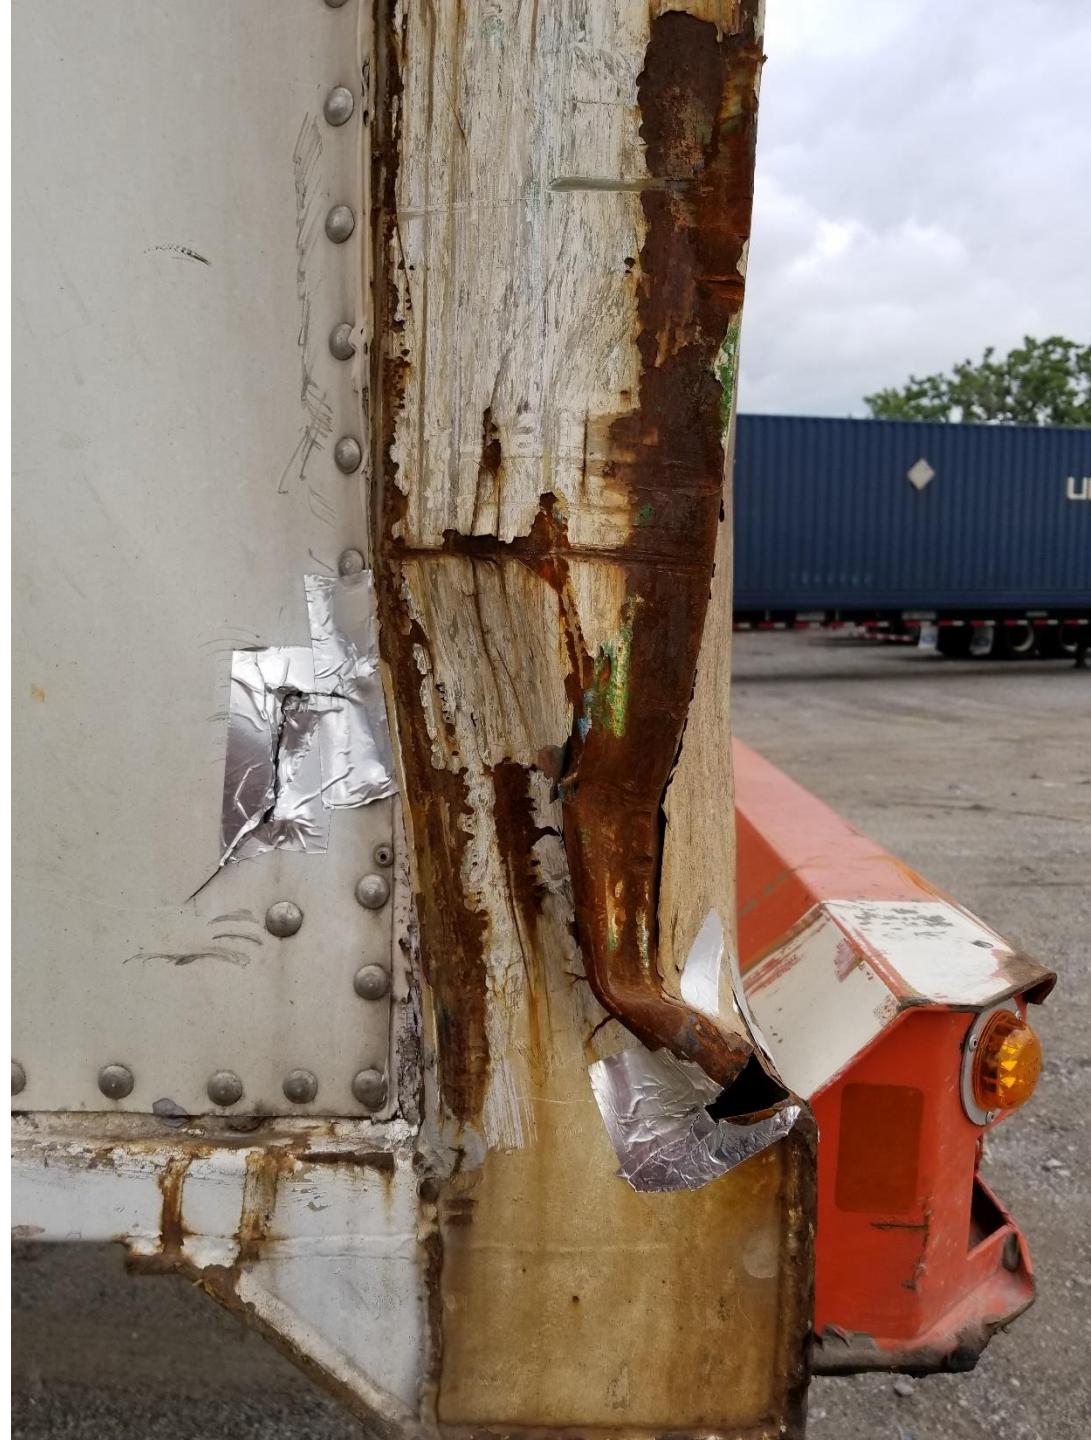
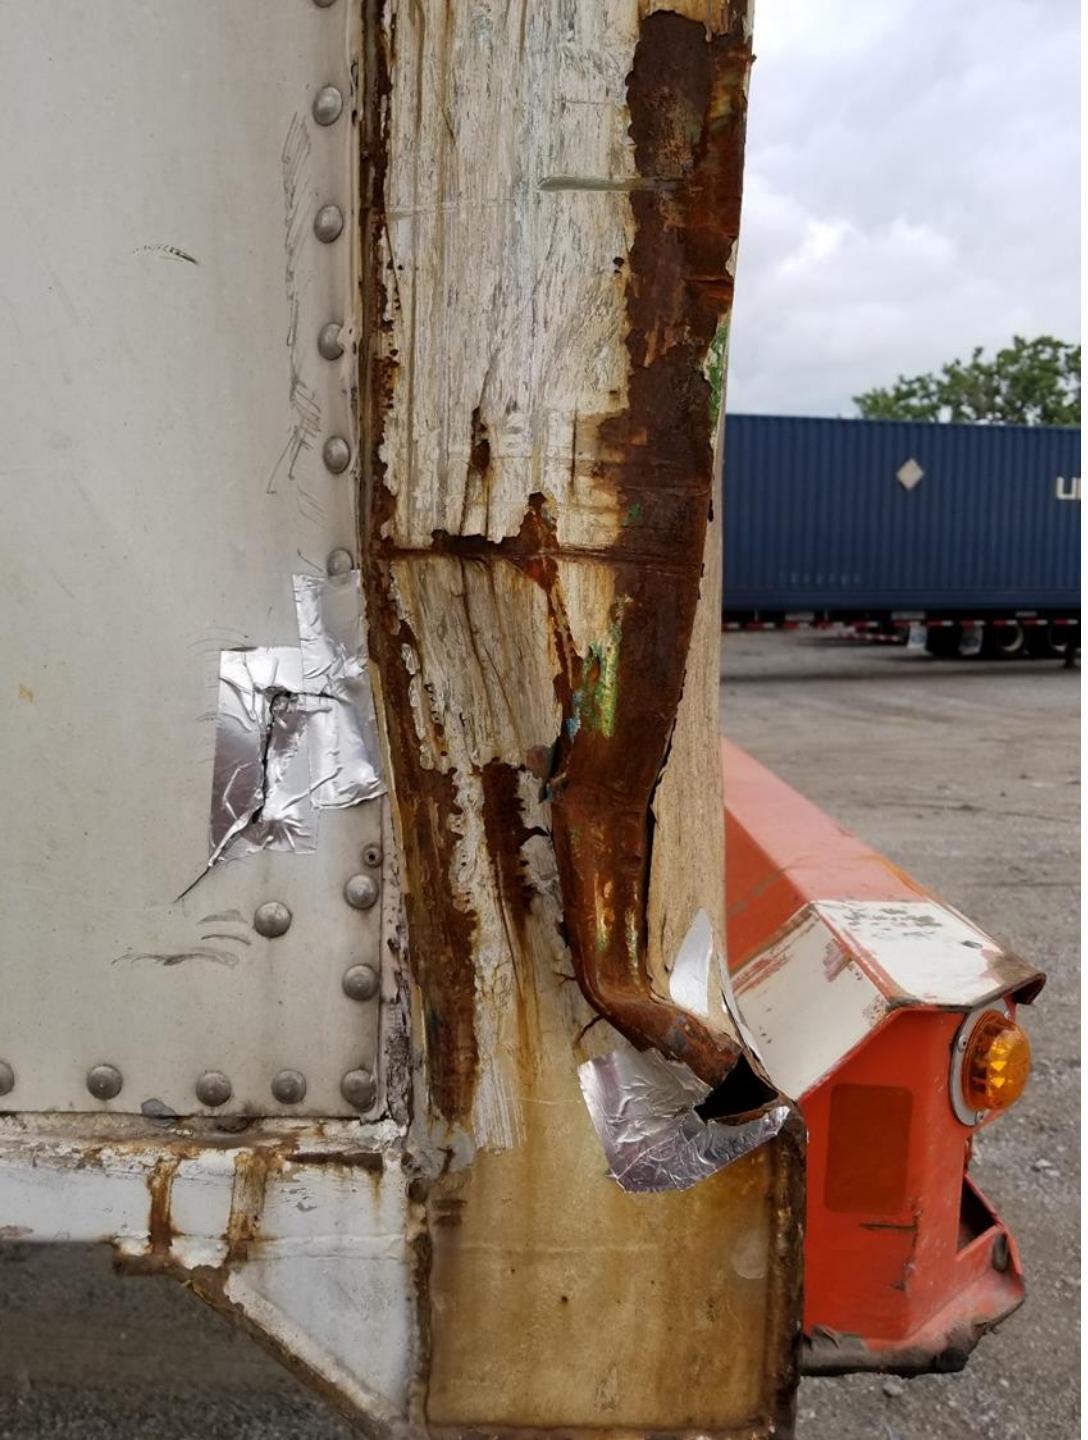
**RF- Corner Post Bent 24"**  
**RF- Corner Post Cut 6"**  
**RSF- Side Panel Bent 12"**  
**RSF- Side Panel Cut 6"**

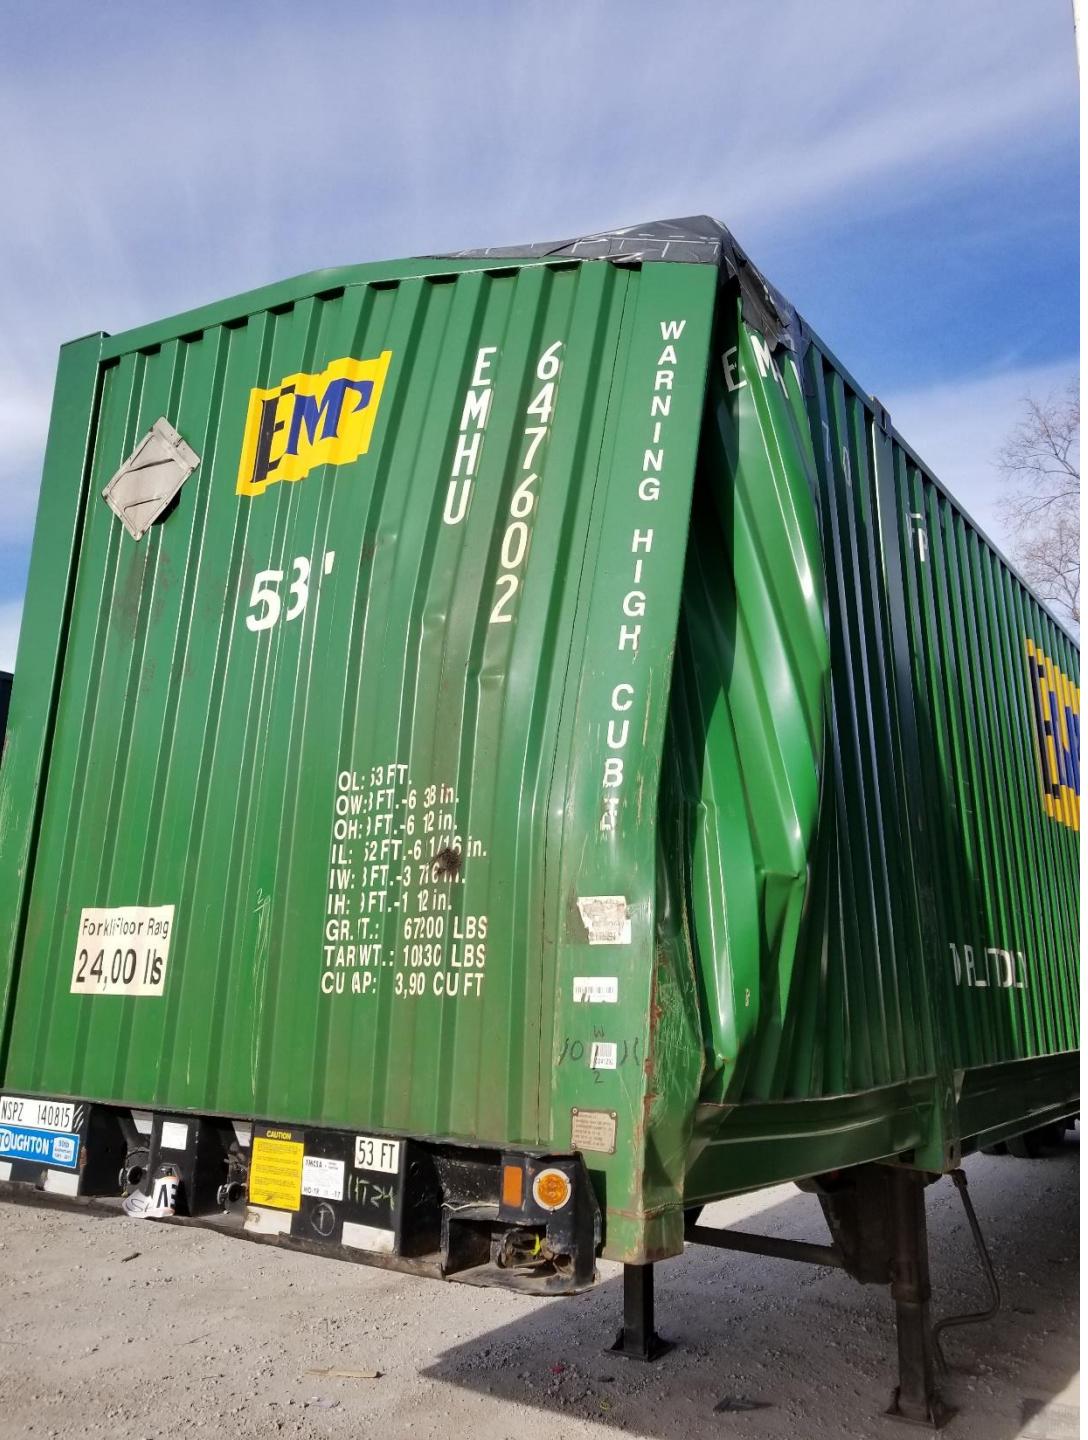
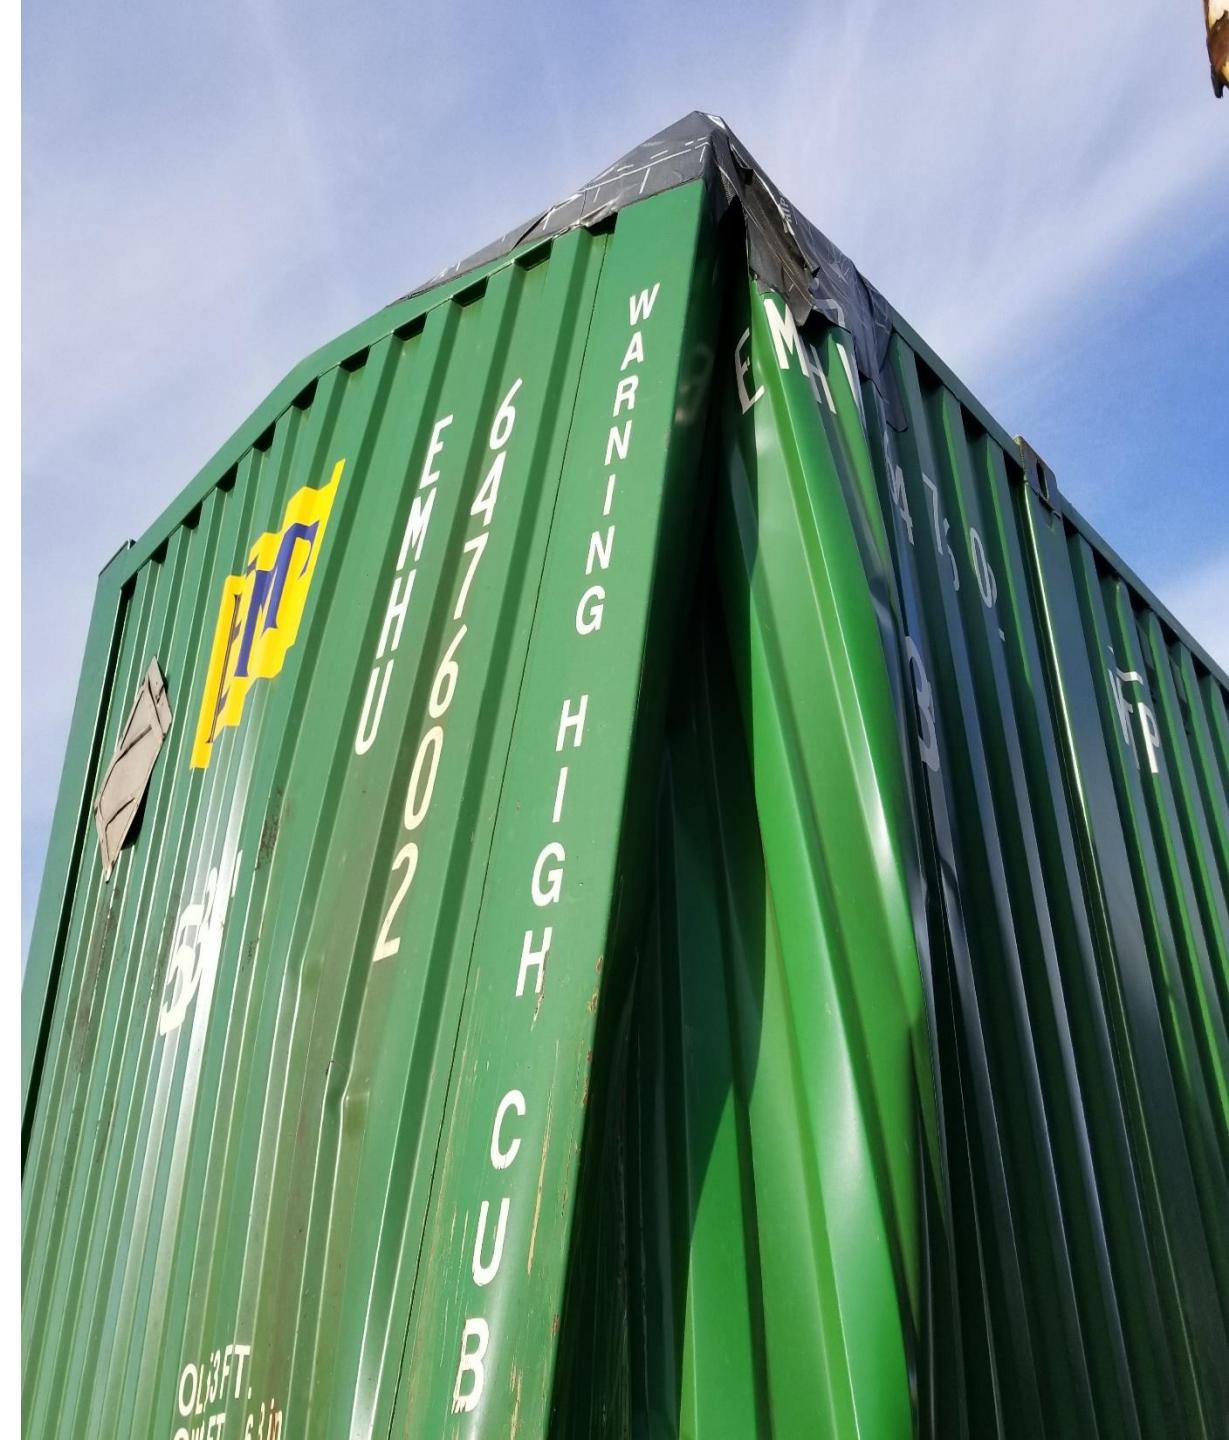
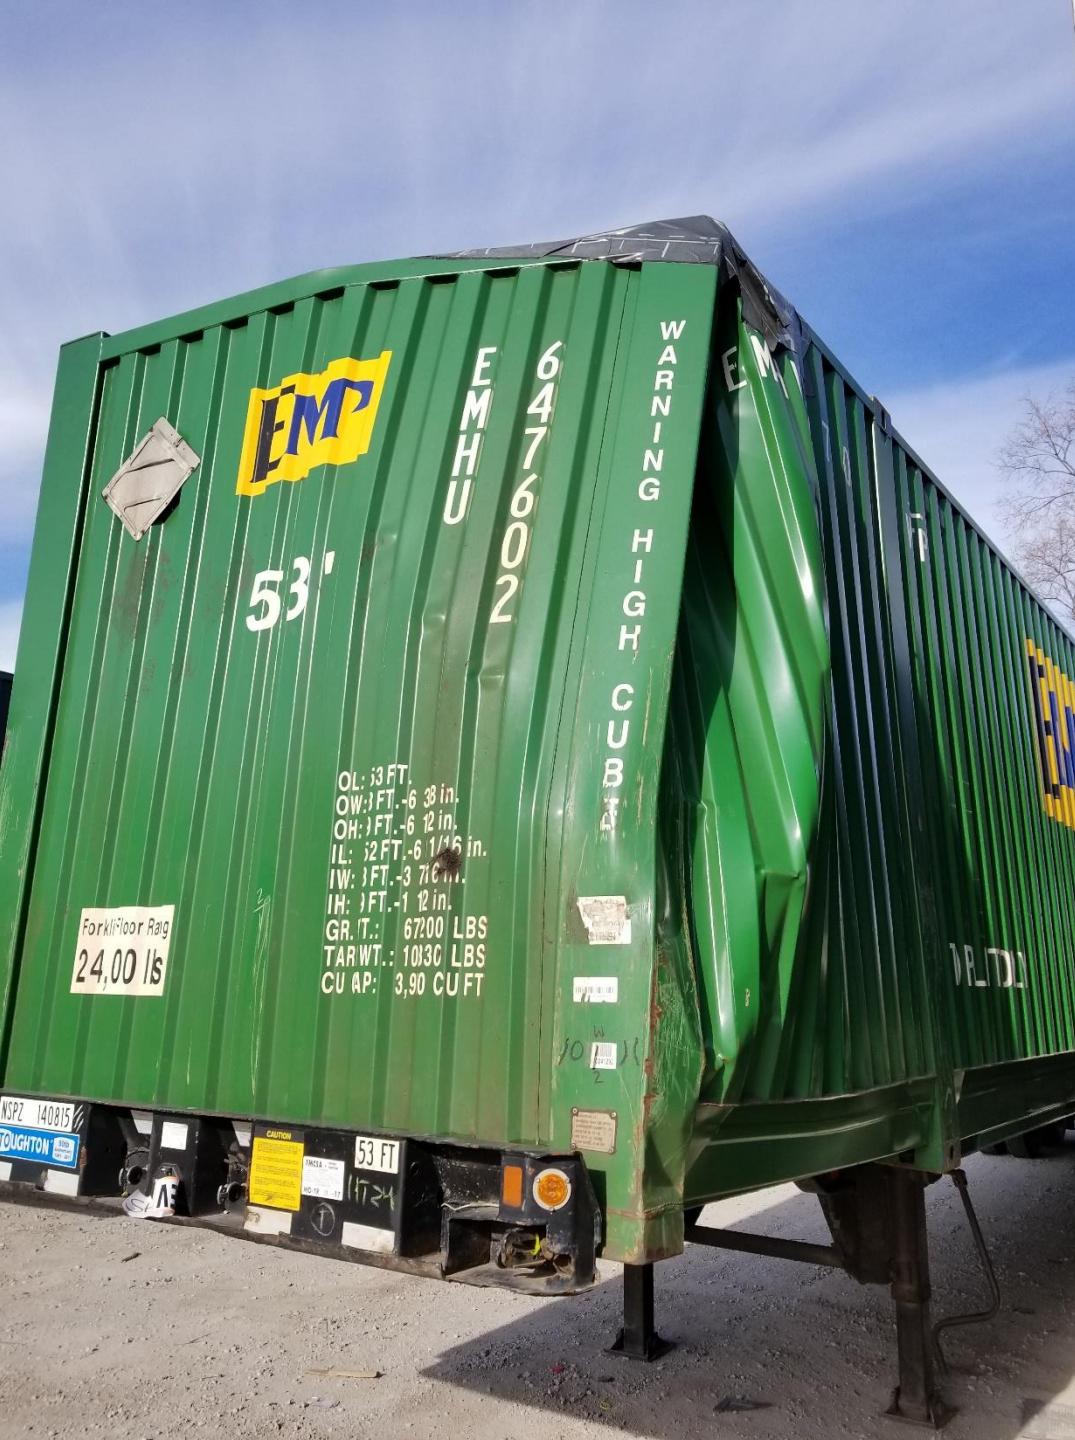
- F- Top Nose Rail Bent 36"
- F- Top Nose Rail Cut 12"
- F- Nose Panel Bent 96"
- LF- Corner Post Bent 96"
- LSF- Side Panel Bent 96"
- LSF- Side Panel Cut 36"
- LSF- Top Rail Bent AND Cut 36" each
- LSF- Bottom Rail Bent 36"
