## INTERMODAL INSPECTION PROGRAM

Properly Identifying the  
Components of Intermodal  
Equipment

## Section F Damage

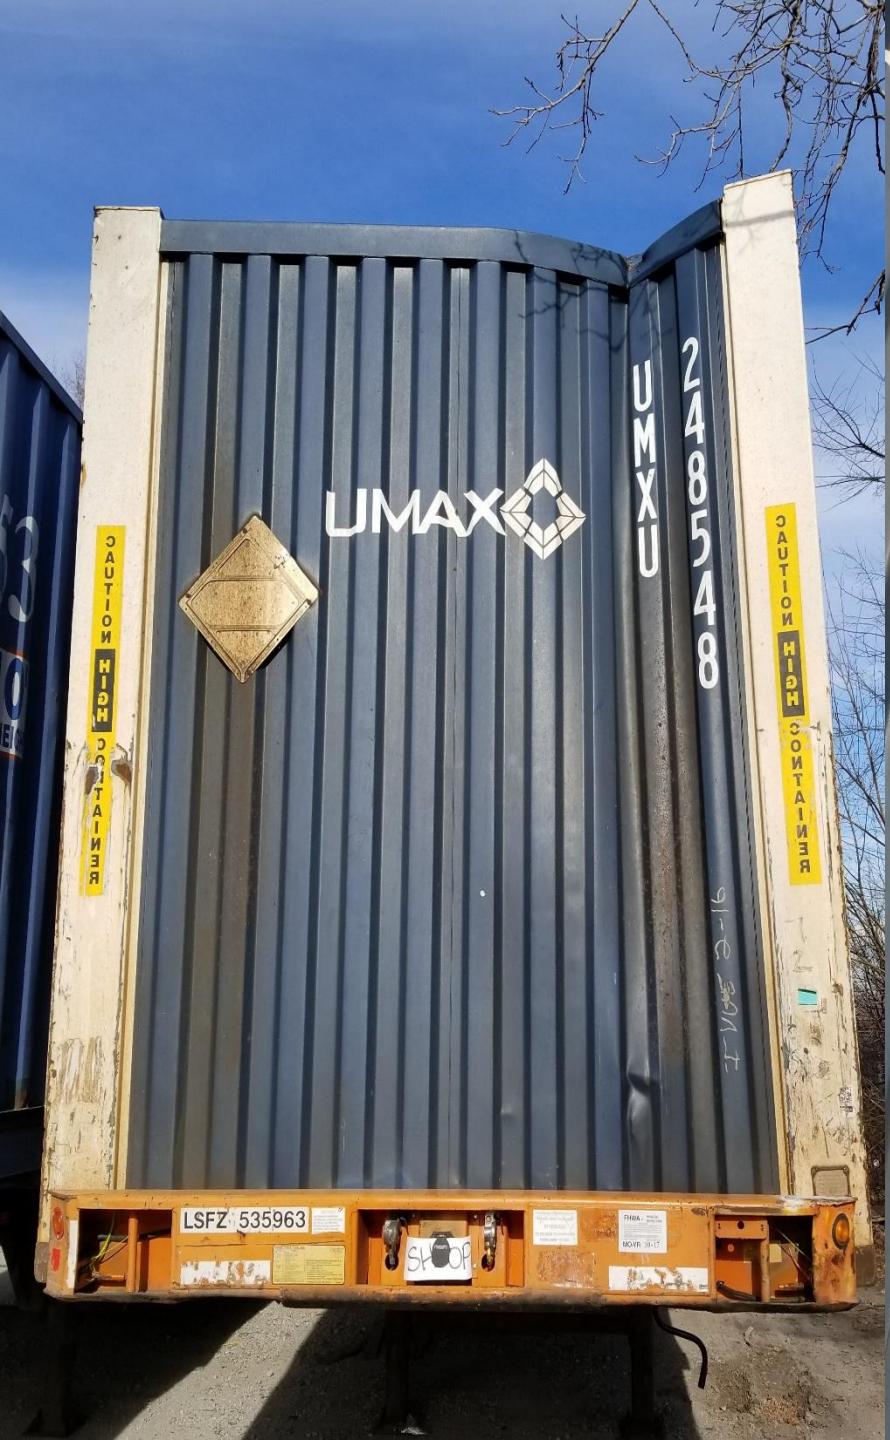
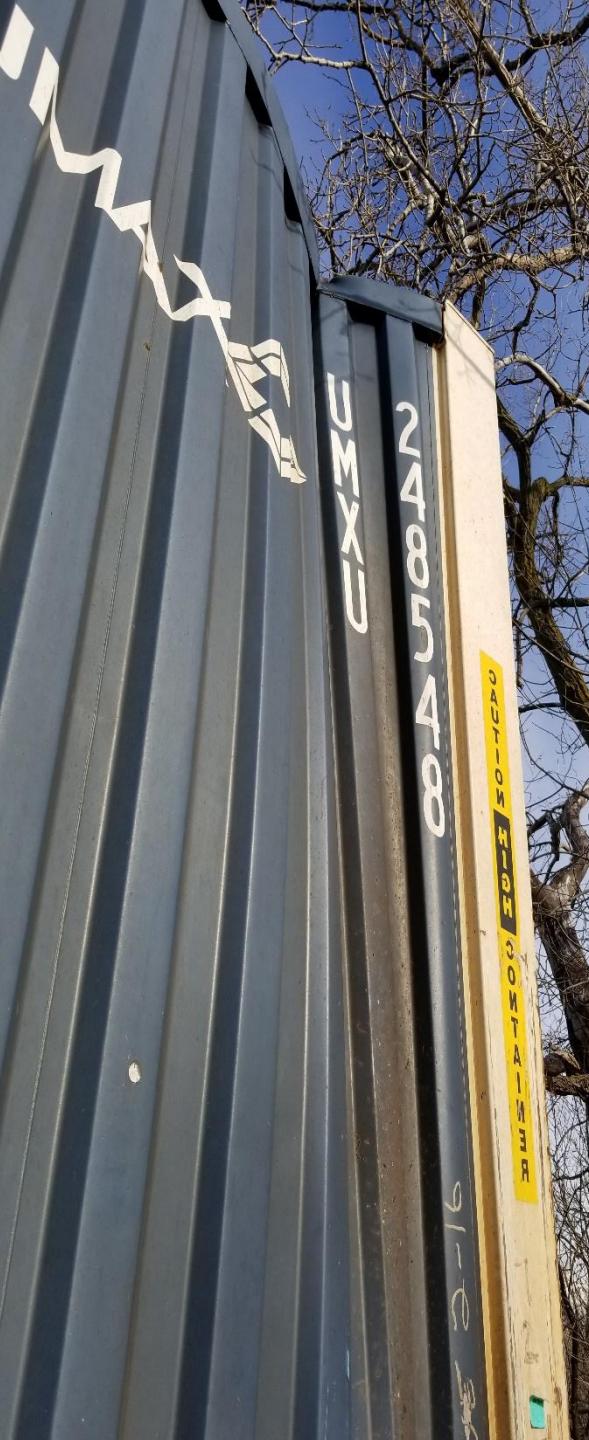
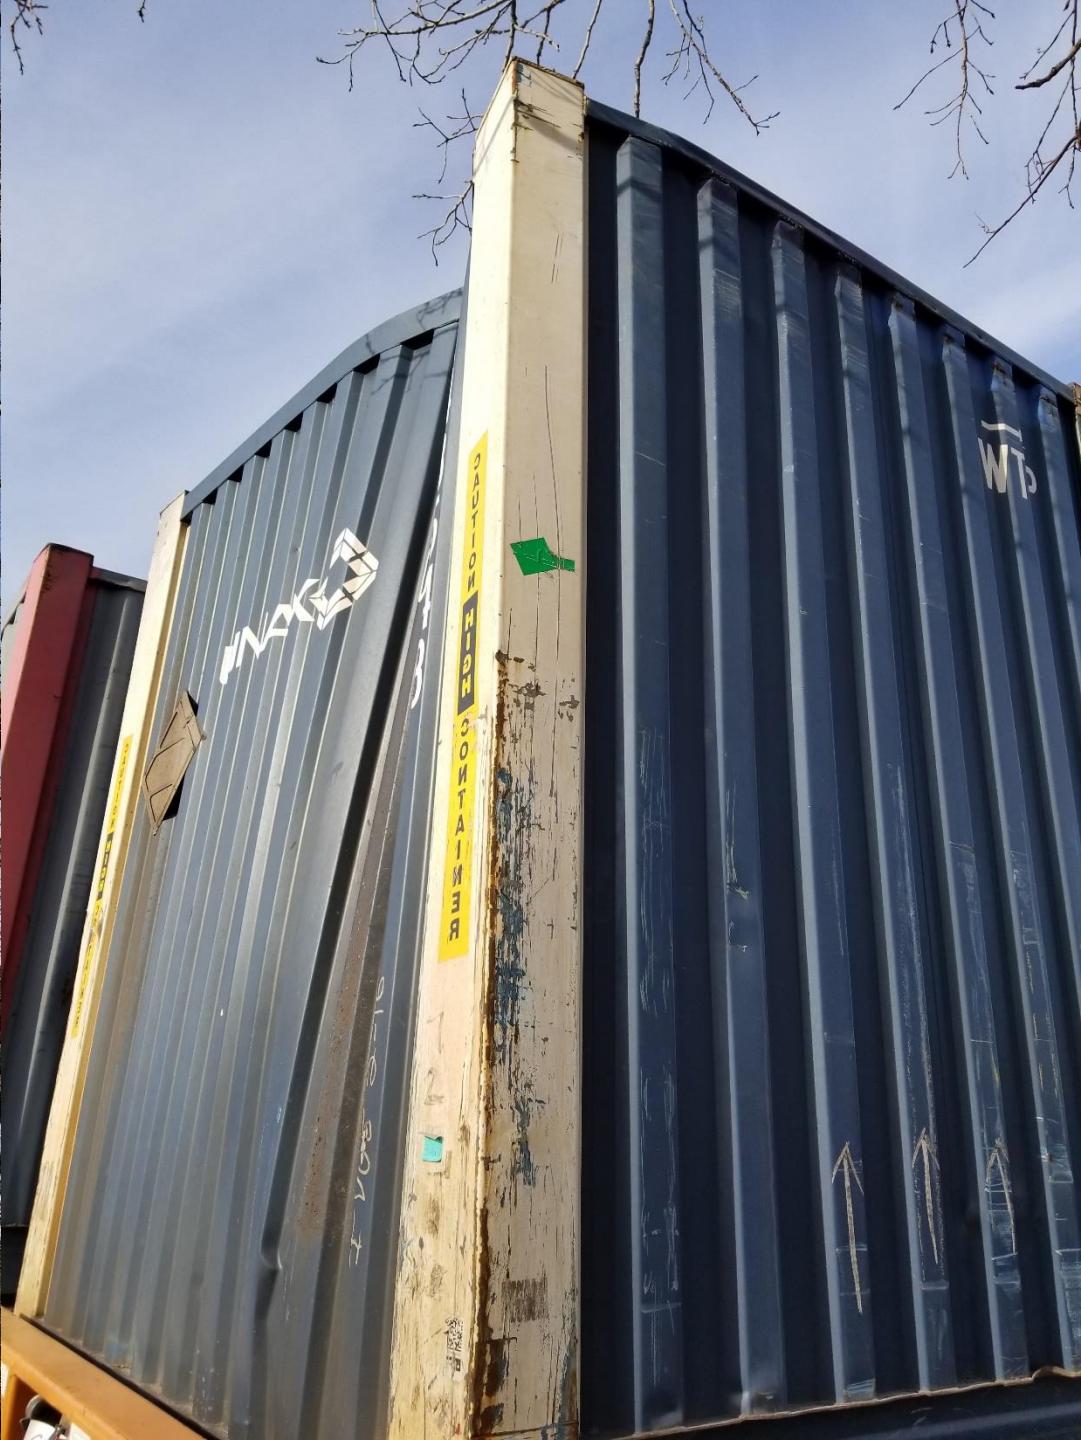
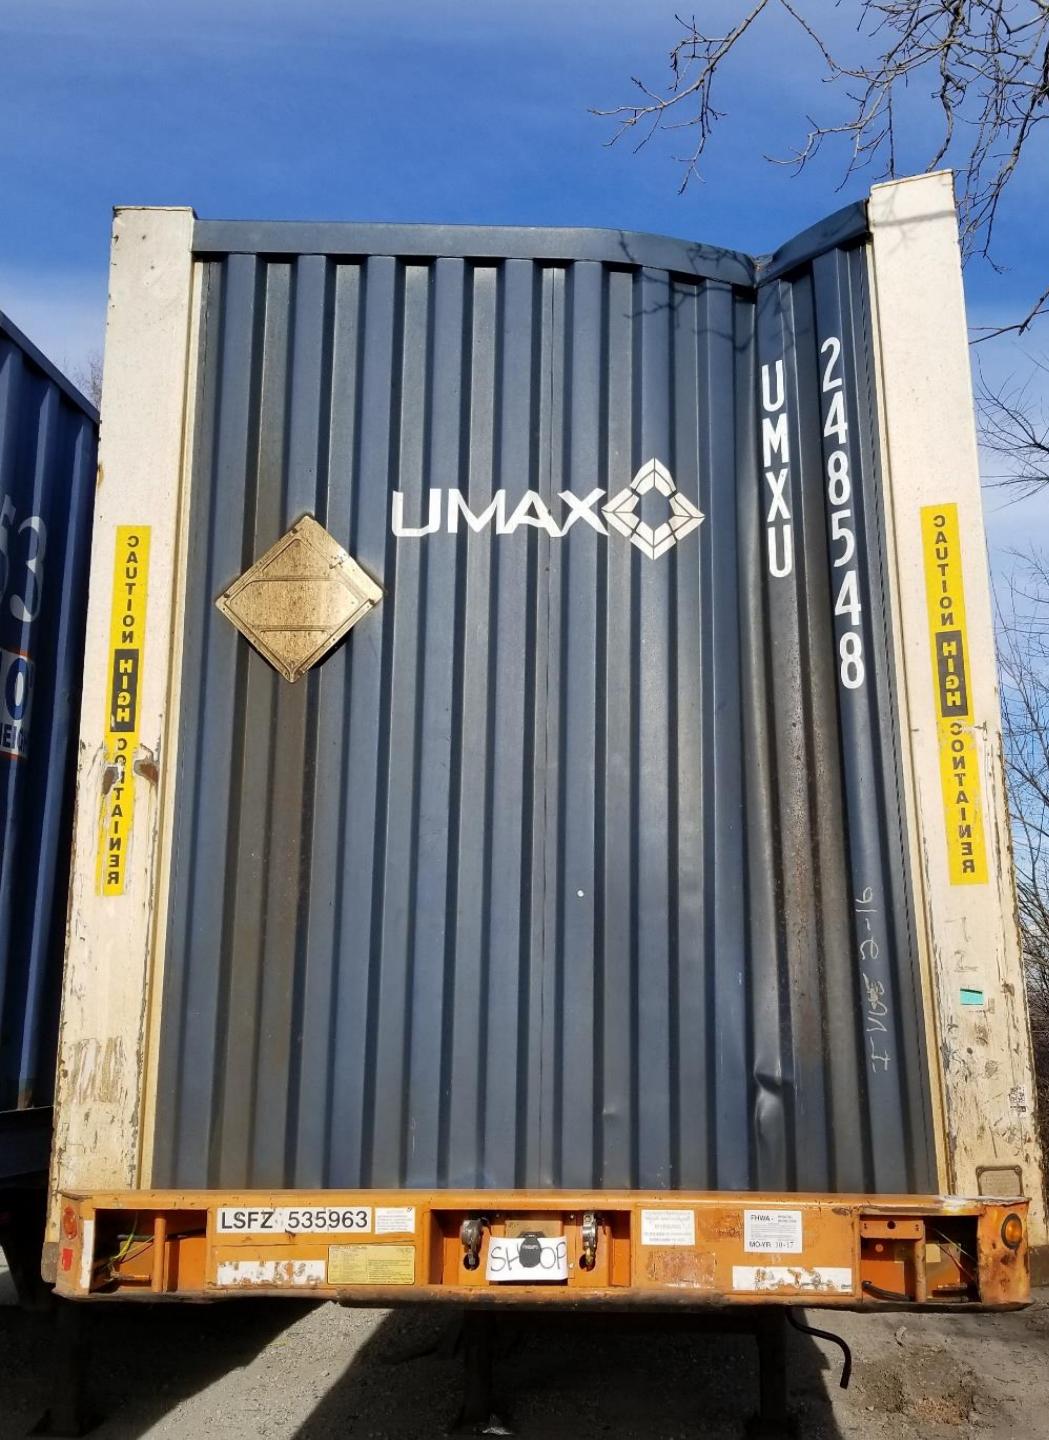
**F- Nose Panel Bent 80"**  
**F- Top Nose Rail Bent 36"**  
**F- Top Nose Rail Cut 4"**  
**LF- Corner Post Bent 72"**

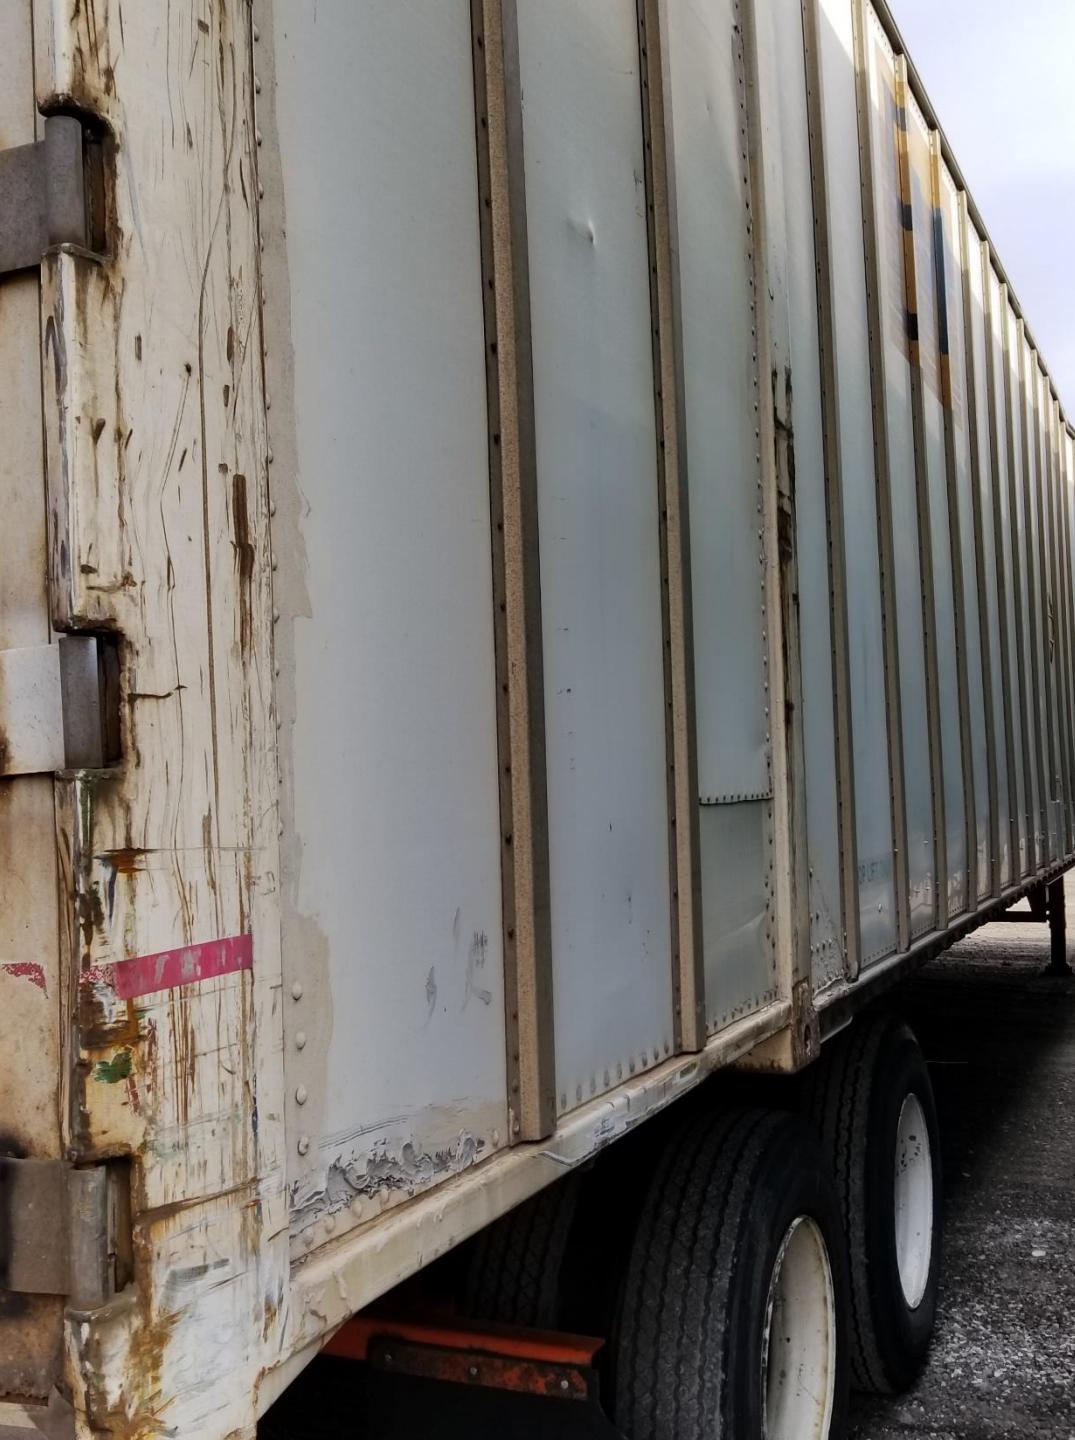
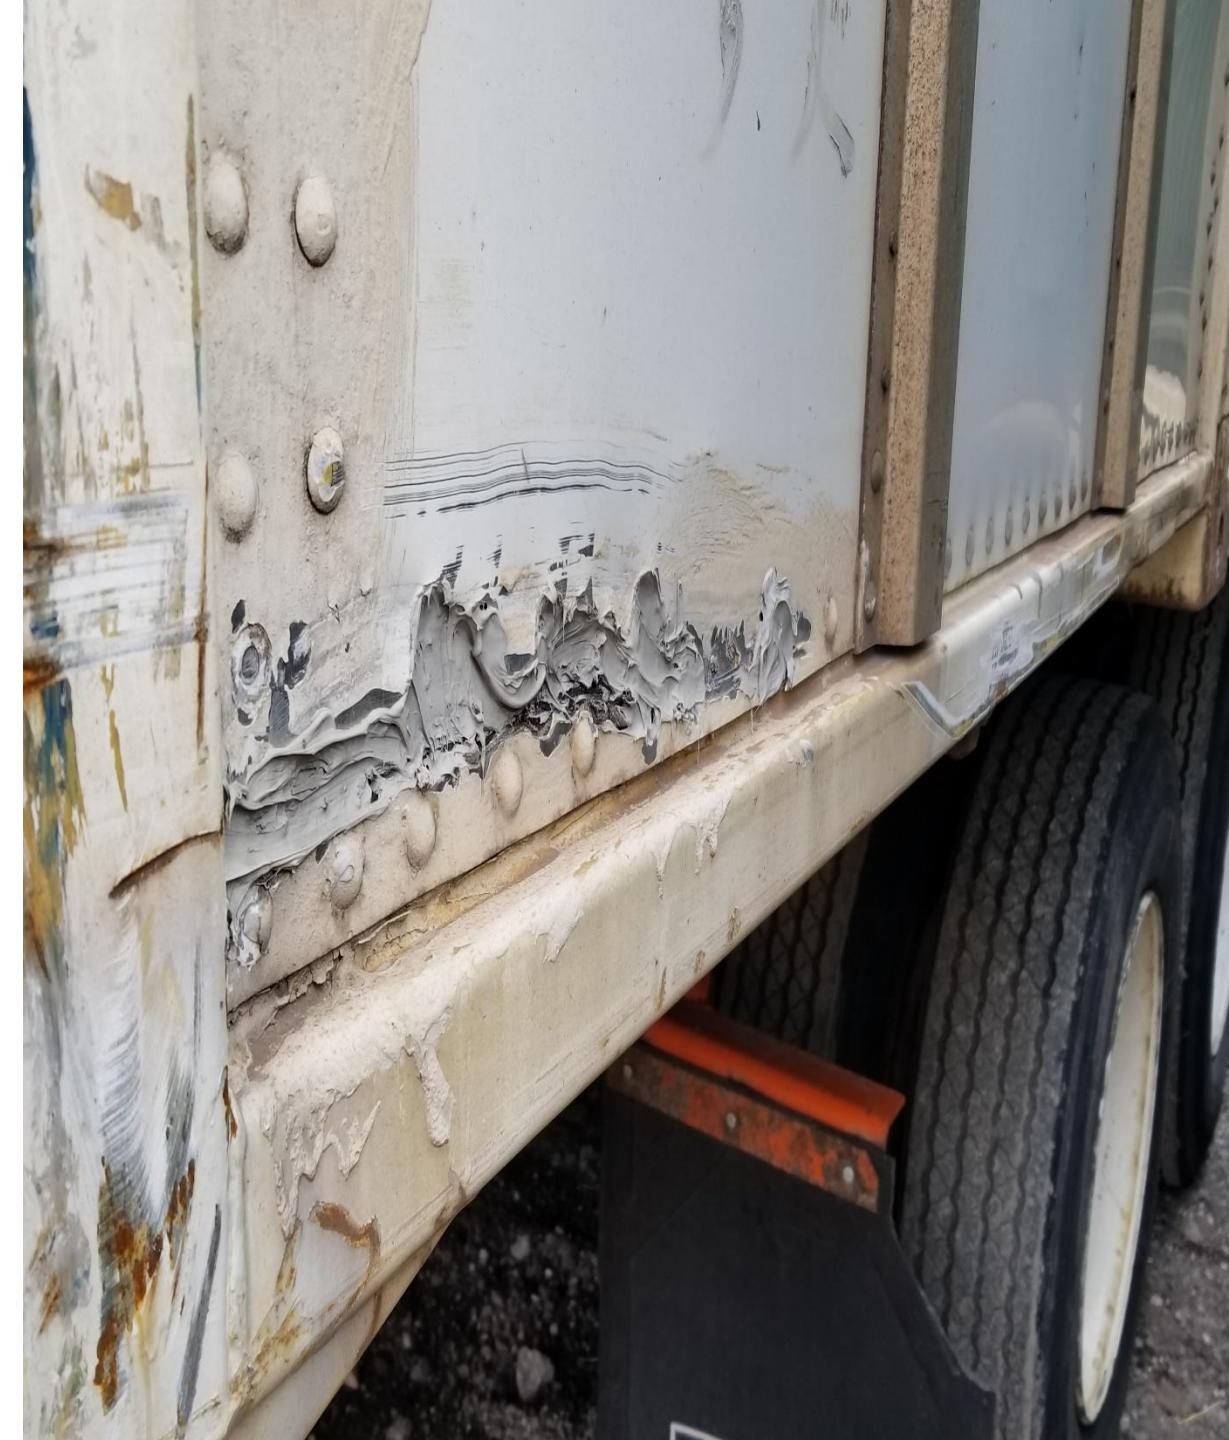
**RSR- Side Panel Cut 24"**

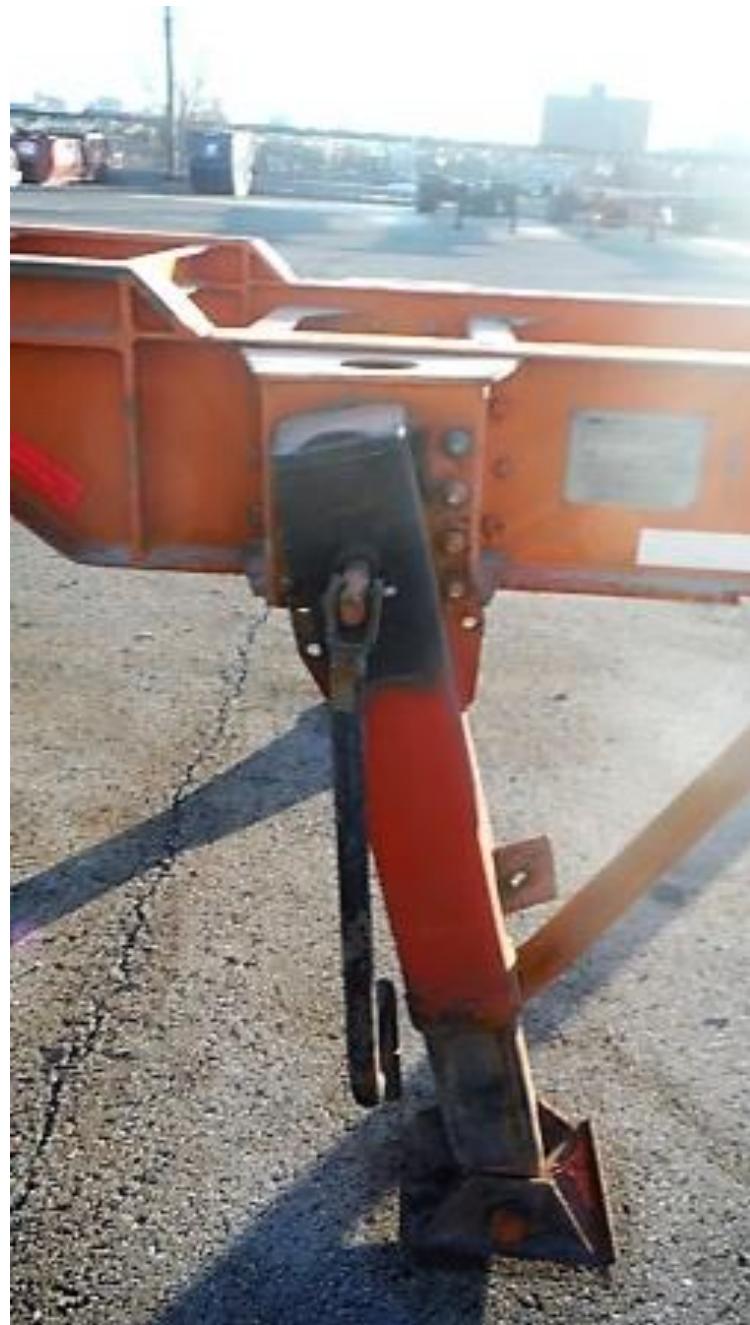
**LS- Gear Leg Bent**

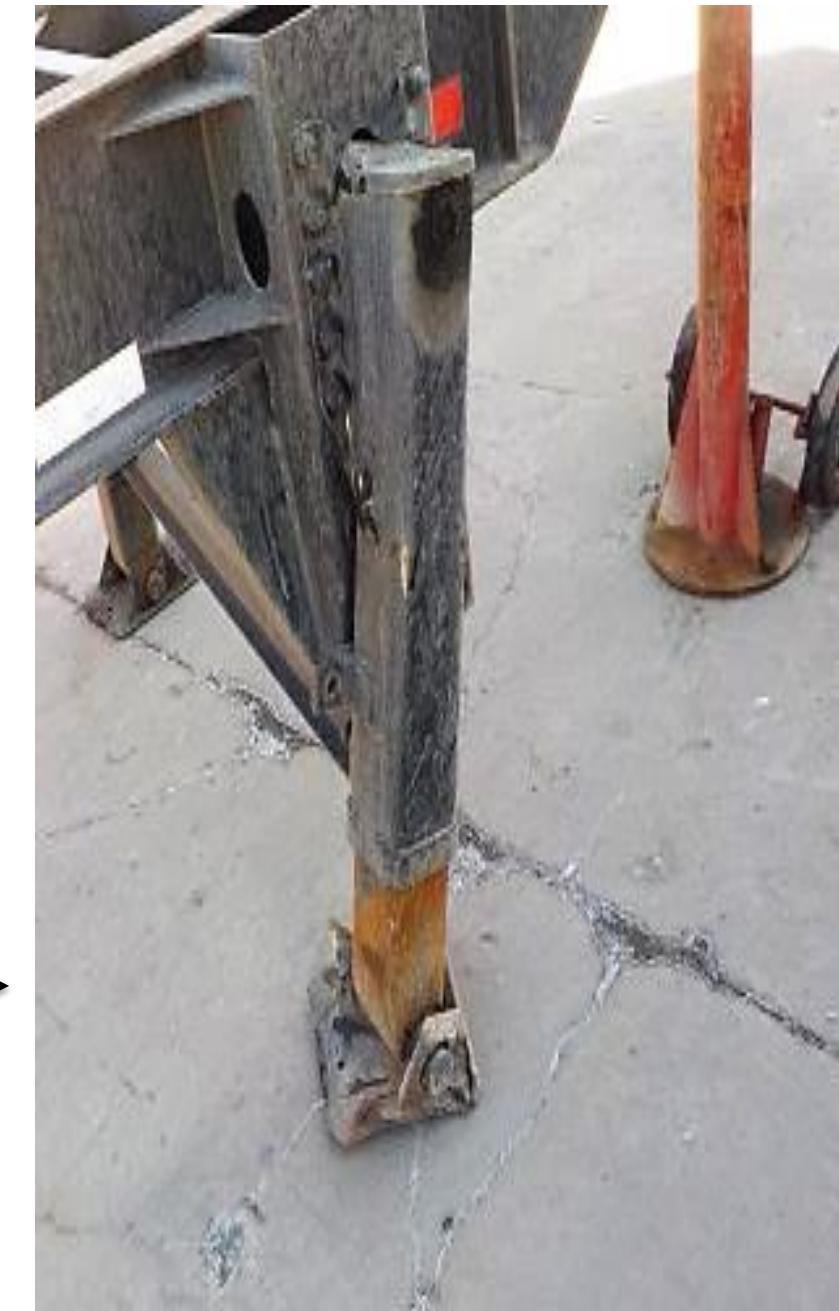
**RS- Non-Gear Leg Bent**

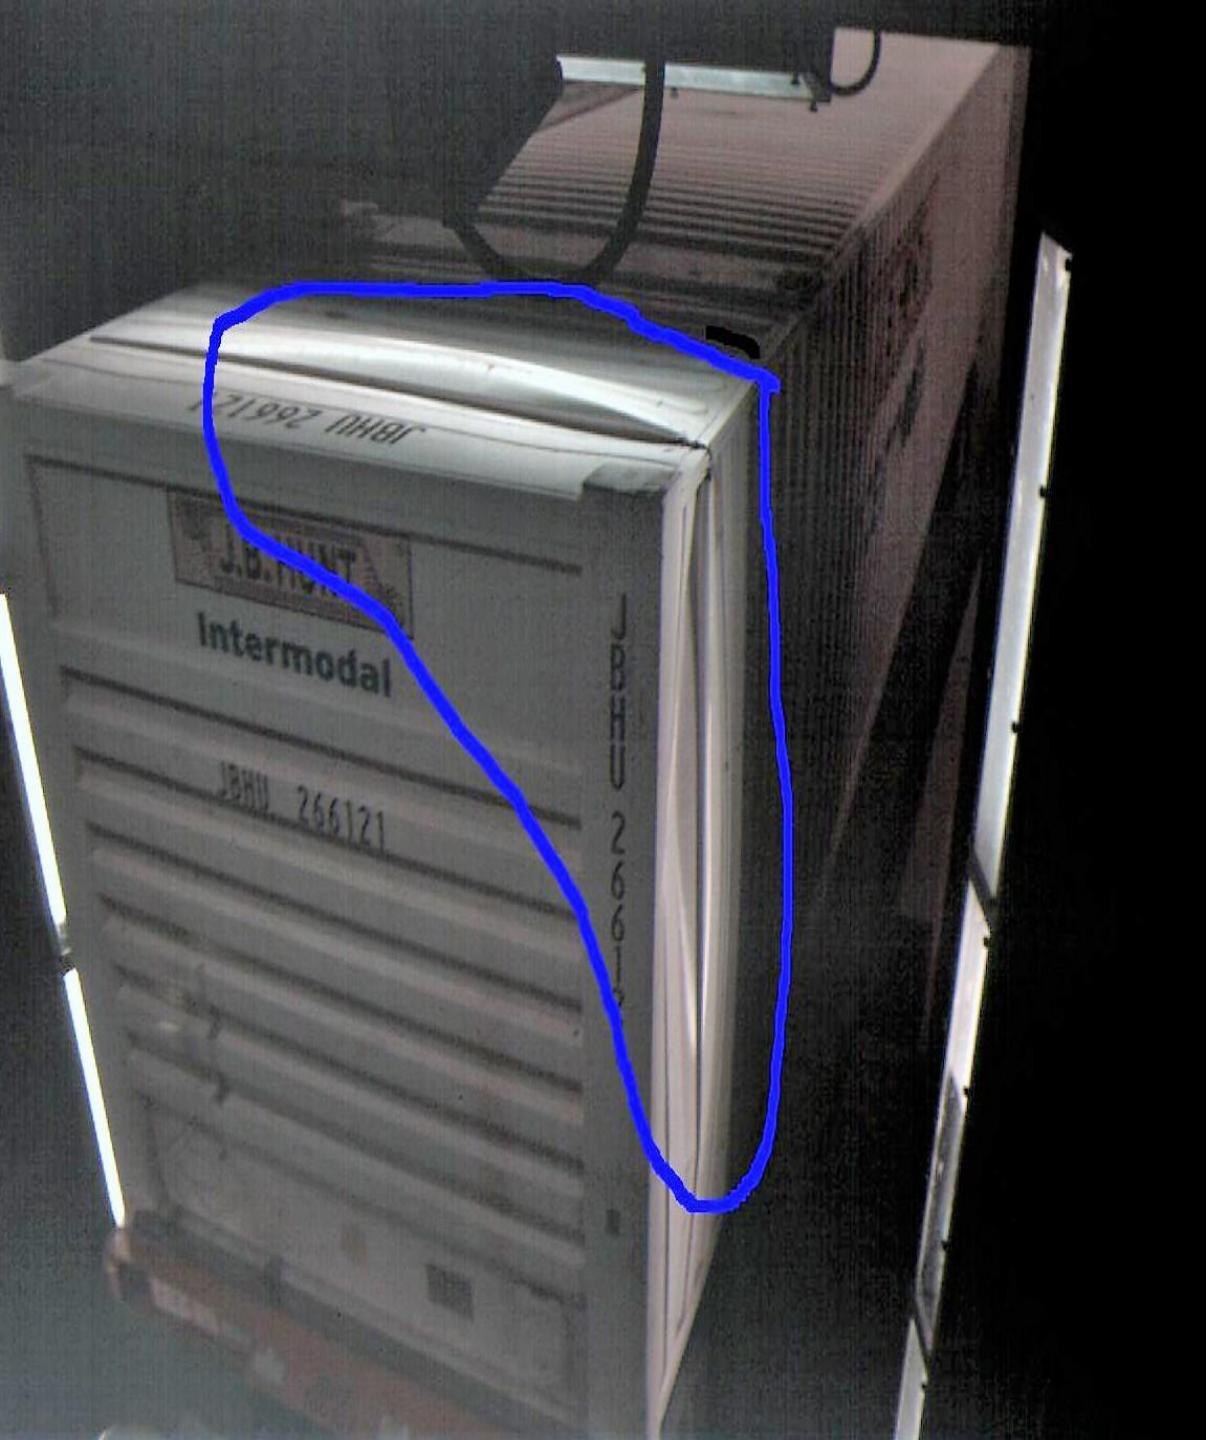
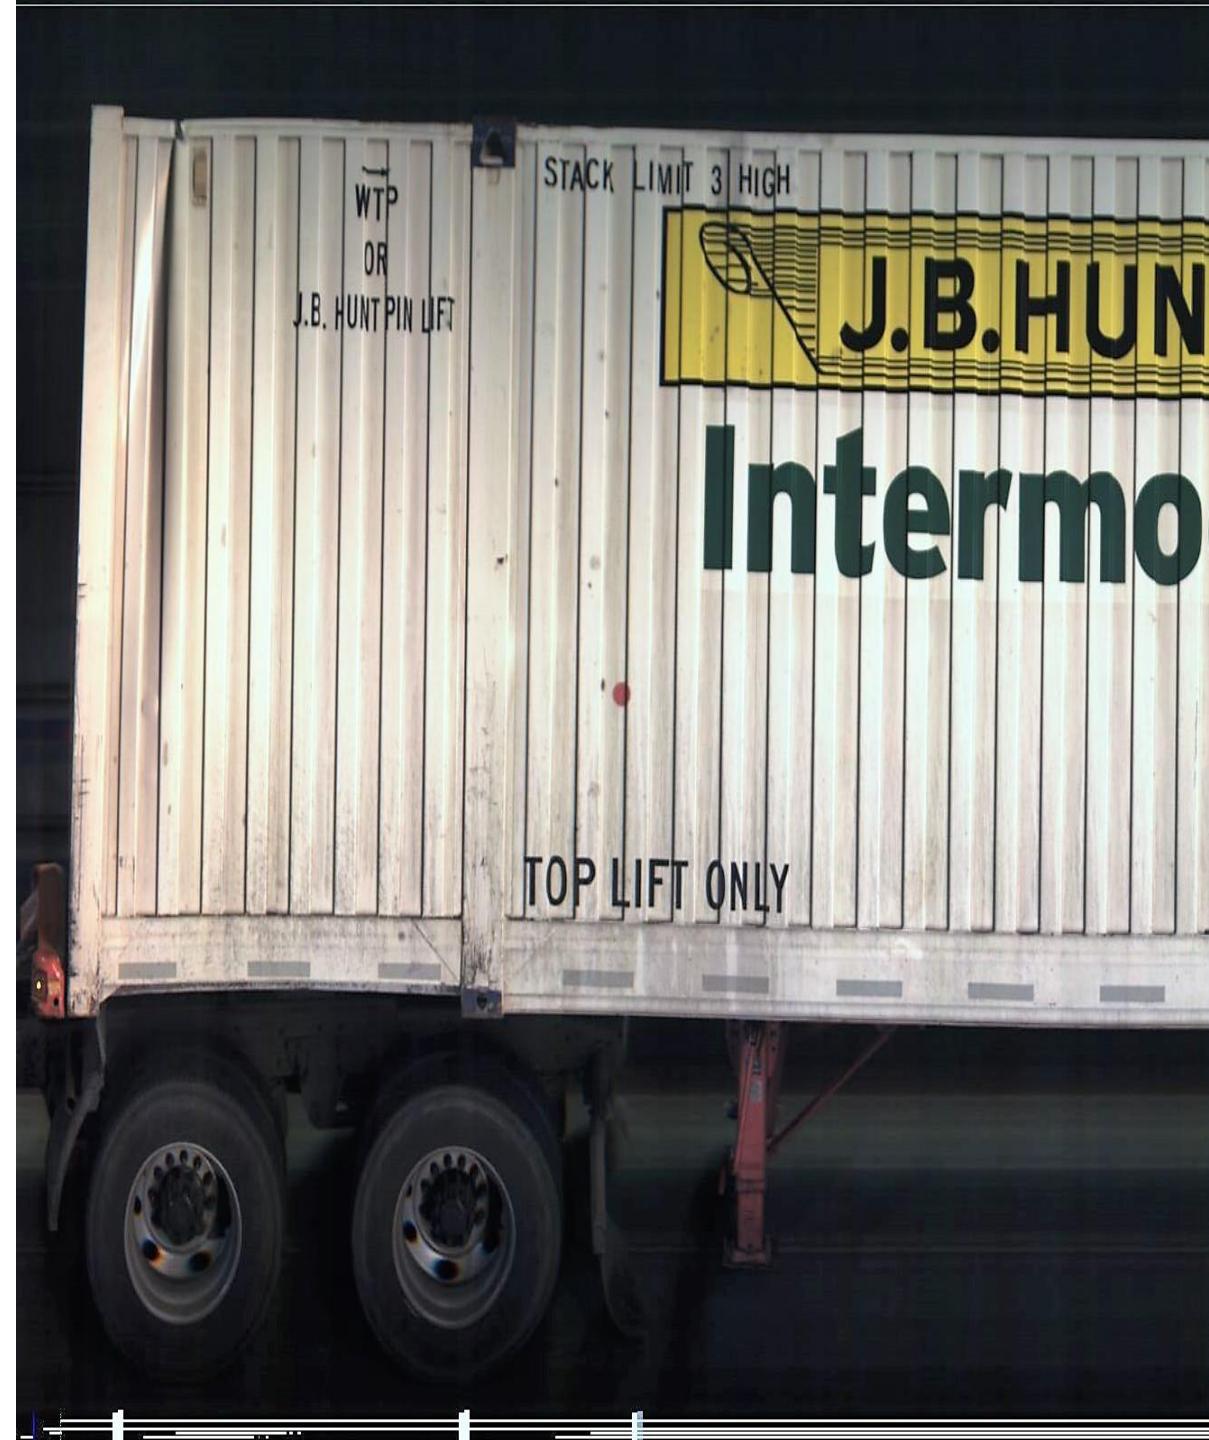
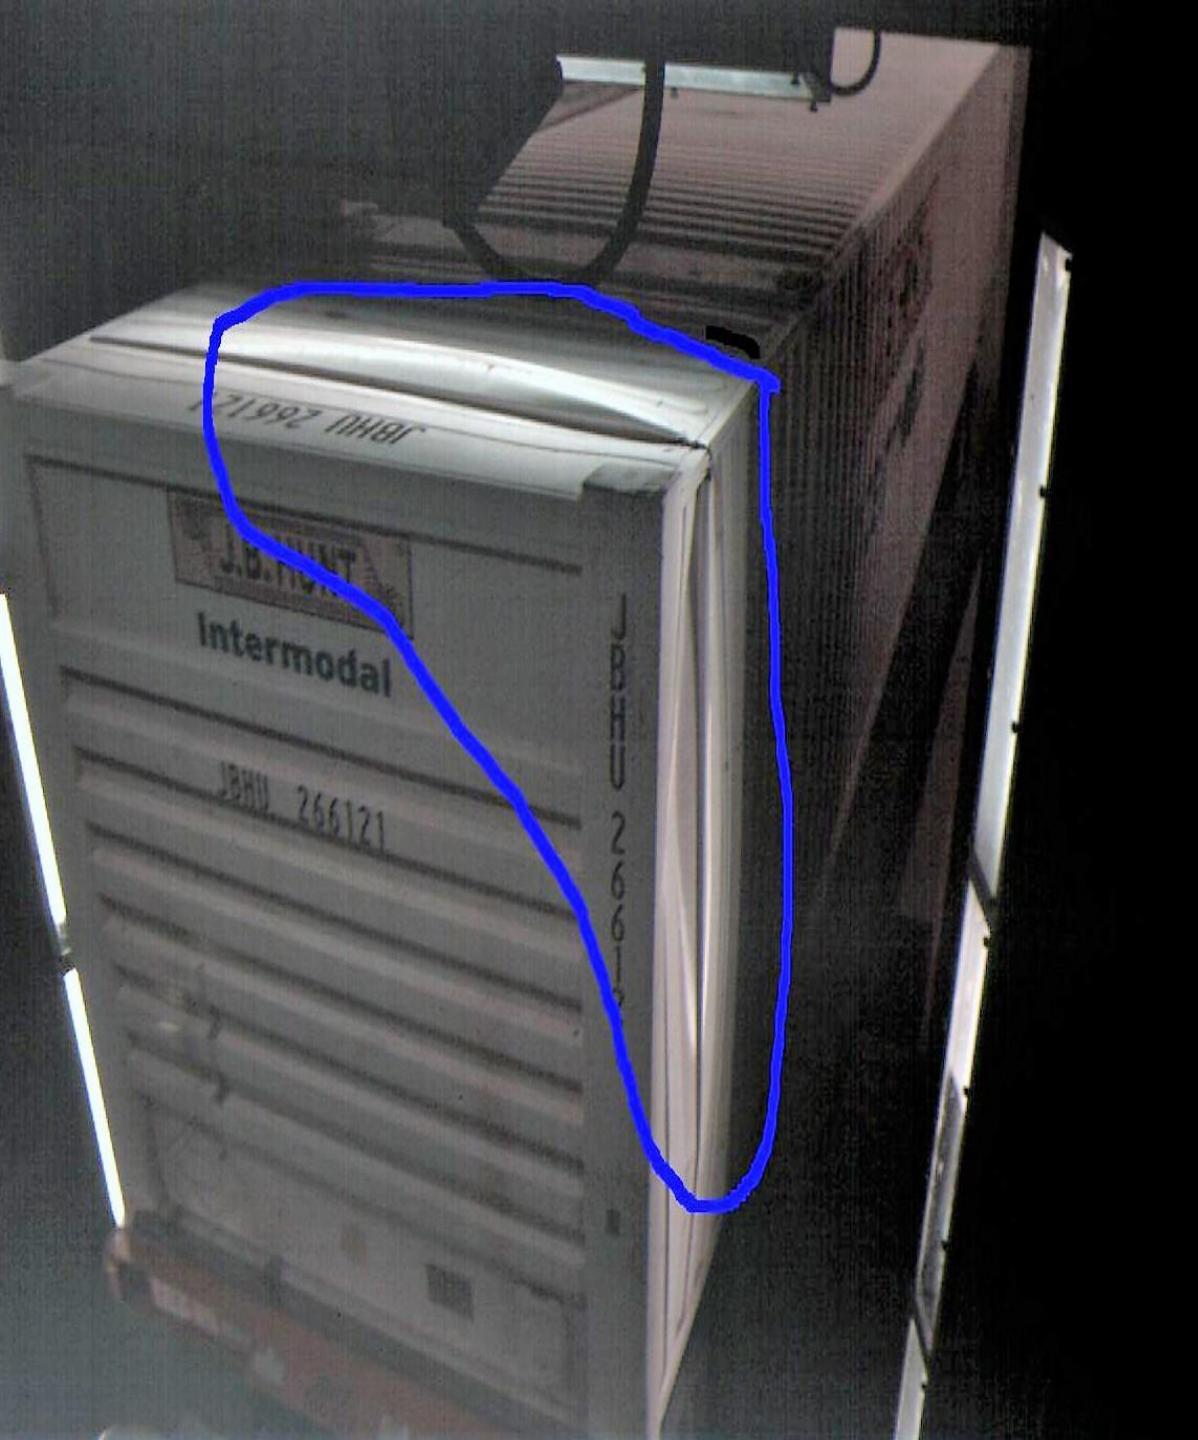
LSF- Steel Side Panel Bent 60"  
LSF- Steel Top Side Rail Bent 12"  
LSF- Steel Top Side Rail Cut 6"  
TF- Steel Roof Panel Bent 36"

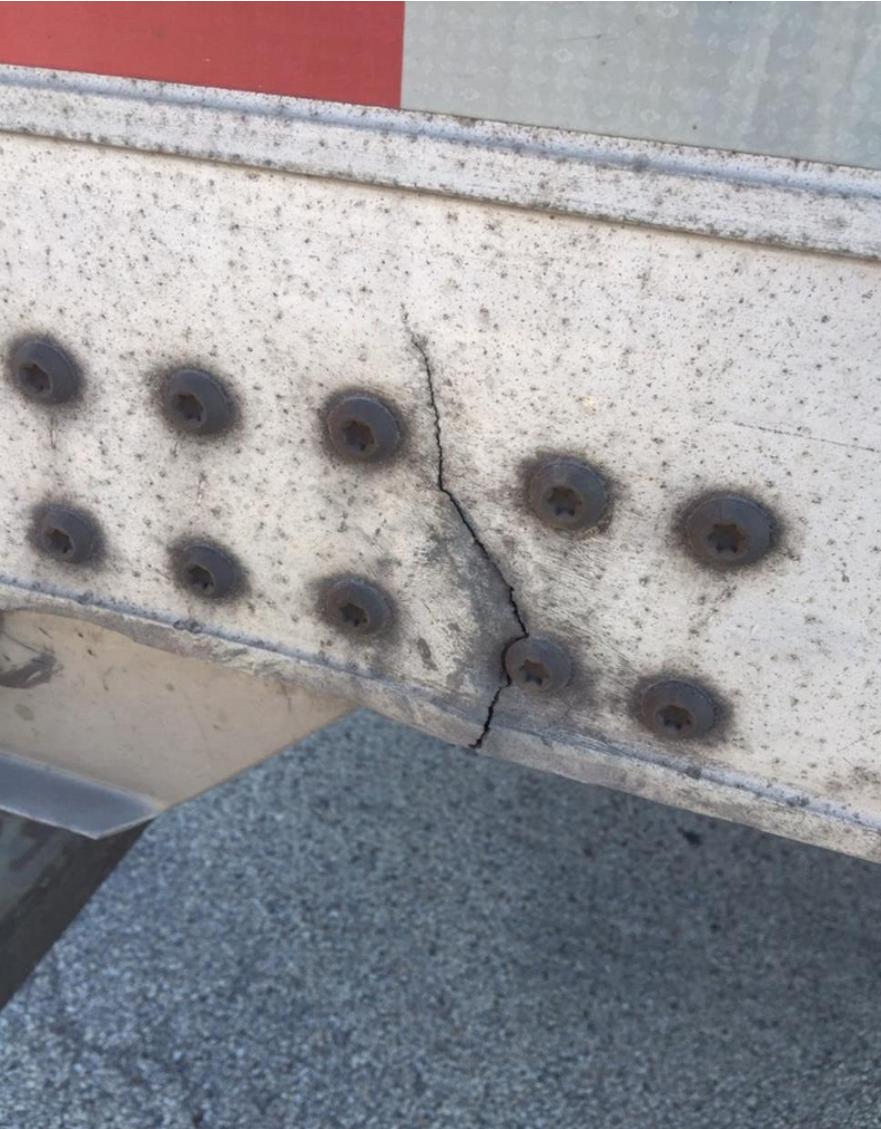
**Bottom Rail Crack – in gate**

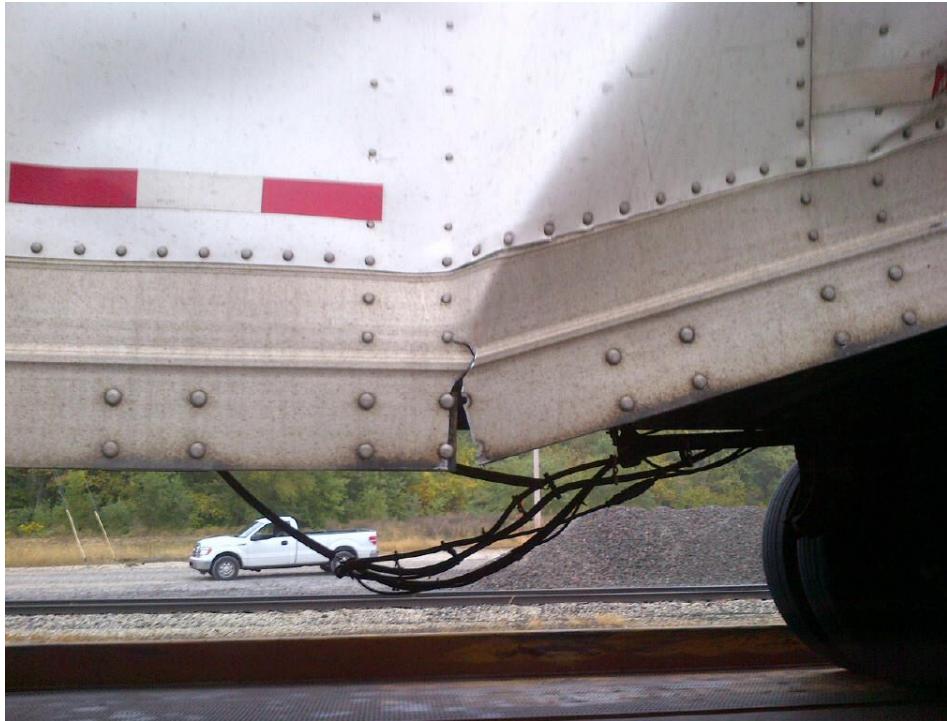
**Bottom Rail Crack – on car**

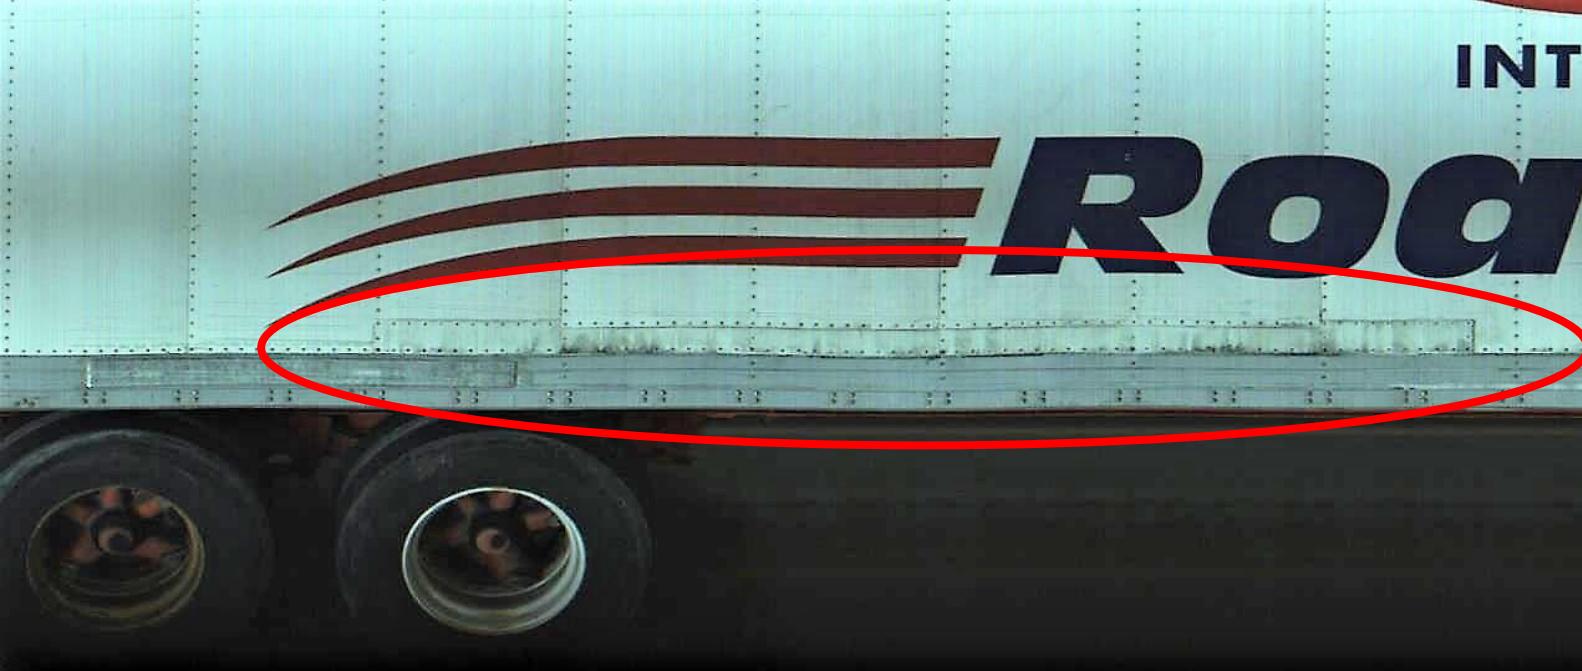
AGS Ingate Photo

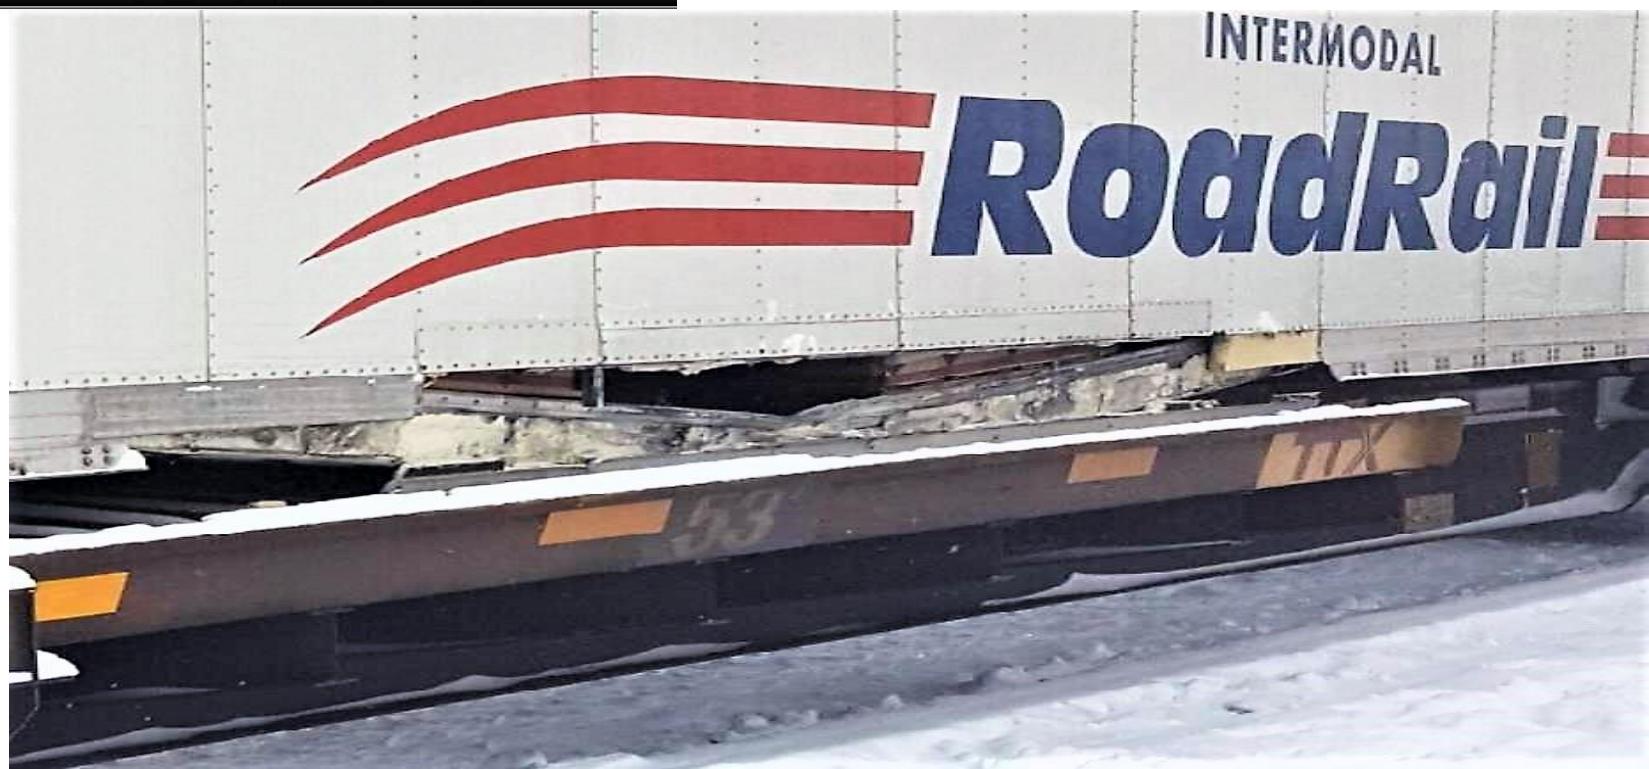
Unit Failure on Car

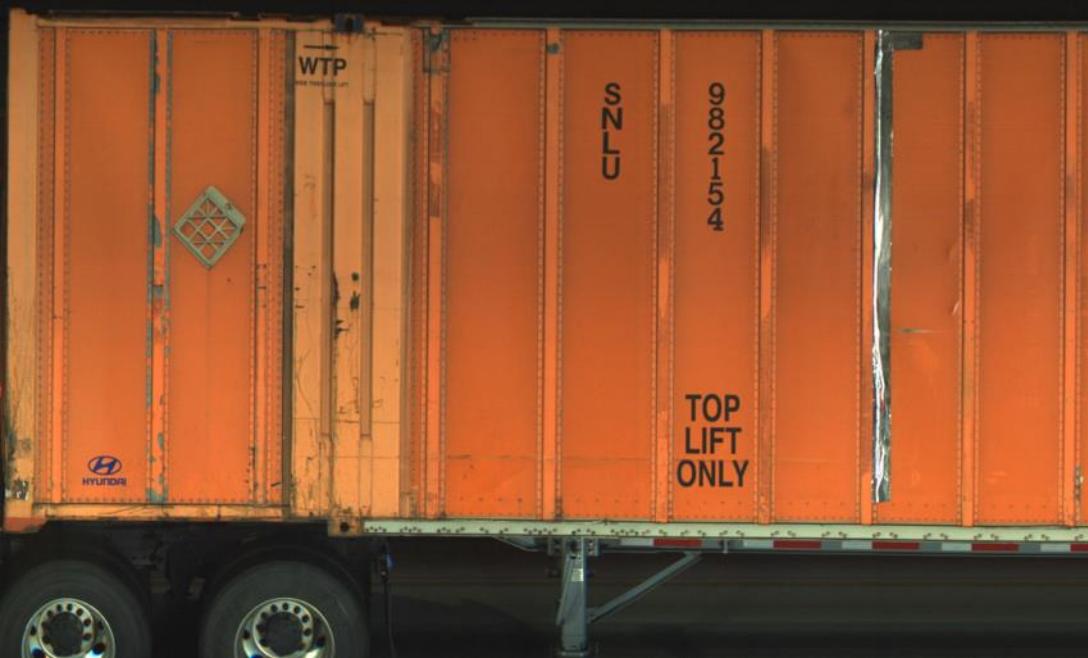
AGS Ingate

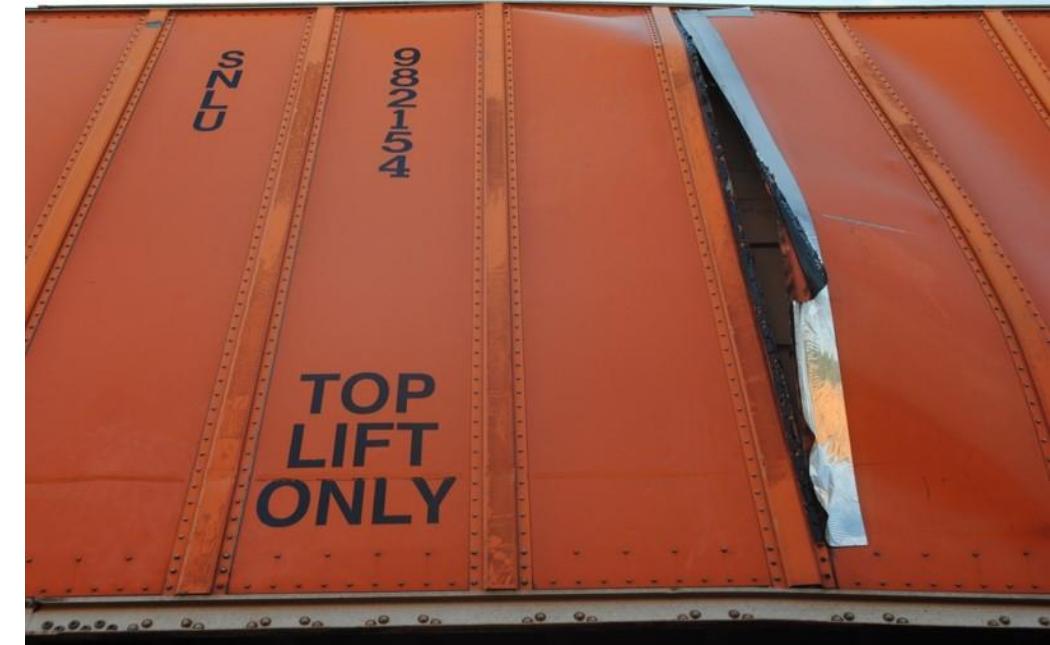
Unit Failure on Car

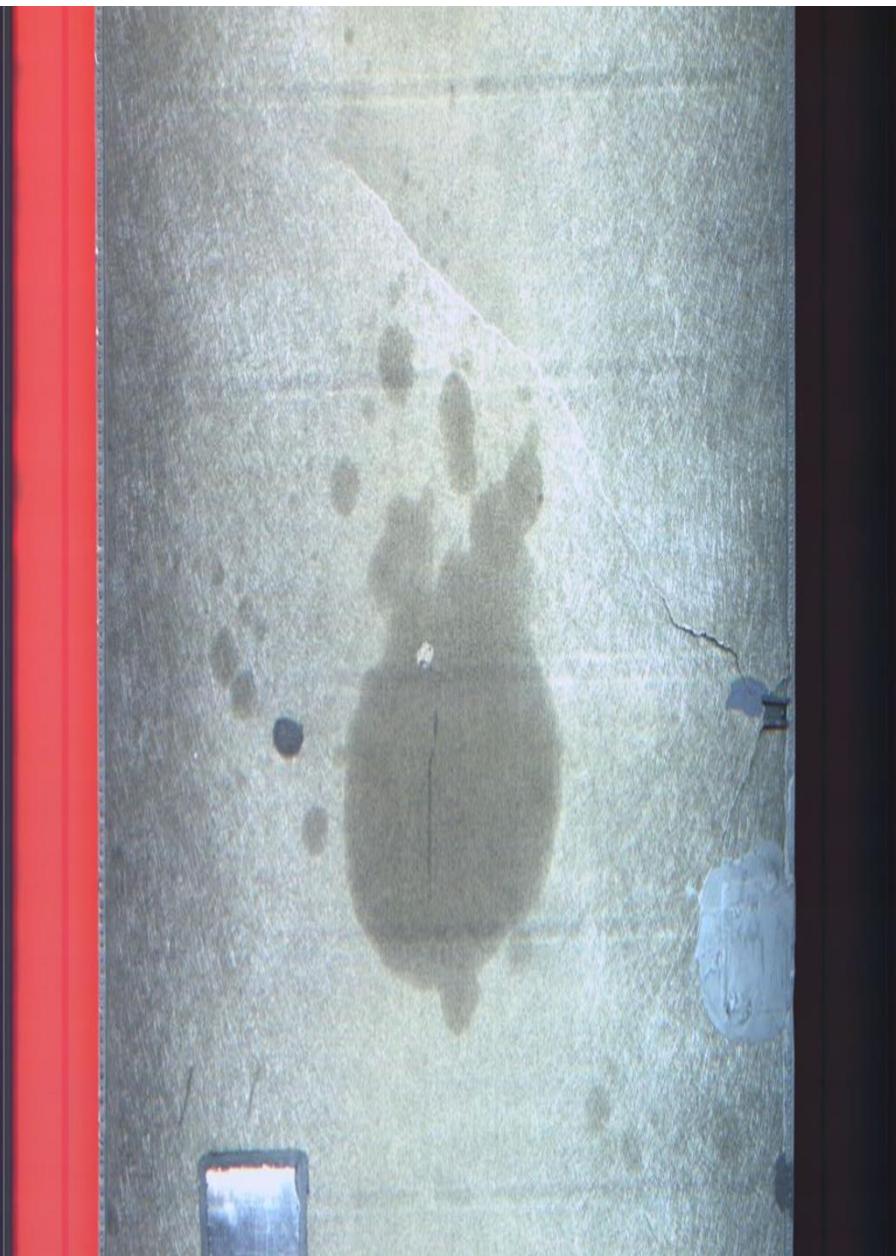
**Roof Sheet Flex Crack – in gate**
