## INTERMODAL INSPECTION PROGRAM

Properly Identifying the  
Components of Intermodal  
Equipment

## Section F Damage

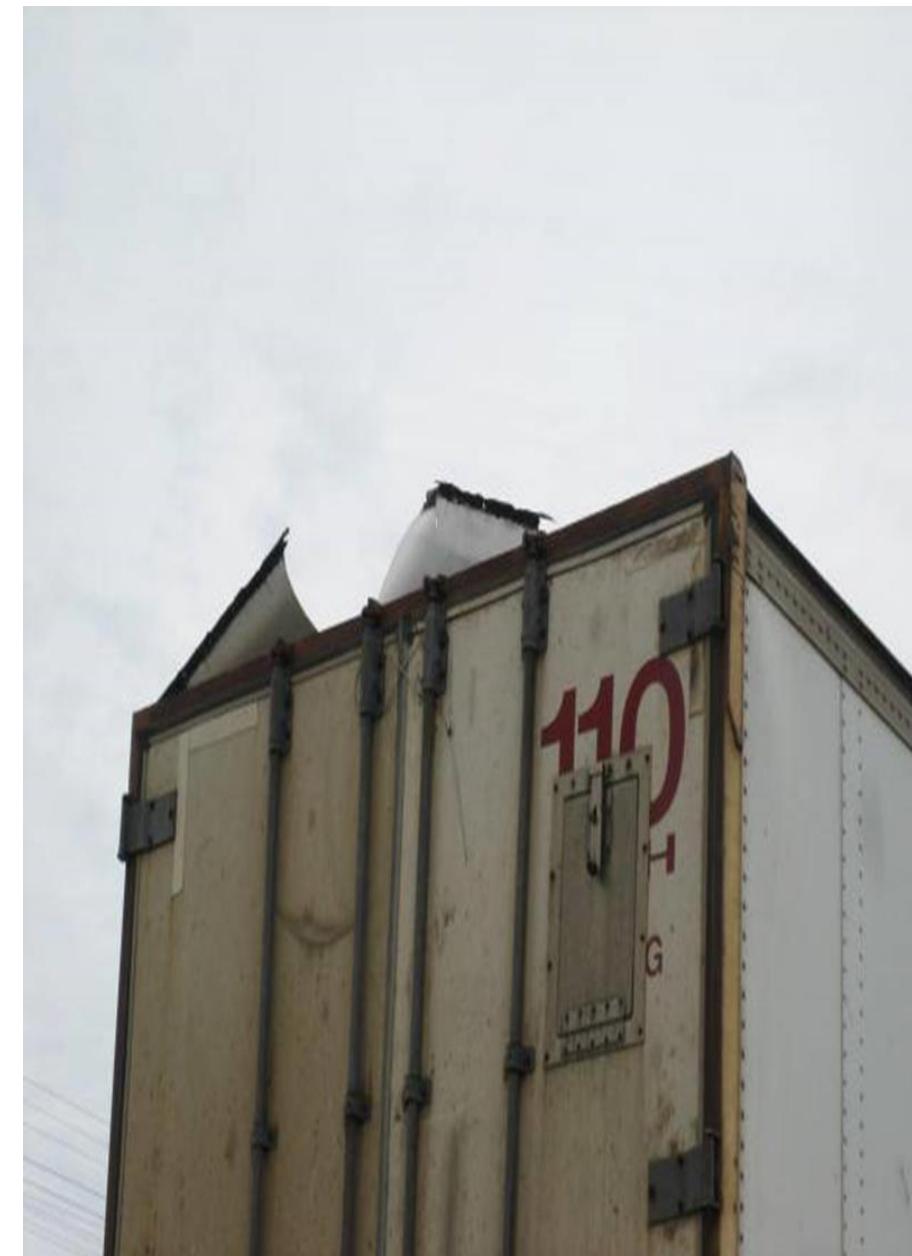
**Roof Sheet Flex Crack – on car**
