Brake Chamber damage caused by improper chassis stacking

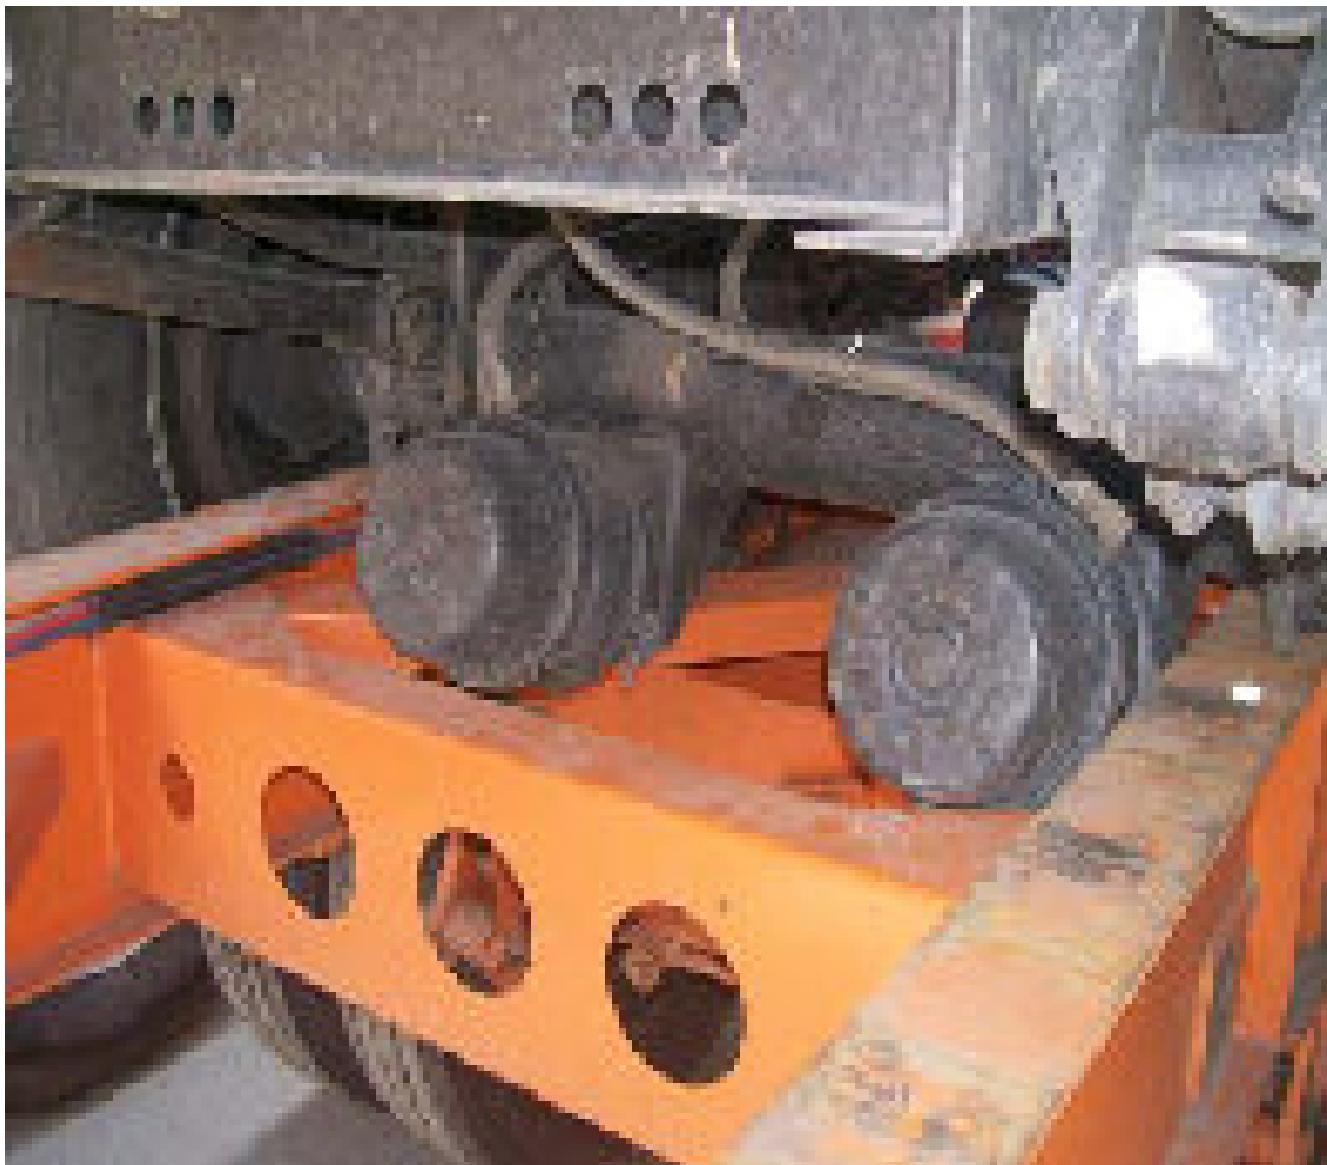
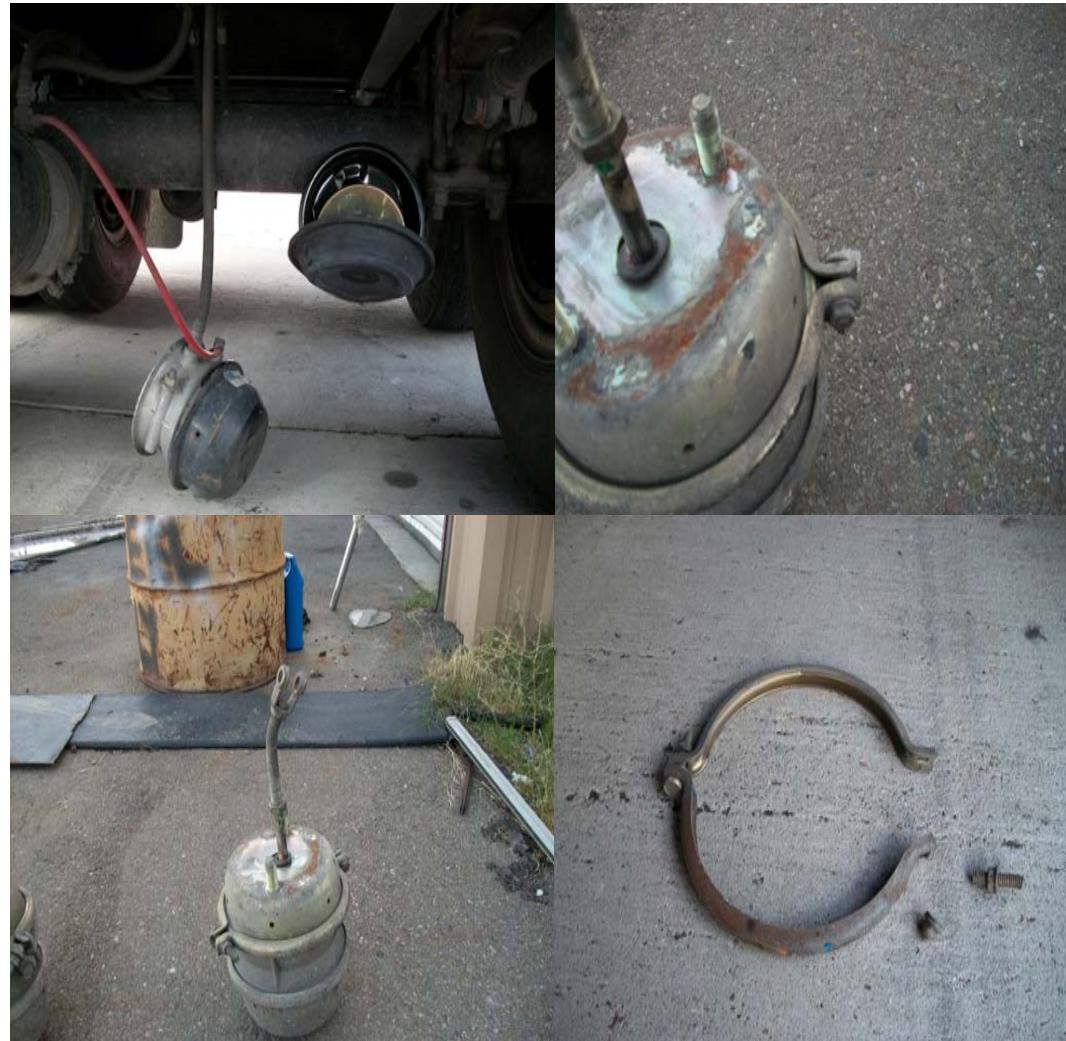
- Driver stated air system for brakes was leaking.
- Mechanic investigated origin of leak.
- Touched brake chamber with hand.
- Due to broken retaining ring bolt (result of stacking), diaphragm became projectile and struck the mechanic.
- Connected airlines prevented serious injury.
