BIAS TIRE CONDITIONS ANALYSIS & REPAIR GUIDE

© Copyright 2008—Technology & Maintenance
Council of American Trucking Associations, Inc.
Printed in U.S.A.

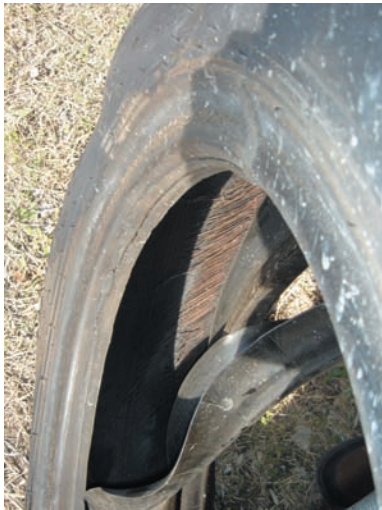
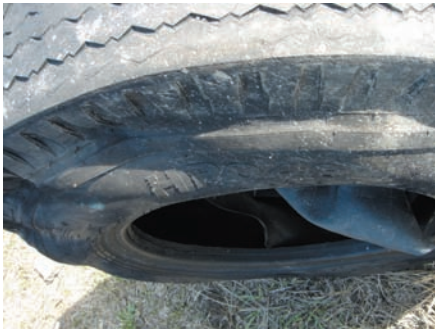
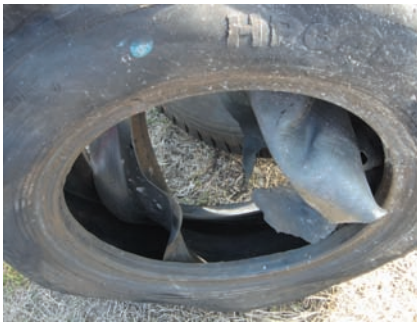
PROBABLE CAUSE

Continued operation while underinflated and/or overloaded.

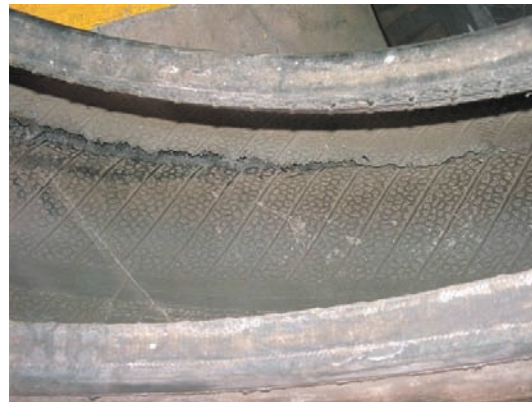
PROBABLE CAUSE

Continued operation while overloaded and underinflated

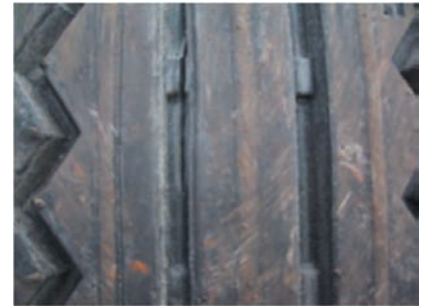
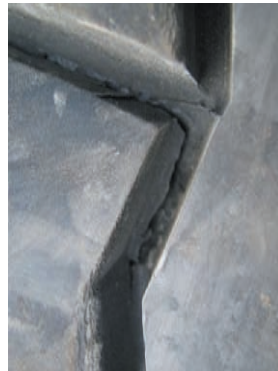
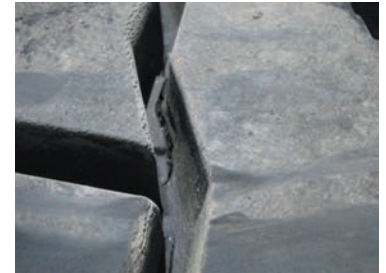
PROBABLE CAUSE

Caused by casing growth, prolonged underinflation, weathering or insufficient undertread in new tire. Can be aggravated by excessive speed and rock cuts.

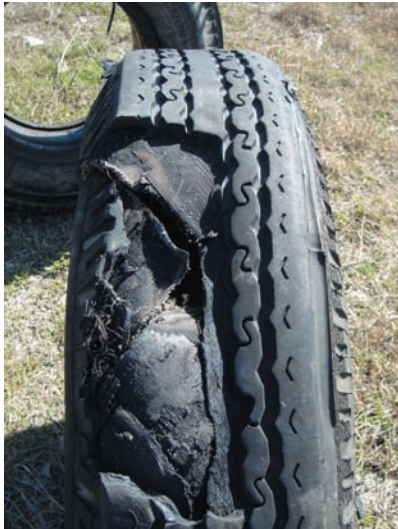
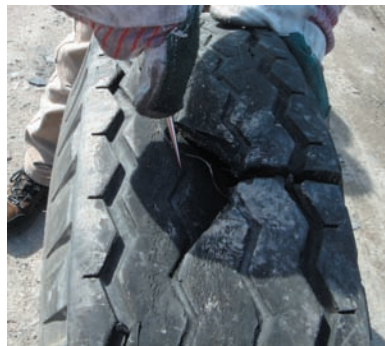
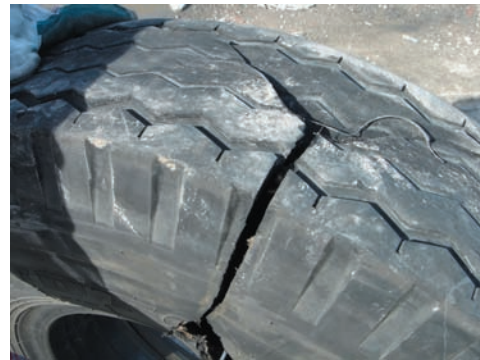
Severe, concentrated impact with a foreign object or a pothole. Aggravated by overinflation and high speed.

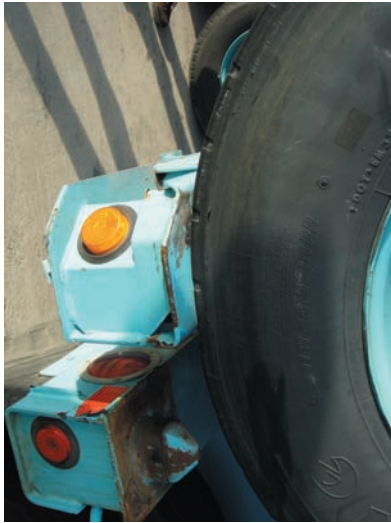
Caused by tire contact with stacked chassis component.

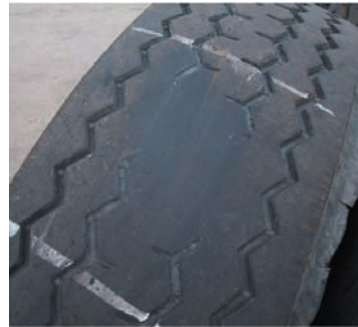
PROBABLE CAUSE

Brake skid usually occurs on trailer and drive tires. Aggravated by new brakes (high friction, not worn in), unbalanced brake system, aggressive use of brakes, driver abuse and unloaded vehicles. Frequently associated with gravel surfaces

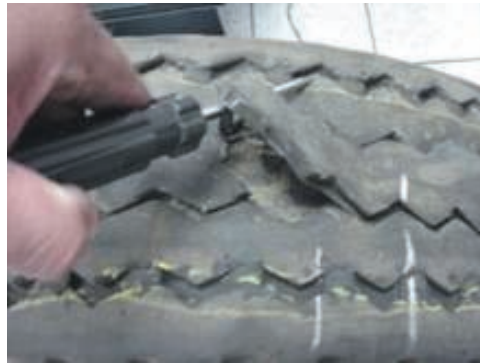
Caused by tire running over curbs or rails or by severe localized impacts.

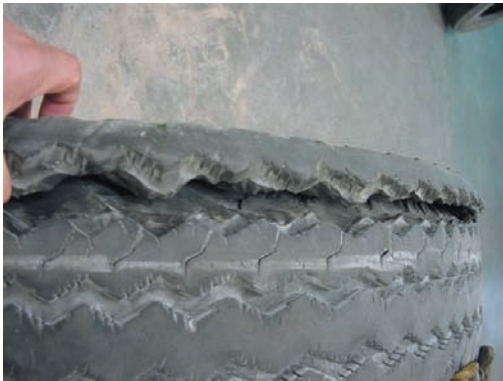
PROBABLE CAUSE

Caused by running over curbs, rails, sidewalks or sharp turning. Sometimes could be caused by a tread leaving casing.

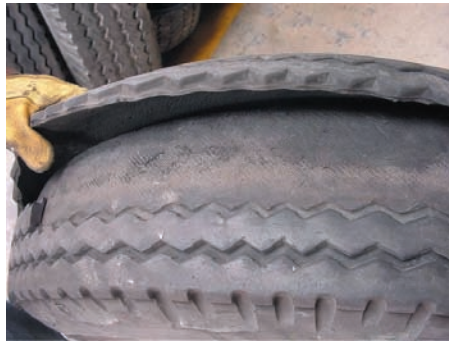
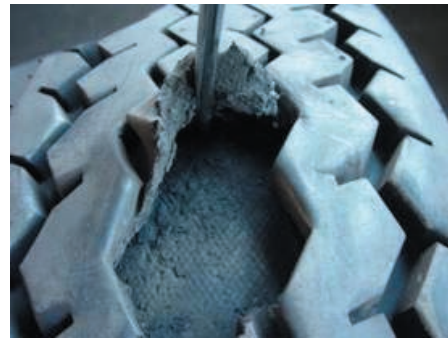
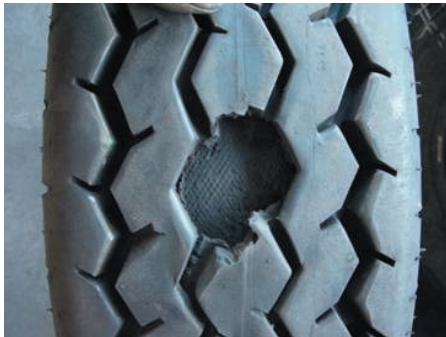
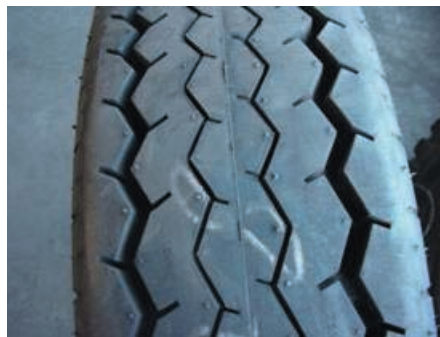
PROBABLE CAUSE

Adhesion loss between the tread rubber and the tire belt package. Can be caused by tread penetration and/or cut. Also, missed nail hole in retread.

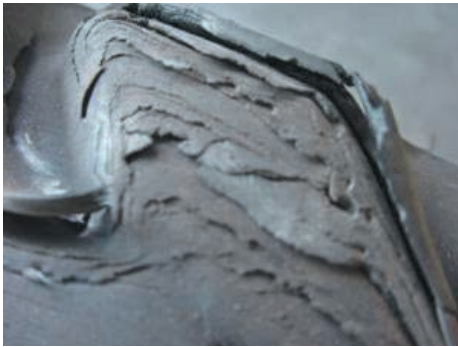
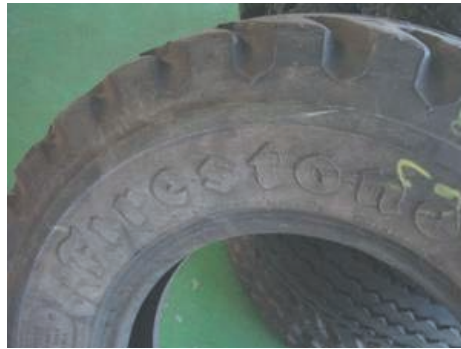
PROBABLE CAUSE

Rubber compounding condition, contamination of tread rubber.

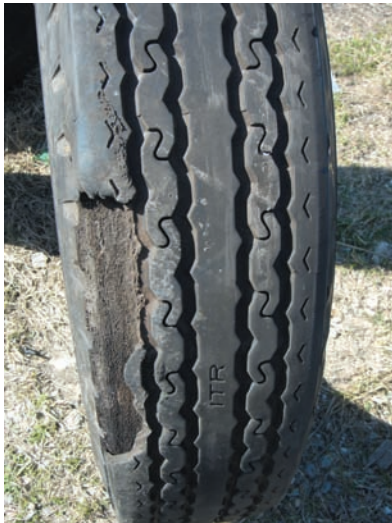
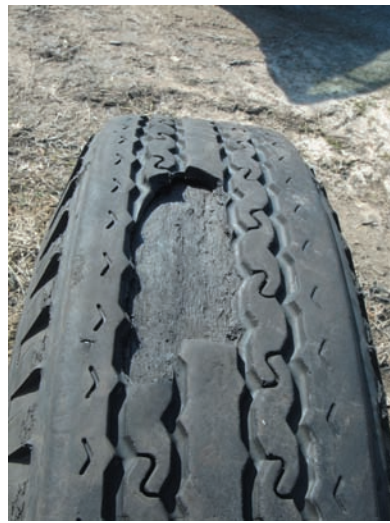
PROBABLE CAUSE

Cure pressure. Faulty retread workmanship and/or material such as a scorched or contaminated buffed surface, old cushion gum, wet cement, or tread rubber, improper cure conditions, missed nail hole, or a faulty repair.

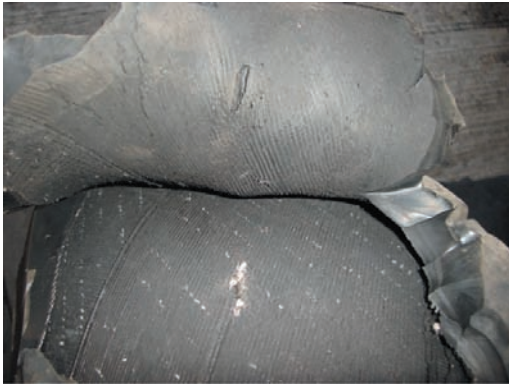
PROBABLE CAUSE

Faulty repair. Air seeped through or was trapped in the injury and under the tread which eventually reduced adhesion between the tread and the tire and resulted in a separation.

Consult your retreader and/or repair supplier for possible warranty adjustment. Repair and retread the tire again if possible.

Review repair techniques with your repair technician or repair supplier.

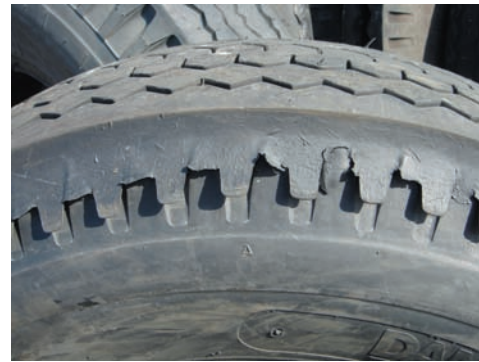
PROBABLE CAUSE

Untrimmed rubber after curing.

Cosmetic condition. Tire can be left in service.
